# Phnom Bakheng Conservation Master Plan

# **Phnom Bakheng Conservation Master Plan: the conservation and presentation of Phnom Bakheng**

## **Volume 2: Supporting Data**

June 2006

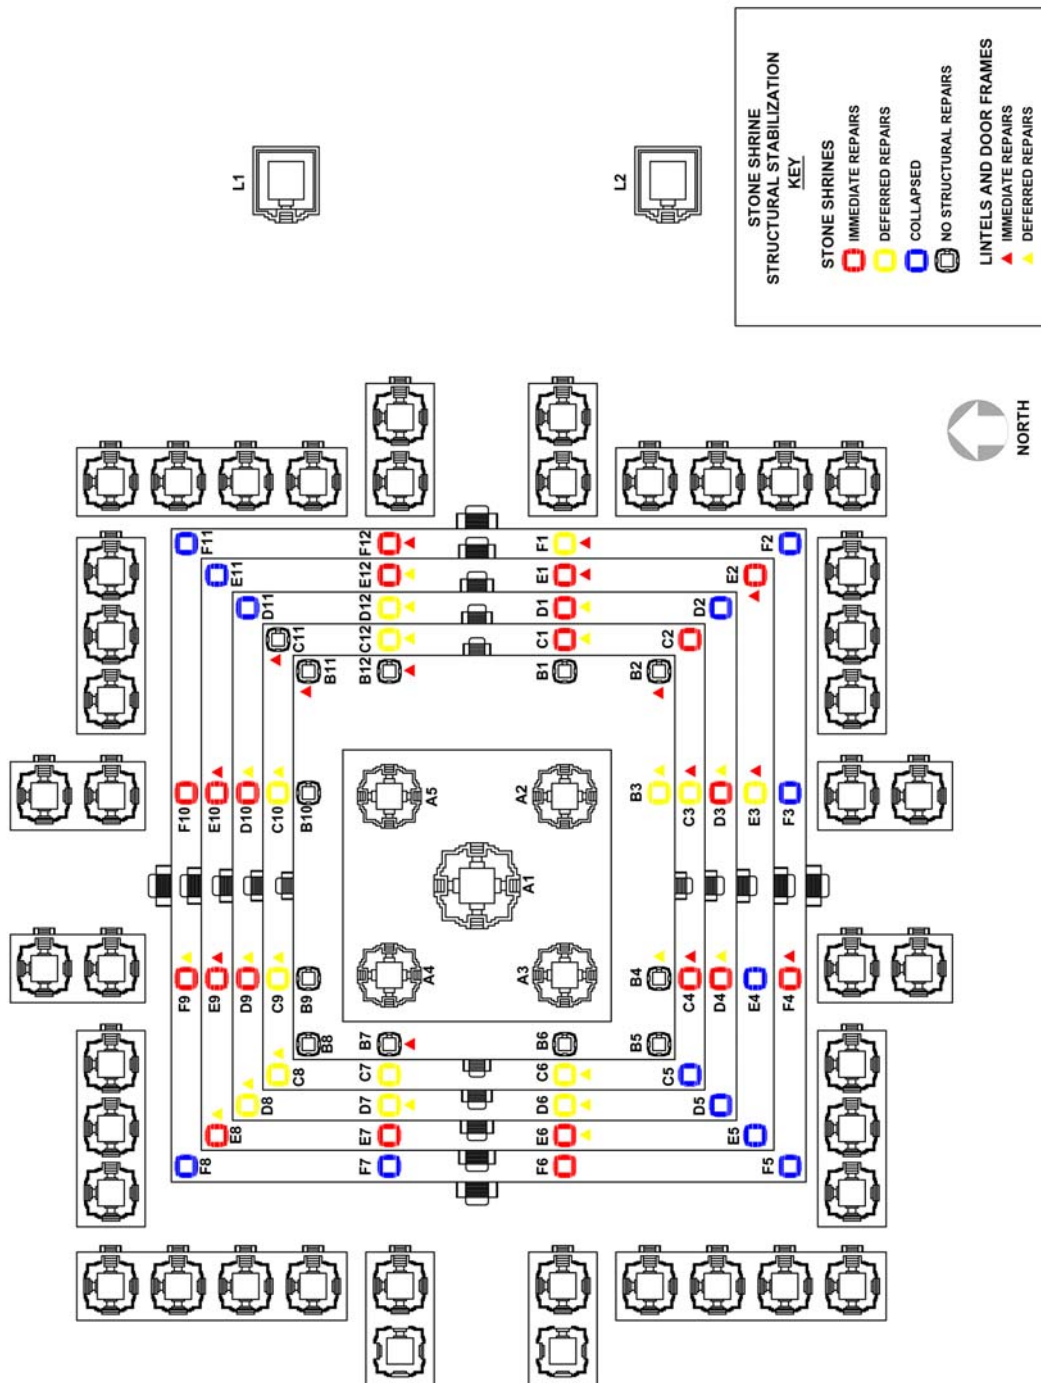
Figure 1 Structural Risk Map – Sandstone Shrines (MS 2006)

7.1.1 **Sandstone Shrines:** 60 sandstone shrines, 12 per terrace at Bakheng temple were evaluated for structural risk during *Mission II*, March 2005. Observations were made on site to evaluate the level of structural damage for each structure, including measurements of wall plumb, crack mapping, evaluation of foundations for movement, and collapse of adjacent structures. Information was input into a database for analysis.

Sandstone Shrine No. <sup>1</sup>	Risk Index	Foundation Risk Index	Measured Lean (degrees)	Repair No.	Notes
C4	1.00	0.75	6	1	Severe movement, tilting to north, foundation movement.
F6	0.55	1.00	6	2	Foundation collapsing, overhang up to 45 cm, severe wall leaning, stones missing at south.
F12	0.45	1.00	8	3	Foundation movement, no longer supporting shrine, severe wall leaning.
E10	0.40	1.00	7	4	Foundation moved/collapsed, up to 20 cm overhang, severe leaning, many crushed stones (replace between 18 and 24), old concrete props.
E2	0.35	1.00		5	Foundation collapsed, concrete props in place.
E7	0.30	1.00		6	Major foundation movement, settlement; stone damage/crushing.
E9	0.30	1.00	4	7	Major foundation movement, up to 40 cm overhang, moderate lean. Reset foundation stones at north, provide foundation bearing.
F10	0.30	1.00	2	8	Foundation collapsed, 20 cm overhang, wall above leaning on shrine, moderate lean.

D1	0.30	0.75	2	9	Wide cracks, leaning, foundation movement.
E12	0.30	0.75		10	Foundation settlement, wide joints.
D3	0.28	0.75		11	Foundation movement at west (moderate leaning), crushed stones, bullet damage.
E1	0.25	1.00	2	12	Major foundation movement, wide joints, minor leaning, stone ready to fall.
C1	0.23	1.00		13	Large displacement, some foundation movement.
C2	0.20	1.00		14	Foundation collapse, potential for future movement.
E8	0.20	1.00		15	Foundation collapsed, 29 cm overhang.
F4	0.20	0.25	5	16	Wall above leaning on shrine, severe lean. Unload by rebuilding wall above.
D4	0.18	0.50		17	Foundation movement, minor leaning, 2 stones ready to fall.
D10	0.18	0.25	3	18	Minor joint opening; displaced stone.
F9	0.15	1.00		19	Foundation collapsed, concrete prop installed to support wall, 12 cm overhang.
E6	0.15	0.50	2	20	Minor foundation movement, wide joints.
D9	0.13	0.25	1	21	Slight foundation movement, minor joint opening. Old concrete props at missing stones.

E4	0.10	1.00		22	90% collapsed, foundation collapsed.
C8	0.10	0.75		23	Foundation movement on west.
C9	0.10	0.75		24	Wide cracks, stone rotation, foundation movement at north.
D6	0.10	0.50	4	25	Wide cracks, moderate lean to east, stone at north ready to fall.
D8	0.10	0.25		26	Slight foundation movement, minor joint opening.
C3	0.10			27	Mostly collapsed. Stones remain as rubble; stockpile for possible rebuilding.
C6	0.10			28	Wide cracks. Stone crushing at northwest corner, spalls.
C7	0.10		2	29	Wide cracks. Stone crushing at northwest corner, spalls.
D7	0.10			30	Wide cracks, stone displacement.
B3	0.10			31	Prior concrete repair failed
E3	0.08	1.00		32	Foundation collapsed, overhangs 26 cm, stone ready to fall at north.
F1	0.05	0.75	2	33	Foundation movement, poor bearing on wall below, stone crushing, wide joints.
D12	0.05		1	34	
C12	0.05			35	Minor movement.
C10	0.03			36	Bullet damage, stone spalls.

D5	0	0.75		37	80% collapsed, foundation movement.
B1	0			38

Sandstone Shrine No. <sup>1</sup>	Risk Index	Foundation Risk Index	Measured Lean (degrees)	Repair No.	Notes
B2	0			39	
B4	0			40	
B5	0			41	
B6	0			42	
B7	0			43	
B8	0			44	
B9	0			45	
B10	0			46	
B11	0			47	
B12	0			48	
C5	0			49	95% collapsed.
C11	0			50	Prior cement patches.
D2	0			51	85% collapsed.
D11	0			52	95% collapsed.
E5	0			53	100% collapsed.
E11	0			54	100% collapsed.
F2	0			55	100% collapsed.
F3	0			56	100% collapsed.
F5	0			57	90% collapsed.
F7	0			58	100% collapsed.
F8	0			59	90% collapsed.
F11	0			60	100% collapsed.

Stone Shrine No. <sup>1</sup>	Risk Index	Repair No.	Lintel/Door Frame Repair Notes
E2	1.00	1	Cracked lintel and threshold. Old concrete prop installed.
F4	1.00	2	Cracked lintel and threshold.
C4	0.70	3	Jambs failed, severe movement of door frame.
E1	0.45	4	Cracked lintel, jambs, threshold, some material deterioration.
E10	0.30	5	Crushing at north jamb, poor bearing condition at lintel.
F12	0.30	6	Spall, crack at jamb near lintel bearing.
F1	0.30	7	Poor lintel bearing, cracked jamb stone at north.
E3	0.25	8	Crack forming in lintel near bearing.
C3	0.20	9	Threshold cracked and displaced, stone deterioration at jambs.
C11	0.20	10	Deteriorated stone at lintel, jamb, concrete beam.
E9	0.20	11	Crack in lintel at north bearing, spall at jamb.
B2	0.20	12	Cracked lintel.
B7	0.20	13	Cracked lintel.
B11	0.20	14	Cracked lintel.
B12	0.20	15	Cracked lintel.
D10	0.15	16	Stone deterioration at door frame.
F9	0.15	17	Stone deterioration, spall at north jamb.

D1	0.13	18	Stone deterioration at jambs.
B4	0.10	19	Severe stone deterioration at door frame.

Stone Shrine No. <sup>1</sup>	Risk Index	Repair No.	Lintel/Door Frame Repair Notes
C1	0.10	20	Stone deterioration at jambs.
C12	0.10	21	Deteriorated stone at door frame.
D4	0.10	22	Deteriorated stone at threshold and jambs.
D8	0.10	23	Minor frame movement, crushing and spall at jamb.
D9	0.10	24	Stone deterioration at jambs.
D12	0.10	25	
E8	0.10	26	Stone deterioration at jambs.
B3	0.05	27	Prior concrete repair failed.
C6	0.05	28	Minor frame deterioration.
C8	0.05	29	Frame cracked at base.
C9	0.05	30	Cracked threshold.
C10	0.05	31	Crack, spall at frame.
D3	0.05	32	Lintel movement at south bearing.
D7	0.05	33	Minor stone deterioration at south lintel bearing.
E6	0.05	34	Crack, spall in jamb near base.
E12	0.05	35	Slight stone deterioration at door frame.
D6	0.03	36	Slight stone deterioration at door frame.
B1	0.00	37	
B5	0.00	38	
B6	0.00	39	
B8	0.00	40	
B9	0.00	41	
B10	0.00	42	
C2	0.00	43	
C5	0.00	44	
C7	0.00	45	
D2	0.00	46

D5	0.00	47	
D11	0.00	48	
E4	0.00	49	
E5	0.00	50	
E7	0.00	51	
E11	0.00	52	
F2	0.00	53	
F3	0.00	54	
F5	0.00	55	
F6	0.00	56	
F7	0.00	57	
F8	0.00	58	
F10	0.00	59	
F11	0.00	60

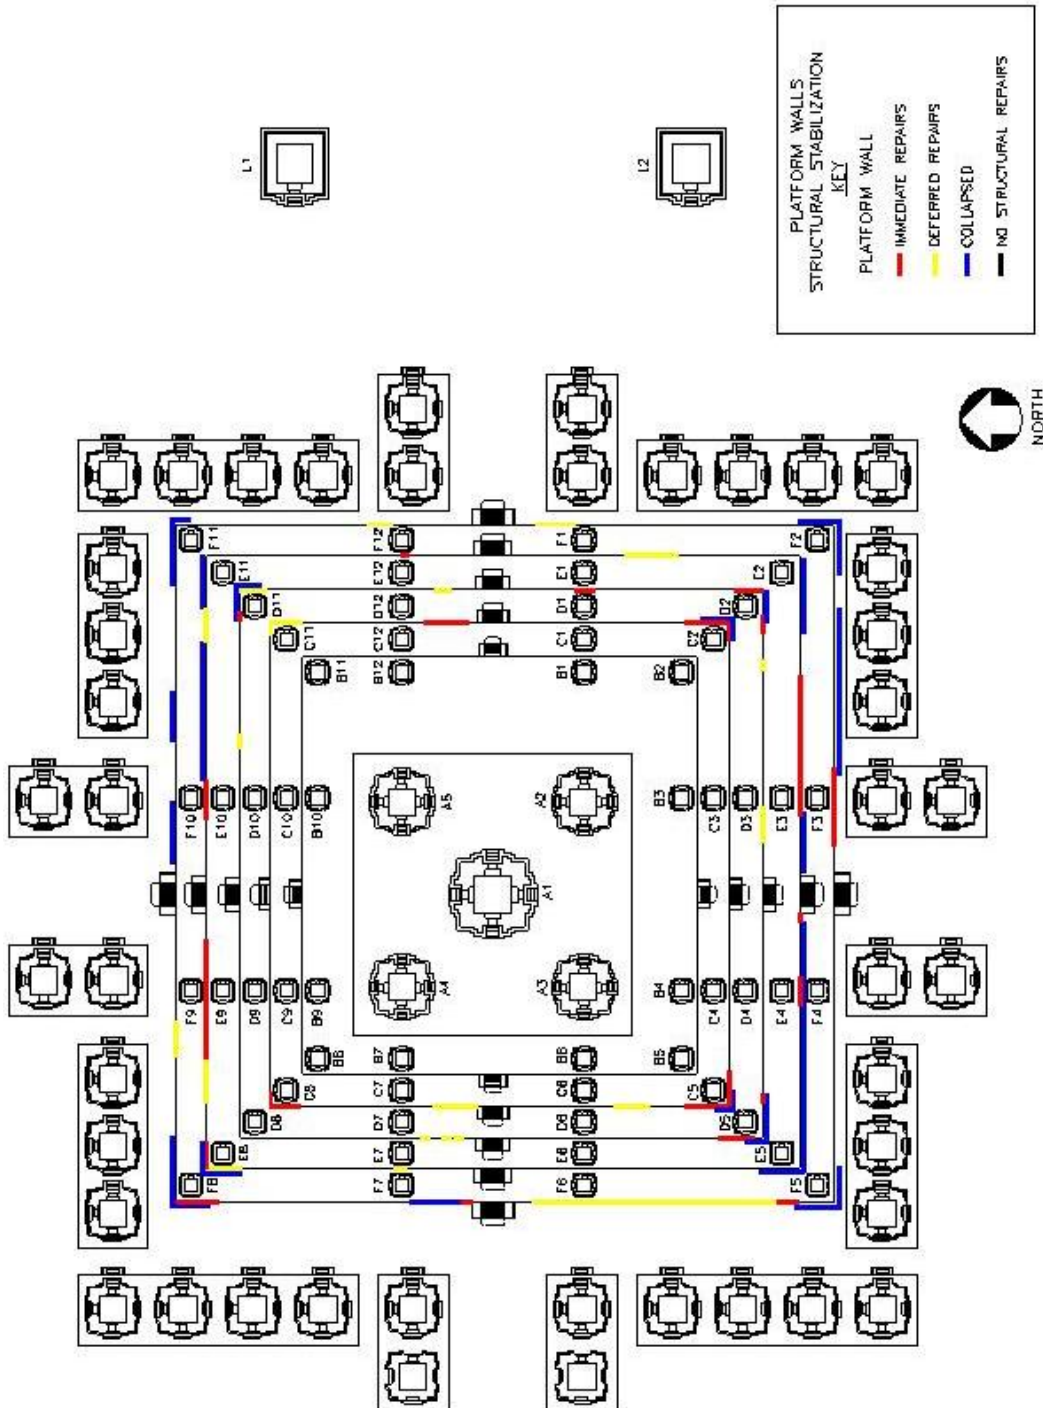
Figure 2 Structural Risk Map – Platform Walls (MS 2006)

7.1.2 **Platform Walls:** the original bedrock of the *phnom* was excavated and shaped to fit the general form of the temple. Dry-laid sandstone was used as a veneer to face the bedrock at each of the five platform levels. Platform walls range in height from 1.79 m (top level, or Level 5) to 3.5 m (bottom Level 1). The total length of all platform walls is nearly 1,200 m.

Platform Walls, Level 5: No immediate or deferred repairs required.

Elevation	Location	Measured Lean (degrees)	Repair No.	Notes	Repair Type
South	3 to 12 m east of stairs	5 - 14	1	Leaning, under shrine bearing	Immediate
West	4 to 6 m from south corner	11	2	Leaning near collapsed area	Immediate
West	4 m from north corner	9	3	Leaning outward	Immediate
West	1 m north of stairs		4	Wall bulging out	Immediate
West	2 m from stairs to south corner	6	5	Top 1 - 2 courses rotated inward	Deferred
East	21 to 24 m from north corner	6	6	Bulged area	Deferred
North	14 m west of stairs	5	7	Bulged area	Deferred
East	2 to 8 m south of stairs	2 - 5	8	Bulged area	Deferred

Elevation	Location	Measured Lean (degrees)	Repair No.	Notes	Repair Type
South	7 to 10 m west of stairs	~30	1	Leaning on shrine below	Immediate
North	0 to 3 m from west corner		2	Top courses missing at shrine bearing	Immediate
North	7 to 12 m east of stairs	4	3	Leaning on shrine below	Immediate
East	8 m north of stairs	3	4	Stone fallen, resting on shrine below	Immediate
South	7 to 23 m east of stairs	9 - 14	5	Bulged, shoring in place, needs stabilization	Immediate
South	1 m west of stairs	9	6	Leaning, adjacent to collapsed zone	Immediate
North	5 to 16 m west of stairs	5 - 9	7	Leaning, shoring in place	Immediate
North	6 to 10 m from east corner		8	Adjacent to collapsed sections, stabilize	Deferred
West	Below north stone shrine	5	9	Top course rotated, wall leaning	Deferred
West	0 to 4 m from north corner		10	Partially collapsed, leaning	Deferred
North	4 to 9 m from west corner	8	11	Bulging	Deferred
East	14 to 20 m from south corner	6	12	Bulged area	Deferred

Elevation	Location	Measured Lean (degrees)	Repair No.	Notes	Repair Type
South	0 to 5 m from west corner	13 - 19	1	Collapsed, rotated stones	Immediate
North	3 to 4 m from east corner	12	2	Leaning near collapsed area	Immediate
West	1 to 4 m from south corner	11	3	Leaning near collapsed area	Immediate
East	0 - 3 m from south corner	10	4	Stabilize at corner	Immediate
East	8 - 9 m south of stairs		5	2 Stones fallen, leaning on shrine below	Immediate
South	4 to 5 m from west corner		6	Collapsed at corner, displaced near collapse	Immediate
North	15 m north of stairs	4	7	Stones displaced outward 14 cm	Deferred
East	3m north of stairs		8	Stones displaced 15 cm, reset	Deferred
South	8 m from west corner		9	Stone displaced 15 cm	Deferred
South	4 to 8 m east of stairs	5 - 6	10	Bulge	Deferred
East	0 to 3 m from north	4	11	Collapsed, leaning section, laterite fill decayed	Deferred
West	1.5, 2.5, 5 m north of stairs		12	Stones displaced outward	Deferred

Elevation	Location	Measured Lean (degrees)	Repair No.	Notes	Repair Type
West	0 to 3 m from northwest corner	14 (inward) 5 (outward)	1	Top course tipped in, severely where stone shrine above bears on wall. Leaning somewhat at corner. Shore/rebuild wall at shrine foundation.	Immediate
North	0 to 1.6 m from northwest corner		2	Movement, bulging, stone shrine directly above.	Immediate
East	1-5m north of stair wall	10	3	Prop top course at missing stone (immediate). Relay stones at top 2 courses where tilted outwards (no repair/defer).	Immediate
South	0 to 4 m from southwest corner	10	4	Collapsed, bulged at adjacent area. Rebuild at corner.	Immediate
East	0 to 5 m from southeast corner	9	5	Collapsed section; severe lean adjacent to collapse. Rebuild at bulged zone	Immediate
South	0 to 2 m from southeast corner		6	Collapsed, displaced stones. Rebuild at corner.	Immediate
West	0 to 5 m from southwest corner	4	7	Collapsed, bulged at adjacent area. Rebuild at corner.	Immediate

West	0 to 5 m north of stair wall		8	Stone rubble piled on wall, overhanging. Remove.	Deferred
North	Northeast corner		9	Several stones missing, stone shrine above.	Deferred
West	12 to 16 m south of stair wall	6	10	Bulged section; rebuild	Deferred
East	0 to 3.5 m from northeast corner	4 - 6	11	Minor damage, some displacement	Deferred

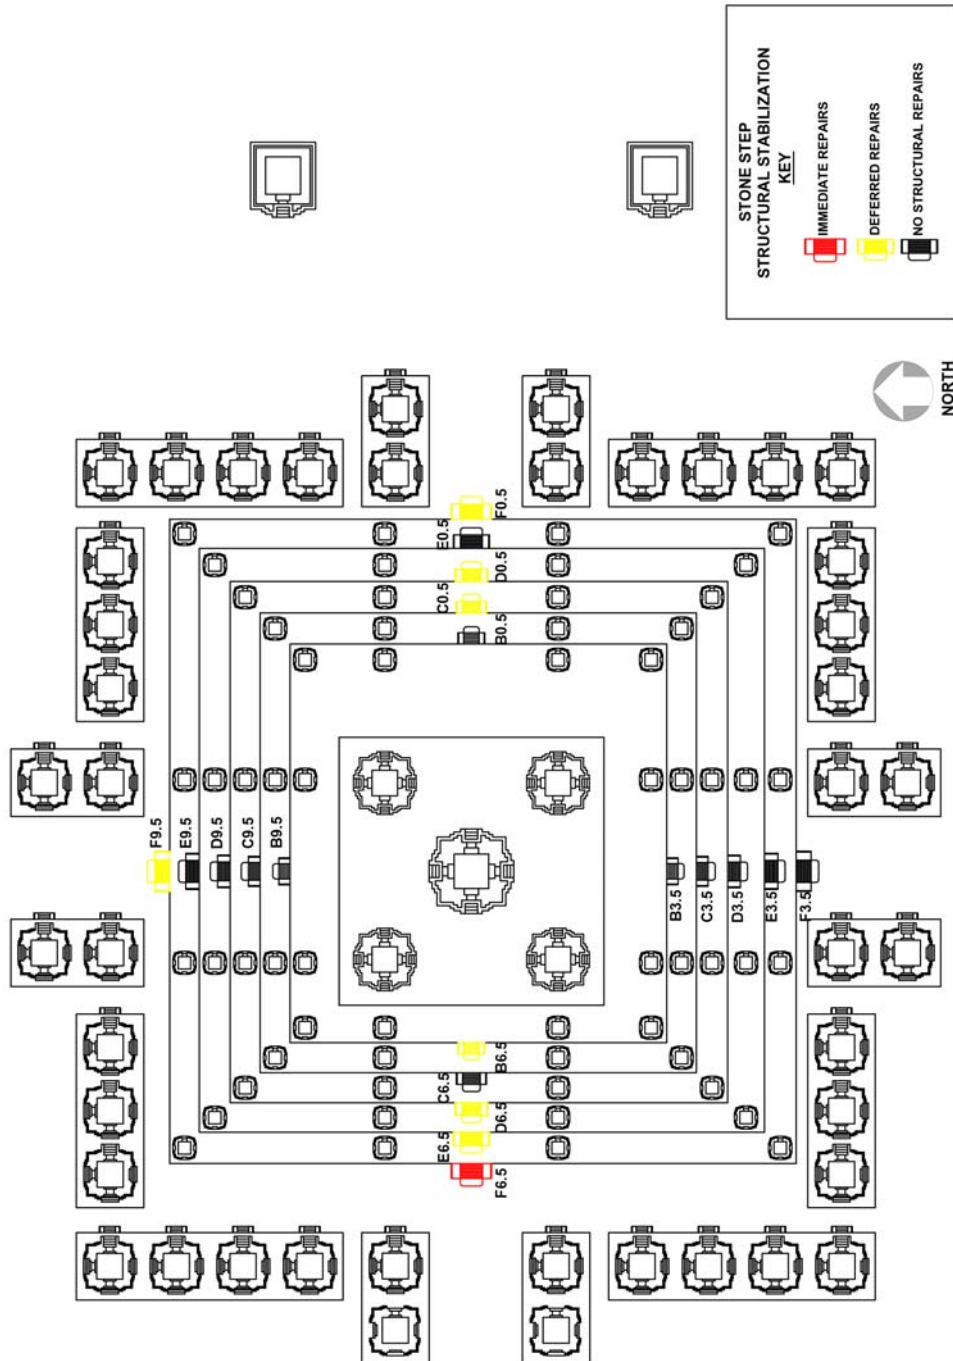
Figure 3 Structural Risk Map – Stone Steps (MS 2006)

**7.1.3 Stone Steps:** Bakheng's Sandstone Steps: a series of stone steps on each cardinal axis provide access to the platform levels. A total of 20 stone step structures are built integral with the platform walls at mid-point along the east and west sides of the temple and offset towards the west on the south and north sides. Each stone step structure rises to the next platform level with between 7 and 11 steps, flanked with integral buttresses projecting out from the platform walls.

<b>Stone Step No.<sup>1</sup></b>	<b>Risk Index</b>	<b>Repair No.</b>	<b>Notes</b>	<b>Repair Priority</b>
F6.5	0.73	1	Westernmost wall portions built on fill. Large movement (8-15 cm), rebuild west portion of wing walls to vertical crack.	Immediate
E6.5	0.65	2	Reset falling stone at north, repair 2 steps with deep spalls	Deferred
B6.5	0.50	3	Broken/spalled step	Deferred
D6.5	0.15	4	Reset stone at south, 2nd course from top: 24 cm movement	Deferred
C0.5	0.10	5	South wall: stone pushed out 6 - 10 cm, reset stones at top 2 courses.	Deferred
F9.5	0.05	6	Replace concrete props at east wall with stone? Top step missing but bedrock forms good step. Landing stones at bottom step scattered - reposition.	Deferred
D0.5	0.05	7	Replace missing stone at south, 2nd course	Deferred
F0.5	0.05	8	Missing stone at north wall, 2nd course. Top step spalled.	Deferred
B9.5	0.50	9	26 cm deep spall at west wall. Cracks wide but stable.	None

C3.5	0.33	10	Wide cracks, stone displacement. Stable but consider resetting stones.	None
C9.5	0.30	11		None
C6.5	0.20	12	Rotated, displaced stones at top 2 courses	None
E3.5	0.15	13		None
D3.5	0.14	14	Several deep spalls, patching needed	None
D9.5	0.10	15		None
F3.5	0.08	16	2 broken steps - climbing hazard	None
B3.5	0.06	17	Place stones back in position, remove improper mortar patches at joints (which are hard, cracked)	None
E9.5	0.05	18		None
B0.5	0.05	19	2nd step from top: spall at one end	None
E0.5	0.00	20		None

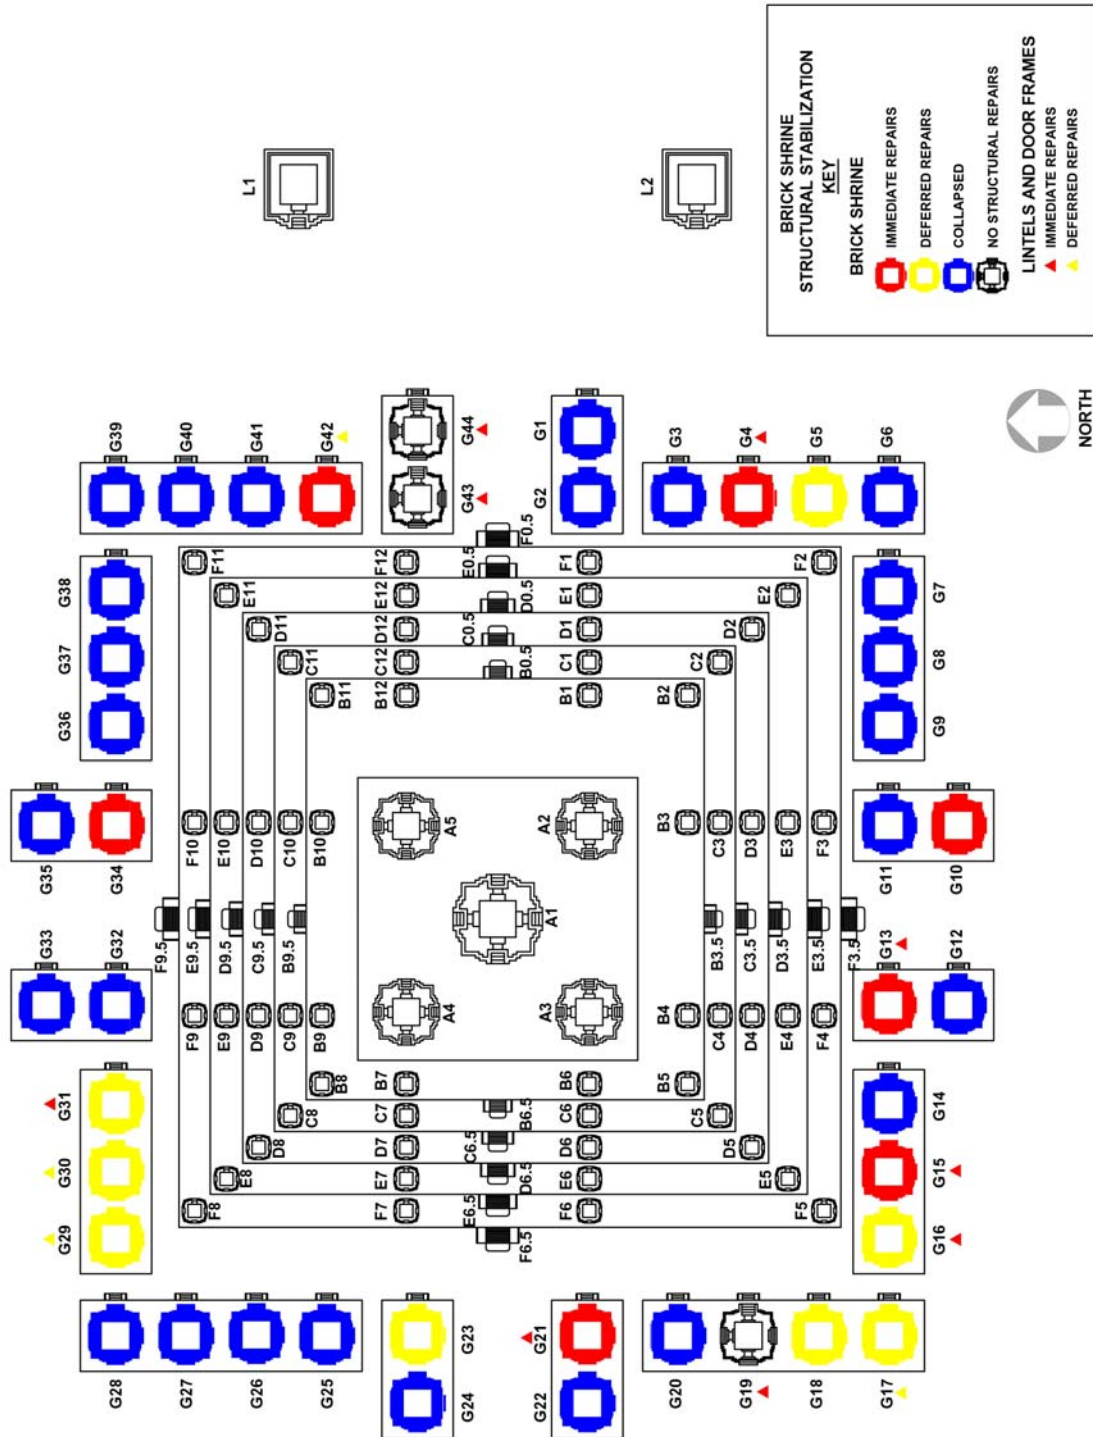
Figure 4 Structural Risk Map – Brick Shrines (MS 2006)

7.1.4 **Brick Shrines:** a total of 44 brick shrines are constructed around the lowermost platform wall of Bakheng. Brick shrines were evaluated for structural risk during the Mission II, March 2005. Observations were made on site to evaluate the level of structural damage for each structure, including measurements of wall plumb, crack mapping, evaluation of foundations for movement, and condition of lintels and door frames. Information was input into a database for analysis.

Brick Shrines No. <sup>1</sup>	Risk Index	Foundation Risk Index	Measured Lean (degrees)	Repair No.	Notes	Repair Type
G-21	0.55	0.80	4	1	Walls: leaning, wide crack opening. Many foundation perimeter stones missing, partial collapse at corners. Brace/stabilize walls; stabilize foundation.	Immediate
G-42	0.50	0.45	2 to 15	2	Severe lean of north wall above door frame: brace. Foundation settlement, stabilization required.	Immediate
G-13	0.45	0.75		3	Replace or rebuild stones at foundation perimeter.	Immediate
G-10	0.30	0.85	4	4	Foundation repairs critical, collapsing, undermined. Walls leaning, damaged. Stabilize/rebuild foundation	Immediate
G-15	0.30	0.60		5	Remove large growing tree from west elevation. Check foundation for stabilization need.	Immediate
G-4	0.30	0.05		6	Stabilize brick corbel above east entry.	Immediate
G-34	0.10	0.20		7	Loose brick in danger of falling: remove or stabilize in place.	Immediate

G-23	0.45	0.20	2	8	Walls leaning, wide cracks.	Deferred
G-5	0.40	(buried)	5	9	Check existing concrete props. Brace upper portion of north wall?	Deferred
G-30	0.40	0.75	6	10	Foundation collapsing, especially at north and southeast corner. Concrete infill and props are in place. Check for adequacy. North wall has severe lean.	Deferred
G-29	0.35	0.95	4	11	Foundation very poor, stone deteriorated: check existing concrete infill for adequacy.	Deferred
G-17	0.20	0.80		12	Stabilize falling stones at southwest corner near base.	Deferred
G-16	0.15	0.80		13	Foundation in poor condition; stabilize.	Deferred
G-31	0.10	0.70	5	14	North wall leaning. Foundation collapsing under north wall, concrete prop in place. Rebuild foundation perimeter.	Deferred
G-18	0.10	0.60	5	15	Wall section rotated, brace. Foundation stabilization required.	Deferred
G-19	0.30	0.80		16	Foundation perimeter stones missing, stabilization required.	No Repair

G-43	0.25	0.30	6	17	Walls leaning, foundation settlement, stabilization required.	No Repair
G-44	0.05	0.55	3	18	Walls essentially collapsed. Severe foundation settlement at corners.	No repair
G-1				19	Collapsed	
G-2				20	Collapsed	
G-3				21	Collapsed	
G-6				22	Collapsed	
G-7				23	Collapsed	
G-8				24	Collapsed	
G-9				25	Collapsed	
G-11				26	Collapsed	
G-12				27	Collapsed	
G-14				28	Collapsed	
G-20				29	Collapsed

Brick Shrines No. <sup>1</sup>	Risk Index	Foundation Risk Index	Measured Lean (degrees)	Repair No.	Notes	Repair Type
G-22				30	Collapsed	
G-24				31	Collapsed	
G-25				32	Collapsed	
G-26				33	Collapsed	
G-27				34	Collapsed	
G-28				35	Collapsed	
G-32				36	Collapsed	
G-33				37	Collapsed	
G-35				38	Collapsed	
G-36				39	Collapsed	
G-37				40	Collapsed	
G-38				41	Collapsed	
G-39				42	Collapsed	
G-40				43	Collapsed	
G-41				44	Collapsed

Brick Shrines No. <sup>1</sup>	Risk Index	Repair No.	Lintel/Door Frame Repair Notes	Repair Type
G-19	1.00	1	Severe damage to east frame, steel strap repair in place. Check for adequacy.	Immediate
G-15	0.80	2	Concrete lintel in place, check for adequacy	Immediate
G-21	0.50	3	West lintel: fractured, dropped. Brace and repair.	Immediate
G-43	0.45	4	Leaning 10 degrees. Brace/stabilize frame at south. West fronton stone collapsed, on site in vicinity.	Immediate
G-16	0.40	5	Repair cracked, spalled frame at lintel bearing.	Immediate
G-31	0.30	6	Frames at east and west racked up to 9 degrees; brace.	Immediate
G-13	0.28	7	Stabilize east door frame - south column falling, stones heavily deteriorated	Immediate
G-44	0.20	8	Critical damage to door frame at west, loose stone ready to fall. Remove or stabilize loose stone.	Immediate
G-4	0.10	9	Replace fronton and lintel stones plus columns at east, stones resting on ground. Brick corbels at east entry in critical condition and require brick removal, shoring or new lintel	Immediate

G-30	0.30	10	Lintel spalled/fractured at bearing: shore/pin.	Deferred
G-42	0.25	11	Minor material deterioration, leaning.	Deferred
G-17	0.20	12	East frame leaning, held in place by strap tie. Check adequacy of tie.	Deferred
G-29	0.20	13	Lintel fractured at bearing: shore/pin.	Deferred
G-10	0.15	14	Brace east frame - leaning out 4 degrees	No Repair
G-5	0.10	15	Brace east frame - leaning out 2 degrees	No Repair

Brick Shrines No. <sup>1</sup>	Risk Index	Repair No.	Lintel/Door Frame Repair Notes	Repair Type
G-23	0.10	16	West frame: jamb cracked (pin). North frame leaning 6 degrees. Brace/stabilize	No Repair
G-34	0.00	17	Stone deterioration at frame.	No Repair
G-1		18	Collapsed	
G-2		19	Collapsed	
G-3		20	Collapsed	
G-6		21	Collapsed	
G-7		22	Collapsed	
G-8		23	Collapsed	
G-9		24	Collapsed	
G-11		25	Collapsed	
G-12		26	Collapsed	
G-14		27	Collapsed	
G-18		28	Collapsed	
G-20		29	Collapsed	
G-22		30	Collapsed	
G-24		31	Collapsed	
G-25		32	Collapsed	
G-26		33	Collapsed	
G-27		34	Collapsed	
G-28		35	Collapsed	
G-32		36	Collapsed	
G-33		37	Collapsed	
G-35		38	Collapsed	
G-36		39	Collapsed	
G-37		40	Collapsed	
G-38		41	Collapsed	
G-39		42	Collapsed	
G-40		43	Collapsed	
G-41		44	Collapsed
