WORLD
MONUMENTS
FUND

PHNOM BAKHENG BRICK SHRINE CONSERVATION AND STABILIZATION WORKSHOP

June 1 - 4, 2010

BRICK SHRINE CONSERVATION AND STABILIZATION WORKSHOP PACKET

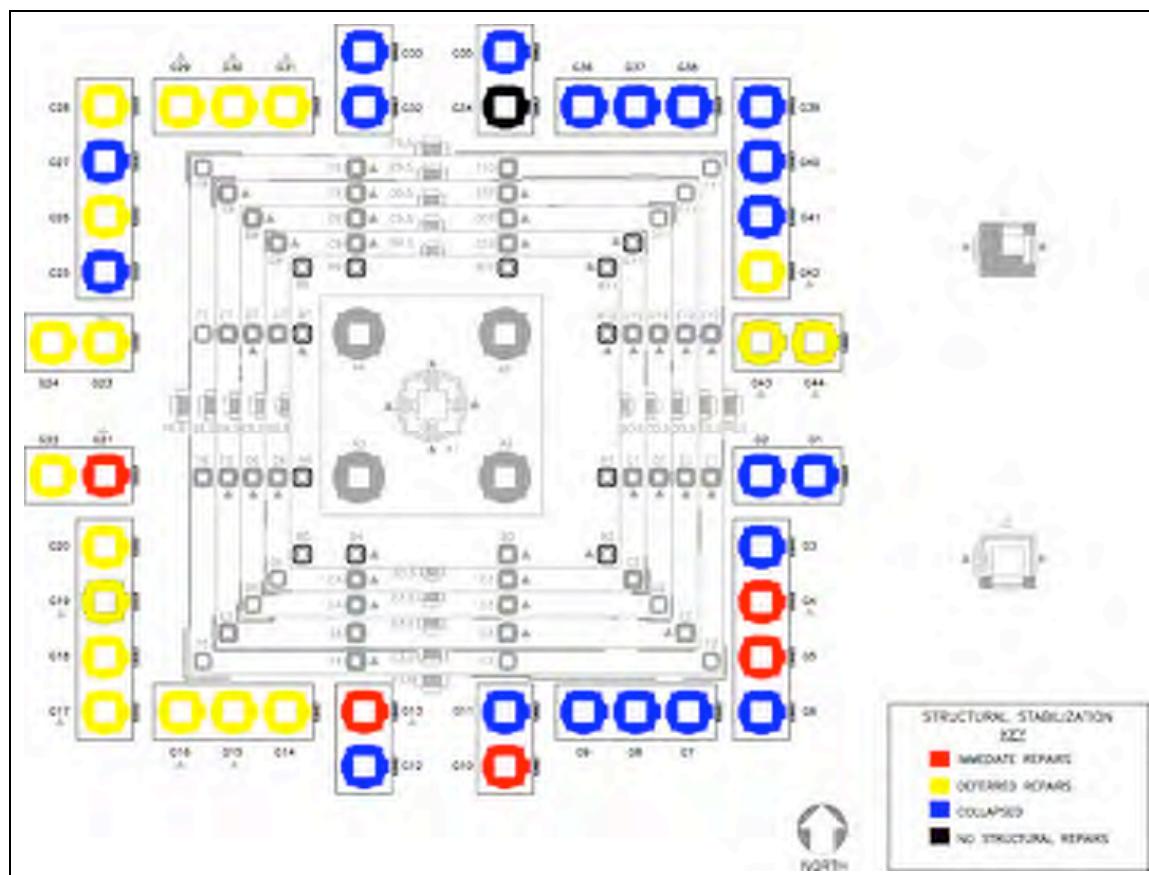
Fig 4: Structural risk map

There are forty-four brick shrines at Phnom Bakheng that encircle the central sandstone temple pyramid of which more than half (twenty-five) are fully or partially collapsed. Six of the remaining shrines require immediate attention and only four are preserved in structural sound condition.

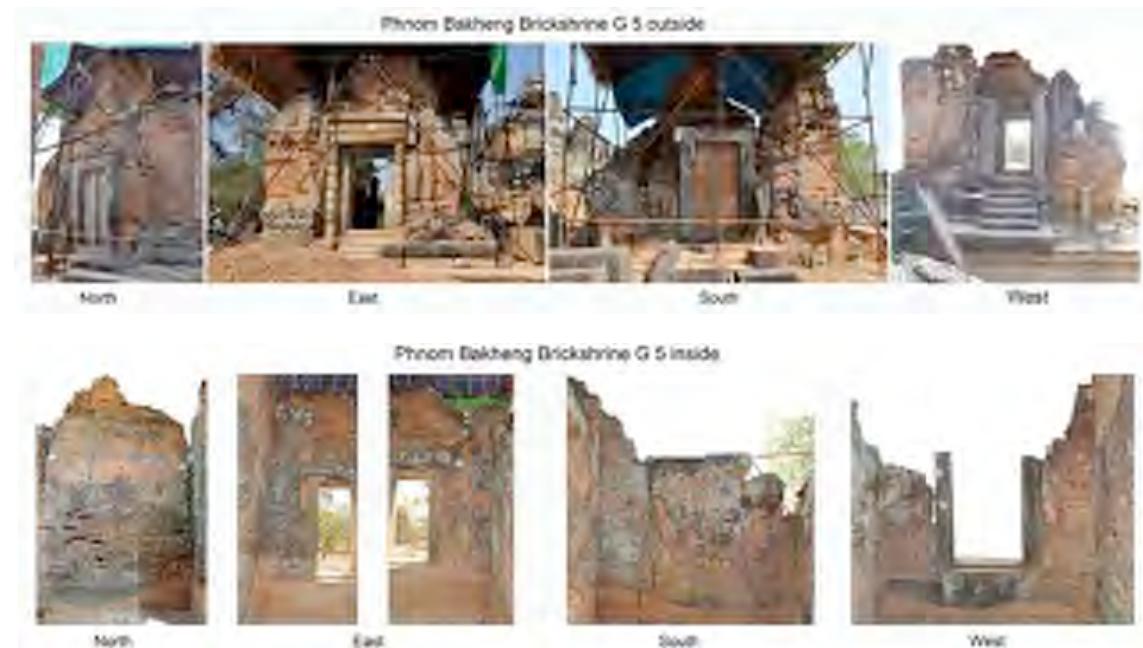
Fig 15: G5 - elevations

Brick shrine G5 is located within a soil ramp that was kept by the EFEO during their restoration and excavation campaign in 1911-1929, most likely to ease material transport to the upper terraces of the main temple. This accumulation of debris and soil has acted as an additional support for the foundation of the brick shrine and left it in structurally decent condition. In addition, several concrete columns were installed by EFEO during their restoration campaign at the southwest and southeast corners, which aided to preserve G5 in relatively sound structural condition.

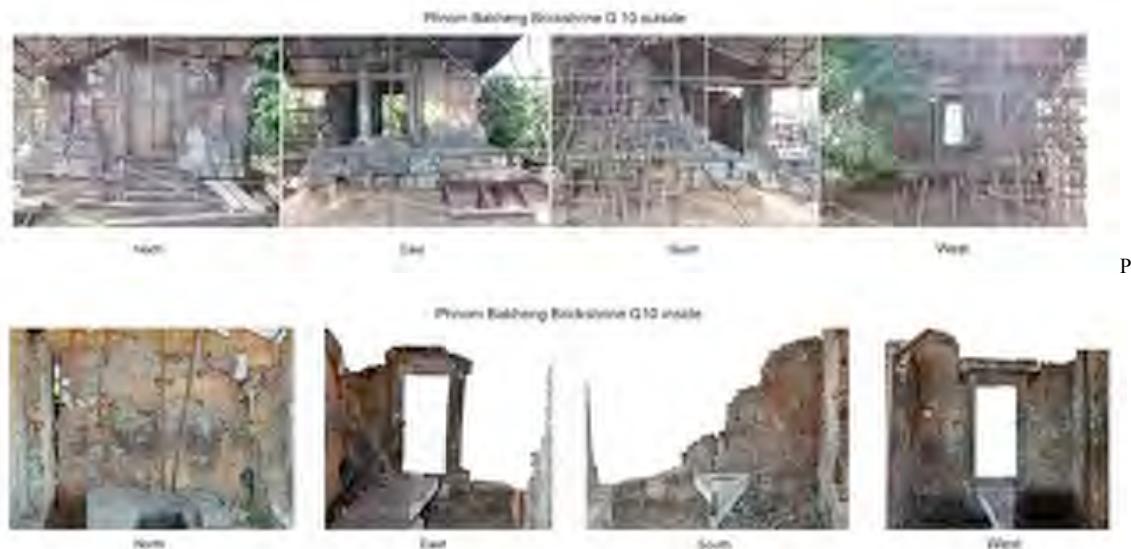
Fig 20: G10 - elevations

The majority of sandstone platform encasement of brick shrine G10 is missing, which has left the laterite blocks exposed to the elements. As a result the laterite foundation has deteriorated to the point that sandstone blocks of the base of the shrine are undermined and destabilized. Several units have dislodged leaving the corners in danger of collapse. The southwest corner is in very bad condition and remaining sandstone blocks are currently being held in place by a pipe scaffolding shoring and wooden props. At the northeast corner, several sandstone blocks fell out of place during a large rain storm in 2009. These blocks were replaced and are currently shored with wood supports.

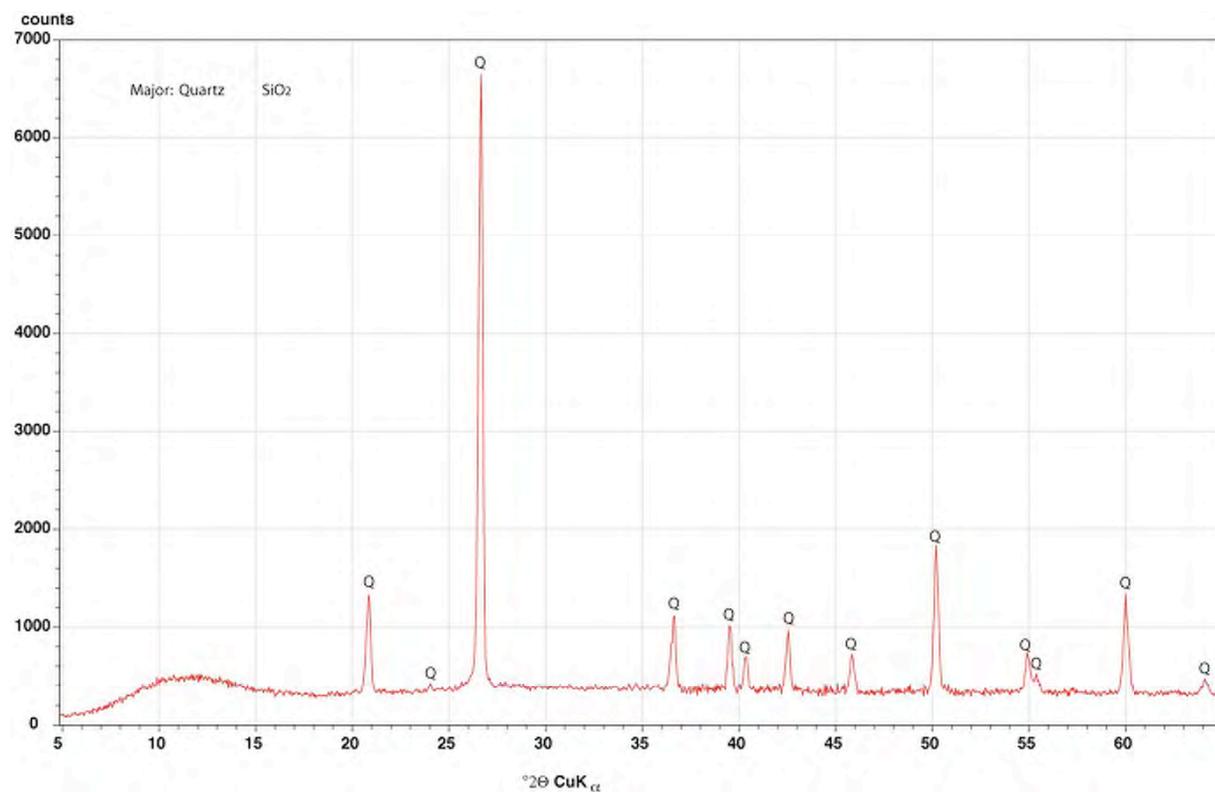
X ray diffraction analysis of the sample (Figure 1) indicates quartz is the dominant component of the brick. No other phases were present in a high enough concentration to permit positive identification, but ferripyrophyllite ($\text{Fe}_2\text{Si}_4\text{O}_{10}(\text{OH})_2$) and possibly illite clay both have peaks that match some of the very small peaks in the pattern. Surprisingly, no peaks for hematite (Fe_2O_3) or other red iron oxides/oxyhydroxides were detected in the pattern. No evidence of salts (gypsum, halite) was found by X ray diffraction.

Fig. 1: X ray diffractogram of fired brick. Quartz is the dominant phase present, though the very small peaks near 10° may be due to clay minerals. The broad hump from 7-15° is produced by the mounting plate, not the sample.

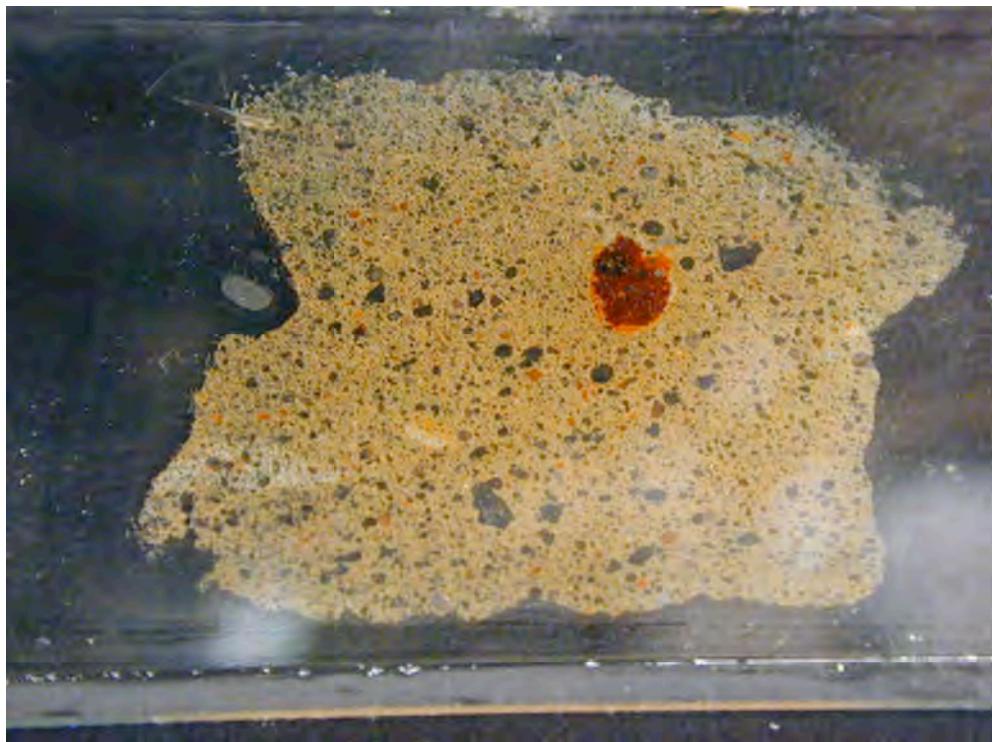
Petrographic examination revealed that the brick contains abundant silt to sand-sized quartz grains held in a very fine-grained, ferrigenous matrix (Figures 2 to 6). The quartz grains range in size from 0.1 to 2 mm. Nearly all the grains are monocrystalline quartz grains, though a few grains of chert were found. Rounded pores 0.4-0.7 mm across are evenly spread throughout the brick. A dark red spot (2.5 x. 3 mm) of very fine-grained hematite was exposed in the thin section (Figures 2 and 7). No evidence of salts was found, either in the matrix or in the pores.

Fig. 2: Thin section of fired brick. The large red hematitic clot is about 2.5mm x 3 mm, with numerous small red-orange pigmented spots throughout the sample in an otherwise tan matrix. Quartz grains and pores are dark gray. The sample is 28 mm wide. Incident light.

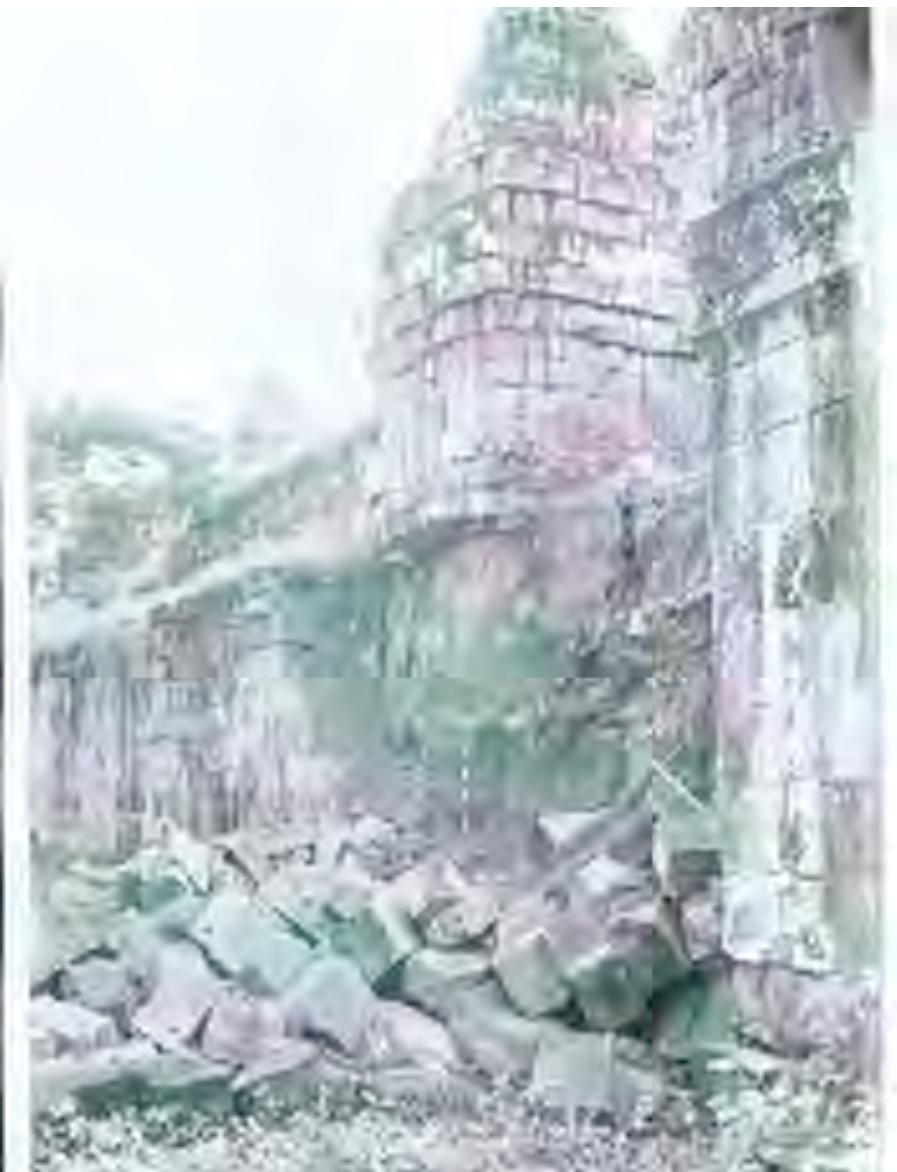
West elevation north of stairs. Stone shrine dismantled, stones laid on level below with most stone in order of placement for each course.

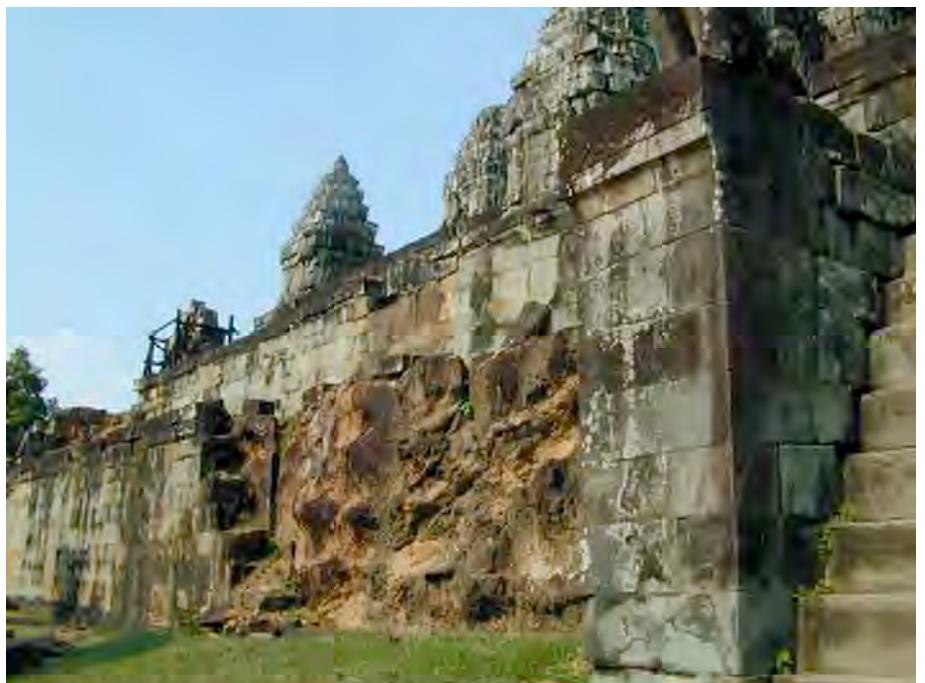
Note bedrock section also removed, lichen growth and stains on end of stair wall similar to older photo.

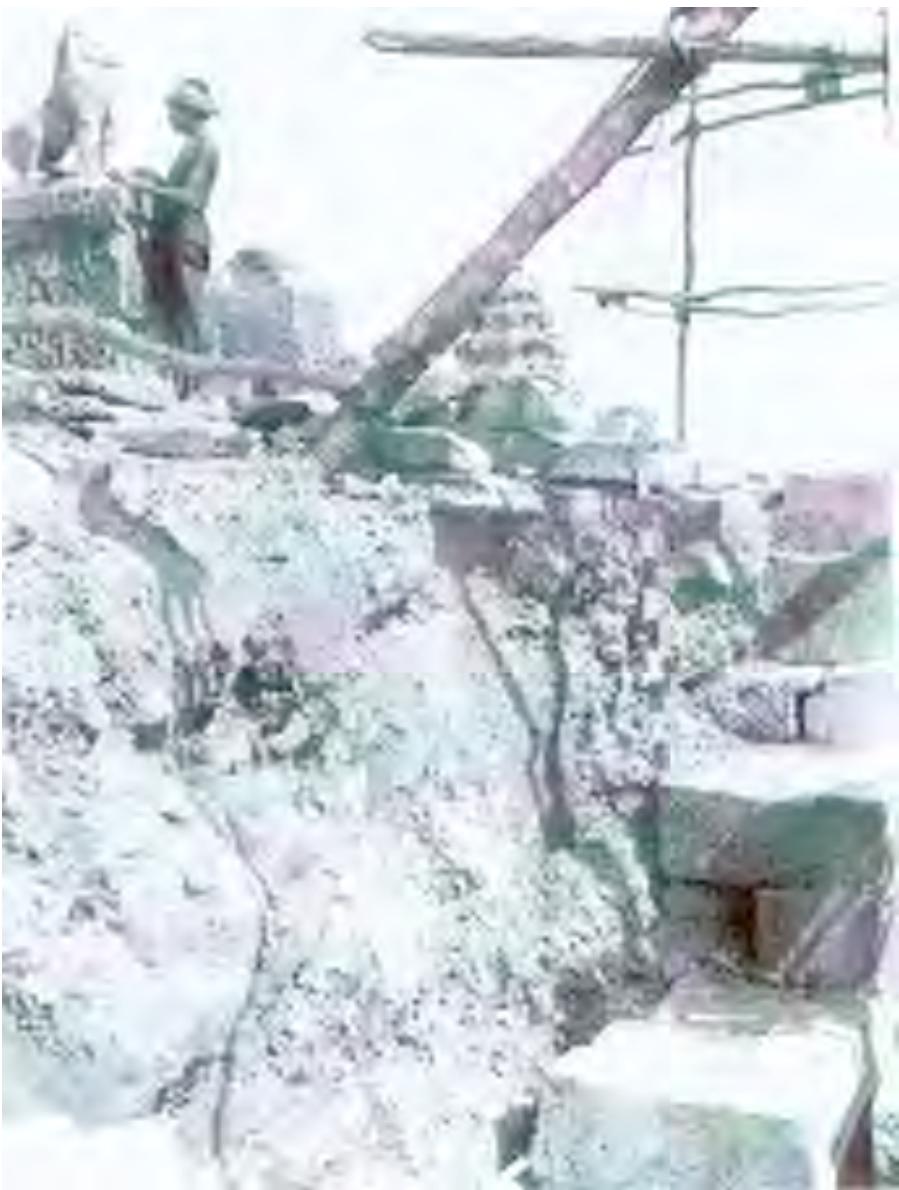
4th or 5th platform ? Note – looks like laterite infill at stair wall
