**PREAH KHAN CONSERVATION PROJECT  
HISTORIC CITY OF ANGKOR**

**REPORT IV**

**FIELD CAMPAIGN I - PROJECT MOBILIZATION**

## Preah Khan, Angkor THE WEST LANTERN APPROACH

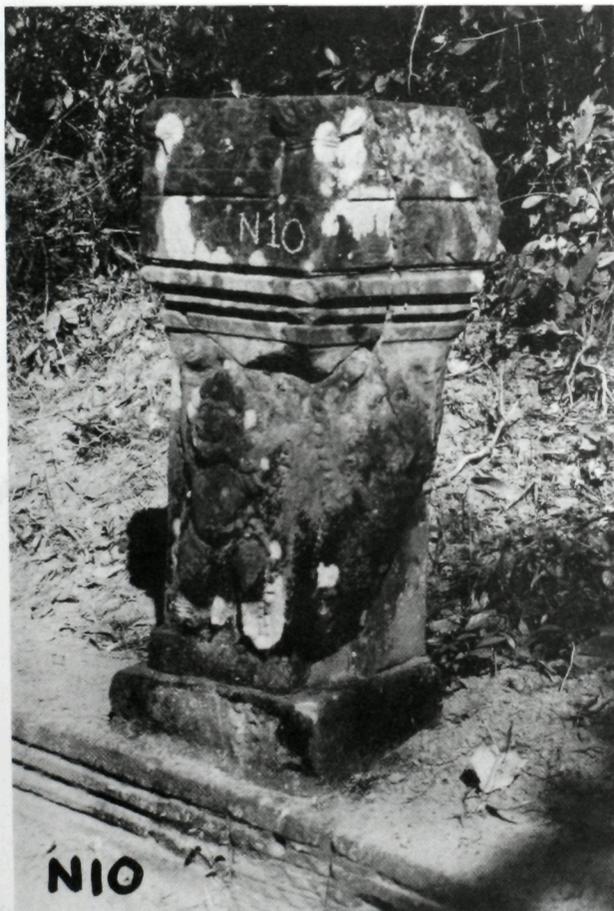
Incomplete stone lantern with a cylindrical body, the top of which is missing, terminating in a horizontal band. The body is decorated with a series of horizontal bands.

The pedestal is in poor condition with no inscriptions.

A small piece of stone is located to N10.

Highly recommended.
