# **Preserving Haiti's Gingerbread Houses**

## **2010 Earthquake Mission Report**

**A World Monuments Fund / ICOMOS Project funded in part by Prince Claus Fund and FOKAL**

**2010 Earthquake Mission Report  
December 2010**

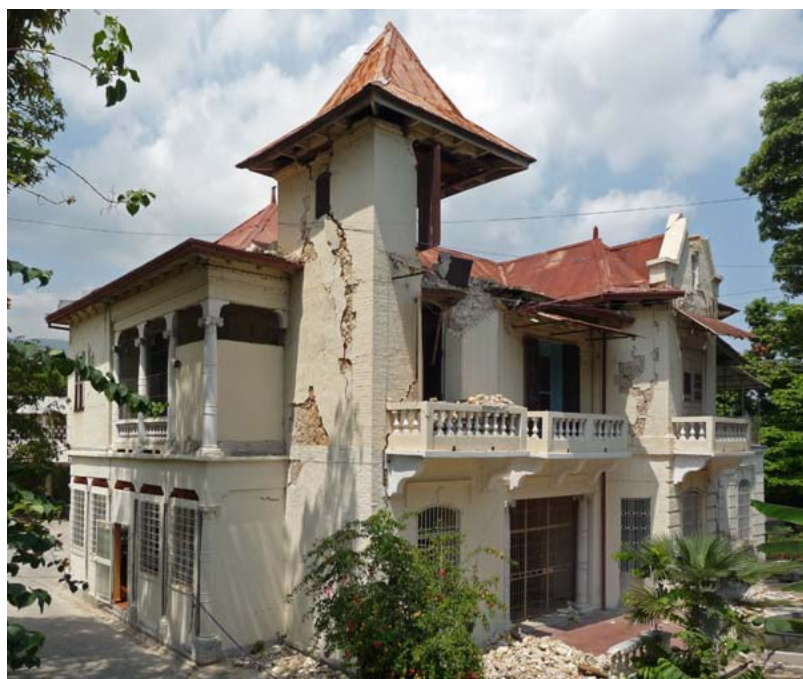
**FIGURE 4** The red painted designation “MTPTC 6” indicates that inspection deemed the tower unsafe for occupancy by the Ministère du Travail Public et Télé Communications.

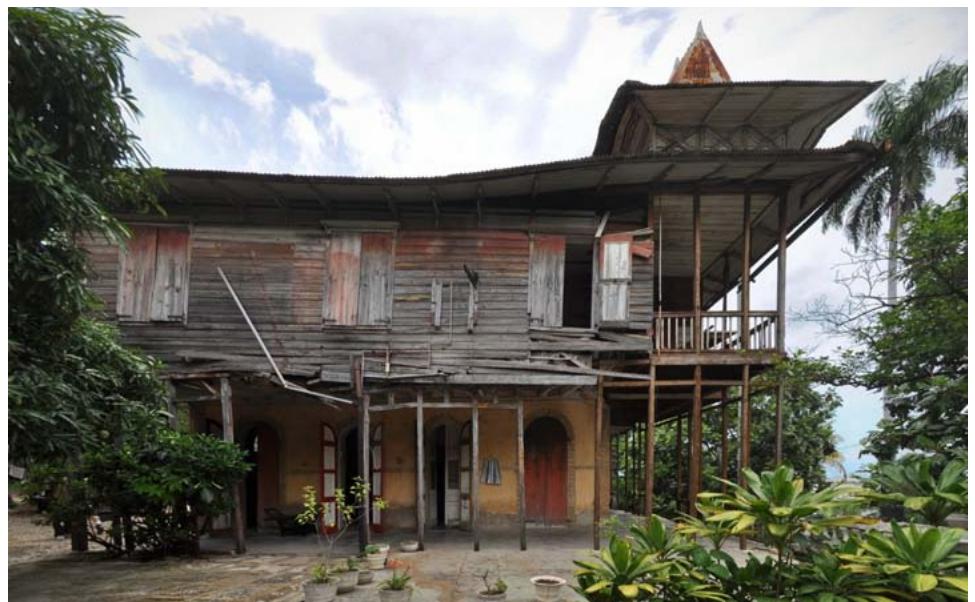
**FIGURE 65:** The Patrice Pamphile House (shown also in Figures 2 and 32) showing the heavily deteriorated wooden part of the structure, which at one time probably had been an open porch.

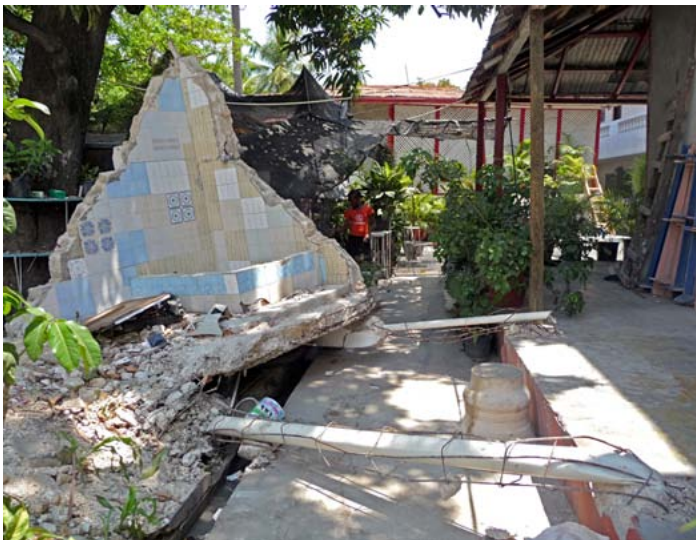
**FIGURE 70** This second floor concrete bathroom addition at 5 Lamartiniere landed on the ground after its concrete columns buckled as it pulled away from its parent Gingerbread house. Note sewer pipes in the center of the rebar of the buckled columns.

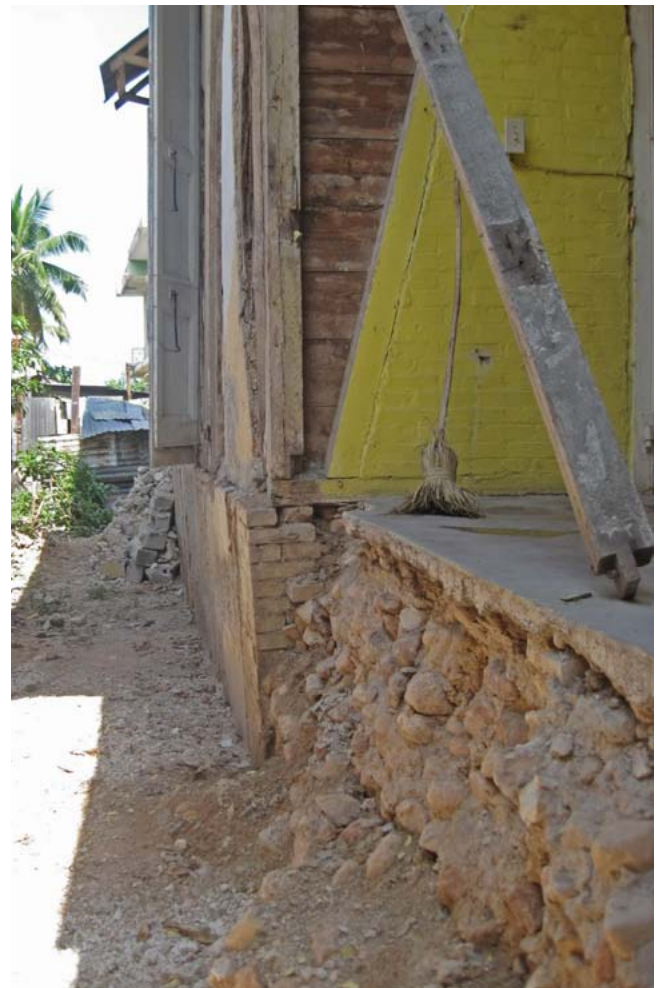
**FIGURE 71** A portion of the foundation wall has collapsed at the house at 2 Avenue N, revealing that the crawl space below the first floor had been filled with rubble and the wood floor had been replaced with a slab on grade. Lateral loads on the wall from the fill caused it to collapse. The foundation wall remaining has rotated outward.

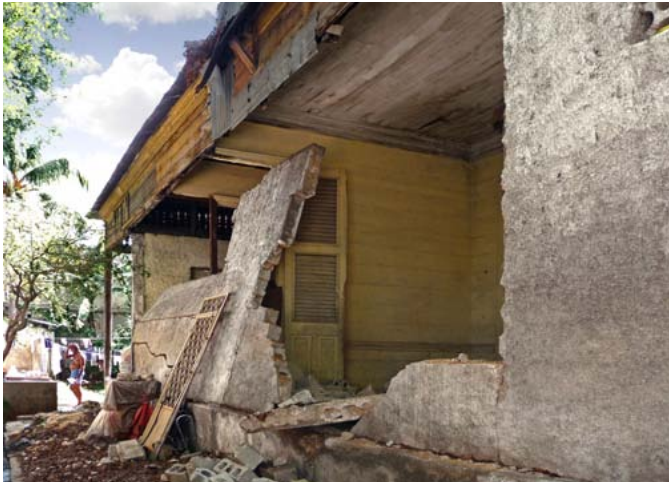
**FIGURE 72** A replacement side wall of concrete block at 19 Lamar-tiniere suffered partial collapse.

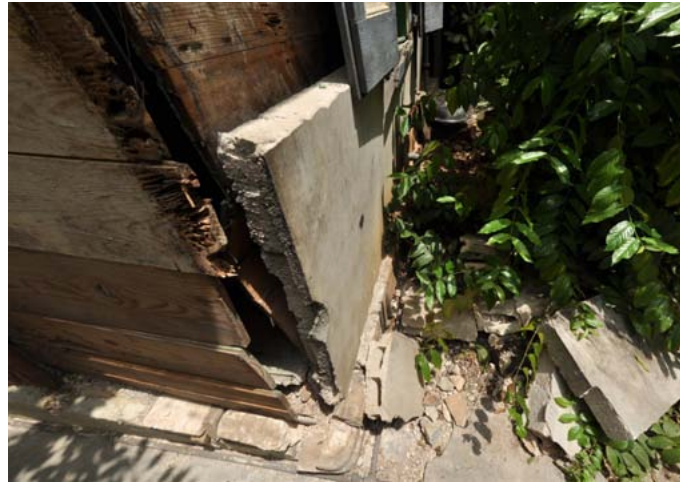
**FIGURE 73** These are examples of *colomage* where the rubble infill has been replaced with concrete. This has accelerated the rotting of the timber framing, which then broke during the earthquake causing the collapse of the heavy concrete infill.

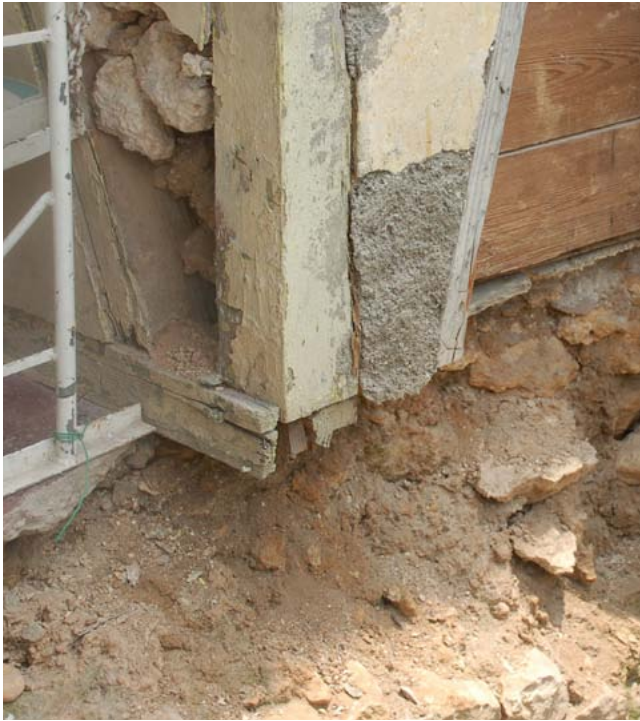
**FIGURE 79** The wood sill that was previously termite damaged was crushed during the earthquake. This caused the entire structure to settle on its foundation. The result is that many of the doors to the exterior cannot be opened or closed.

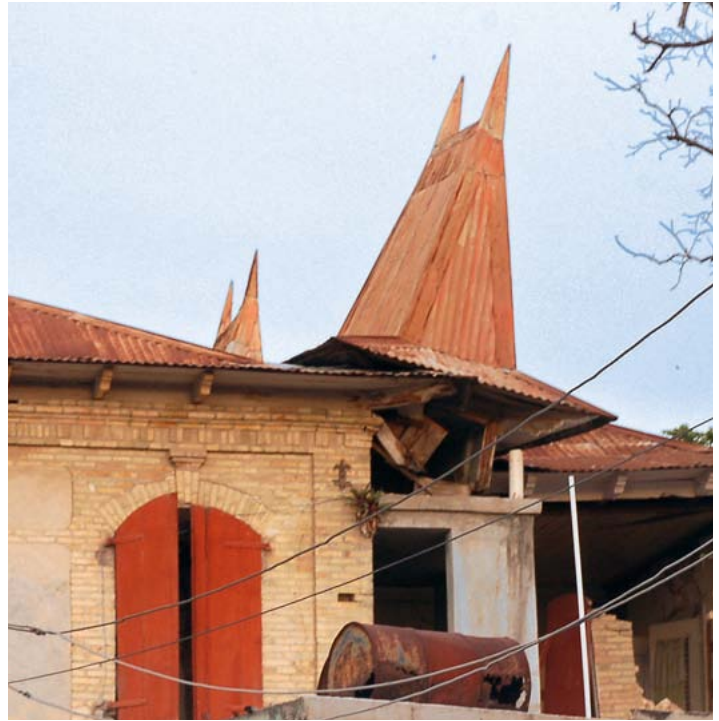
**FIGURE 80** Both of the steeples of this Gingerbread house were shaken out of plumb during the earthquake.

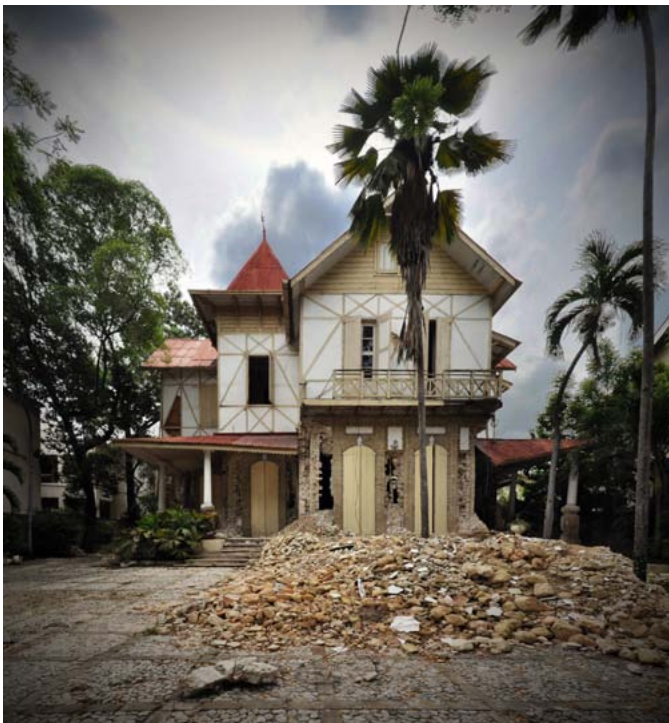
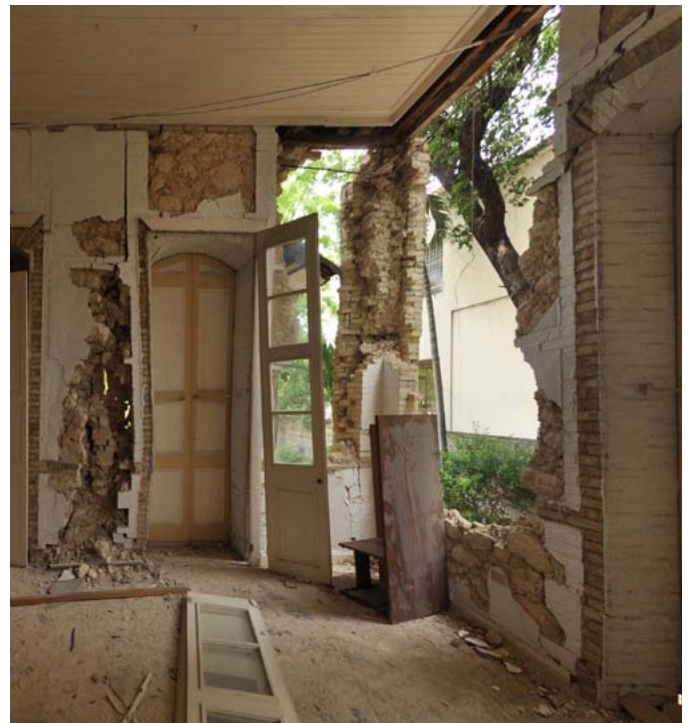
**FIGURE 95** *above left* The Dufort House showing the collapse of the rubble panels, leaving the piers standing holding up the almost undamaged upper floor structure. The remarkably large pile in front shows the volume of rubble masonry removed from the house after it had collapsed. *above right* The interior of the Dufort House, also shown in Figure 77, showing how the collapse of the rubble panels left the house standing on the brick piers which were left like free standing columns. *left* This house also had steel or wrought iron reinforcing chains made up of rods hooked together for the full length of the exterior and major interior walls. In this case, rather than exterior plates to hold them, their wall anchors were imbedded under the outer wythe of masonry. The rods are also visible where they intersect at the corner pier that is still standing, which can be most clearly seen in Figure 93.

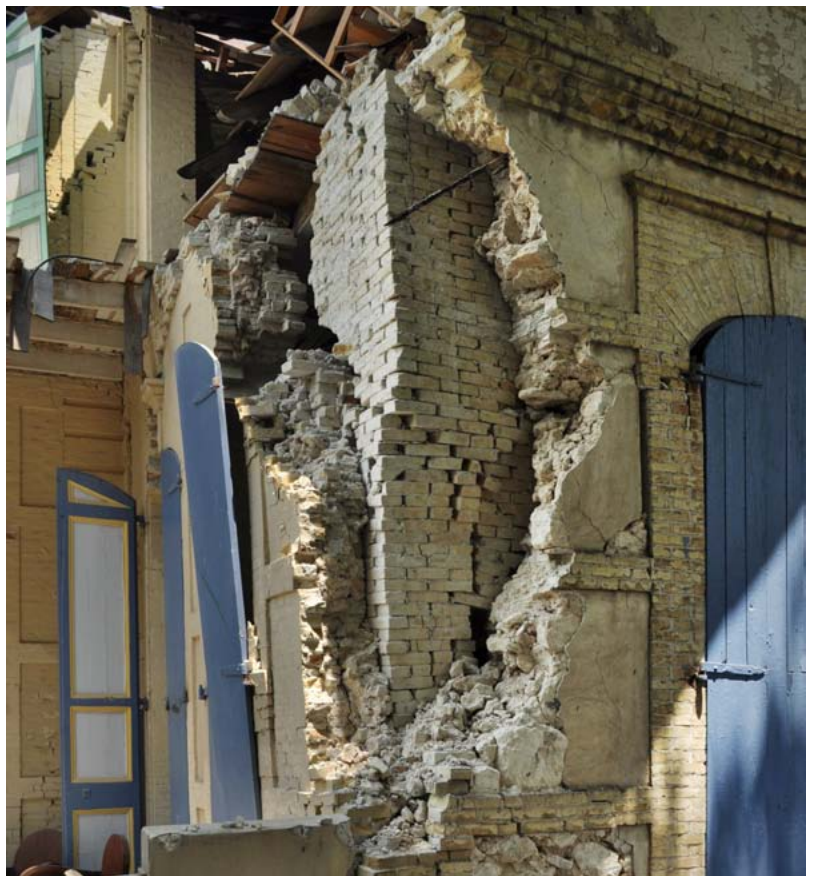
**FIGURE 97** Two-story masonry house at 46 Avenue Christophe. During the earthquake, part of the second floor collapsed, followed by the subsequent collapse of the rest of the second floor. These photos show the ground floor, which remained standing, but with major rupture to the masonry walls, particularly at the corners. *right* The iron rod that had held the building together at the floor level is visible where it had failed because of corrosion. This image also reveals how the inner wythe of brickwork was not bonded to the outer layers of rubble stone. To form the inner corner of the room there is a layer of brick, whereas in the middle of the room, the rubble stone panel goes through the entire thickness of the wall.

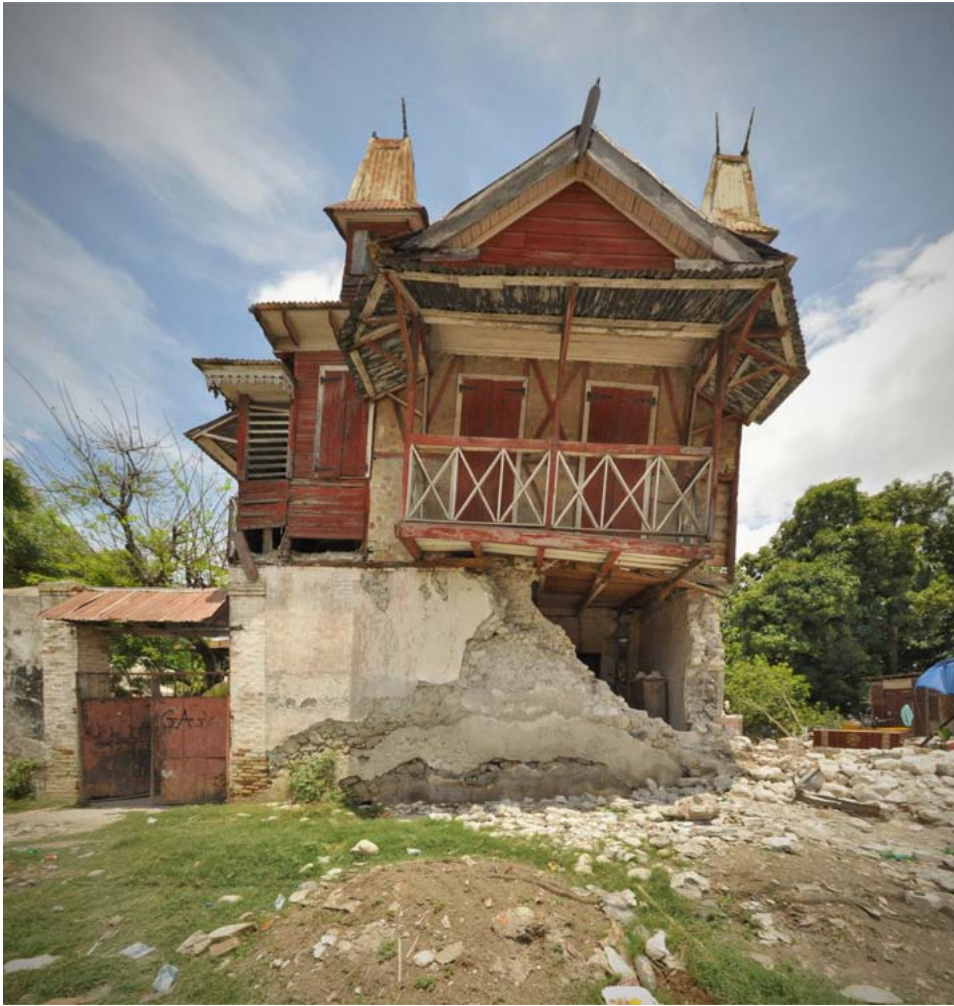
**FIGURE 98** House in Léogâne where the solid rubble stone wall on one side partially collapsed, while the side with the two door openings with brick piers and rubble panels seen through the collapse remained standing with much less damage.

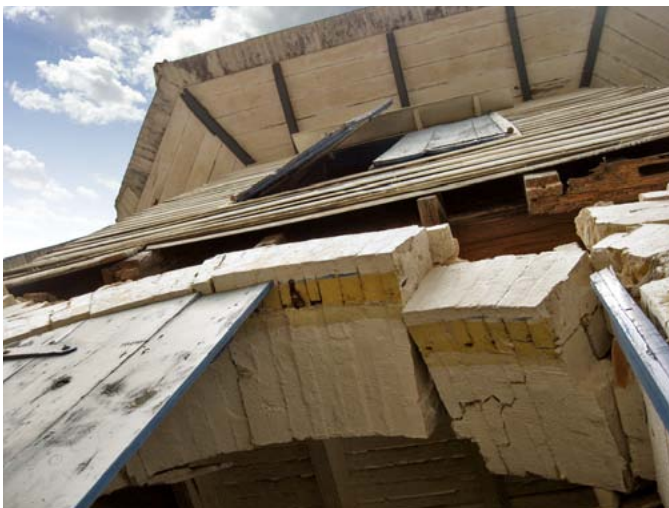
**FIGURE 105** Severely damaged arch, and displaced wood framing above. Absence of tie rods, combined with decay of the timber sill plates made the building more vulnerable.

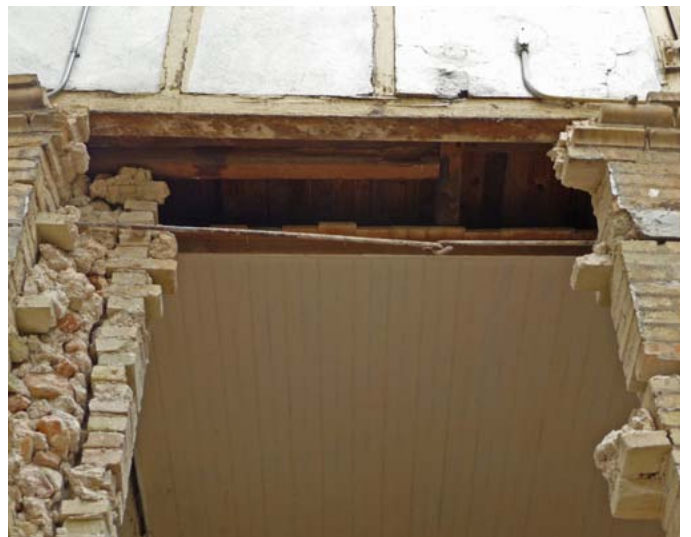
**FIGURE 106** Linked iron tension rods exposed after the limestone infill panel was discharged. The rod may have prevented complete wall collapse.

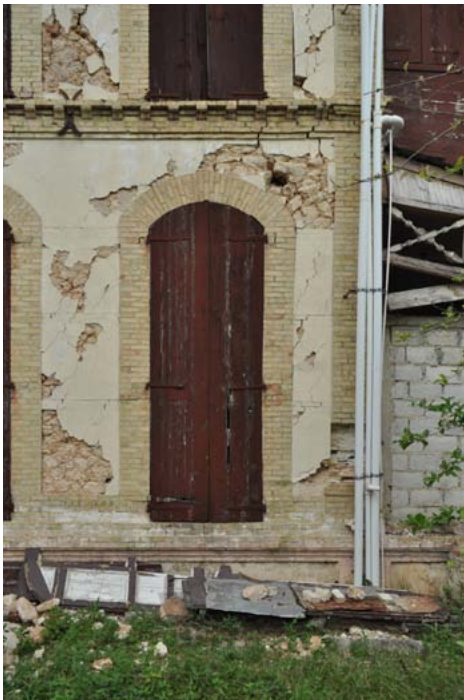
**FIGURE 108** The Villa Castel Fleuri shows the effect of the absence of iron chains at the 2nd floor level corners. The pier on the right has been slightly displaced to the right at the second floor level. It is possible to repair it without rebuilding it, but the deflection will then remain visible. A better quality and more resilient restoration will require shoring and relaying of the masonry of the corners of the building with new masonry units to replace the rubble stone. The rebuilt masonry need only extend across to about the middle of the arch.

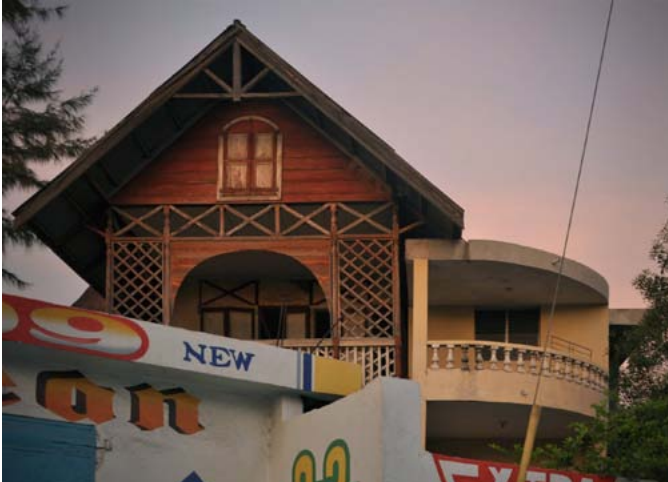
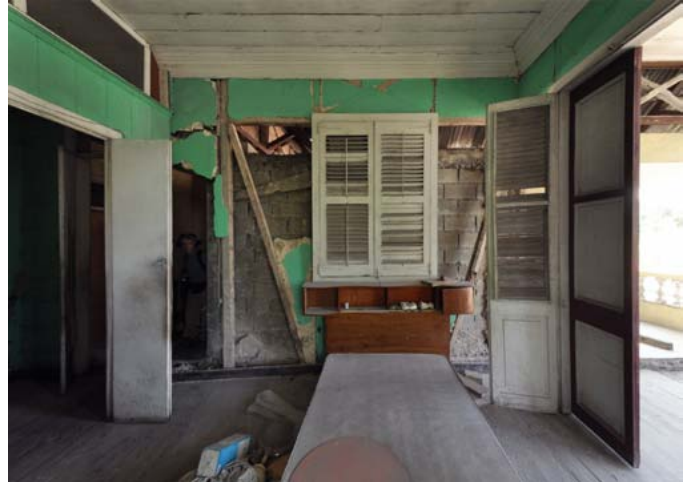
FIGURE 109 Interior and exterior of 51 Avenue Christophe showing reinforced concrete addition to the timber and *colombage* house. The two parts pulled away from each other during the earthquake.

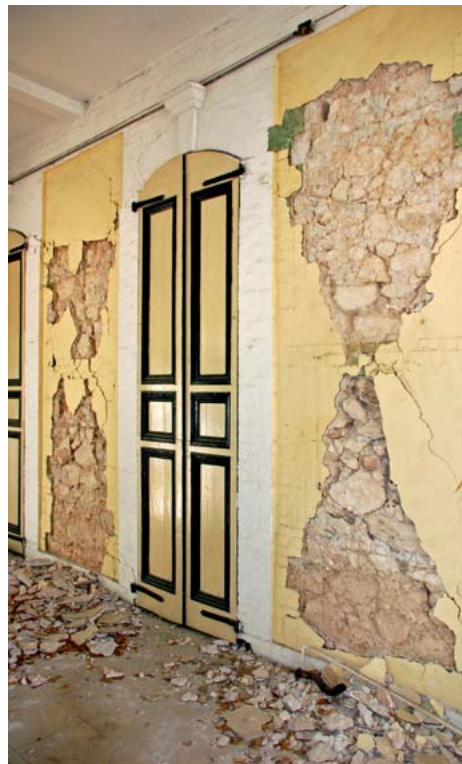
**FIGURE 115** The characteristic X-cracks seen on masonry wall infills of concrete frames are also present at Le Manoir. These are due to the reinforced concrete second floor slab (above the damaged wall in this picture).

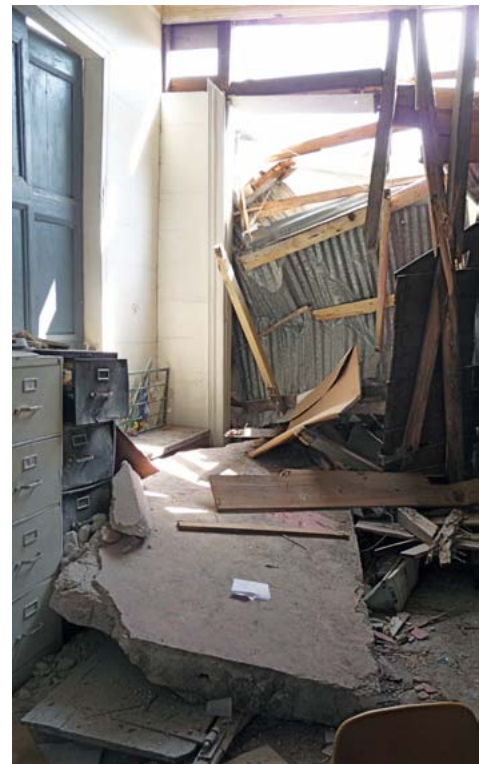
**FIGURE 116** The most damage this Gingerbread suffered was from a concrete slab ejected through its back door from the collapsed concrete building behind. The building's front porch roof was also damaged, by a collapsed concrete building to its side (see Figure 82, page 40).

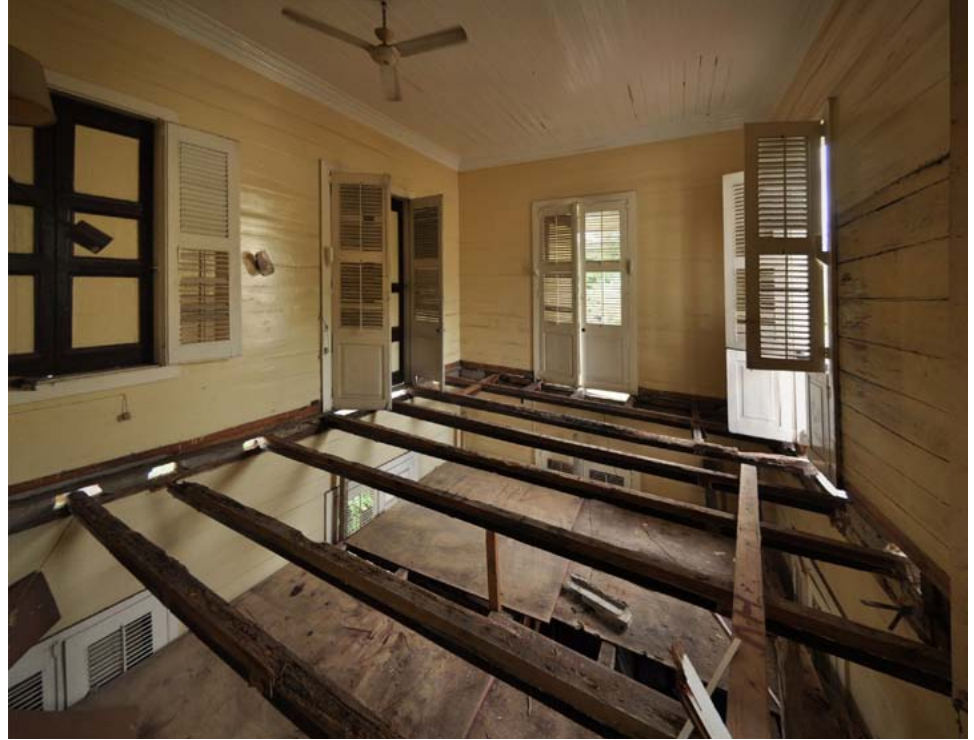
**FIGURE 124** House at 32 Avenue Lamartiniere now under restoration, showing the decayed ends of the joists.

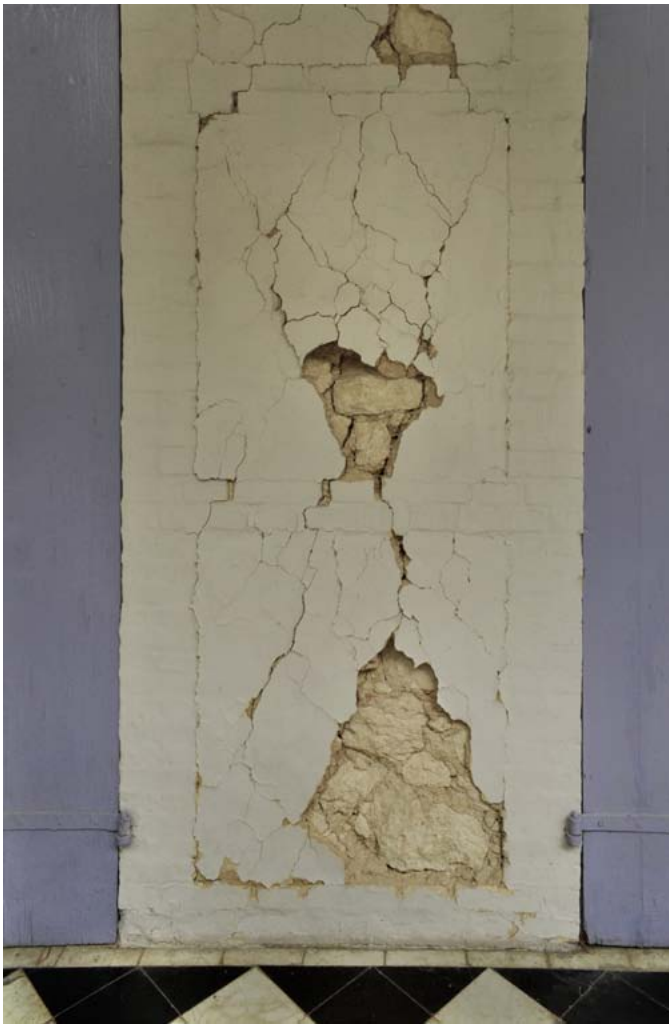
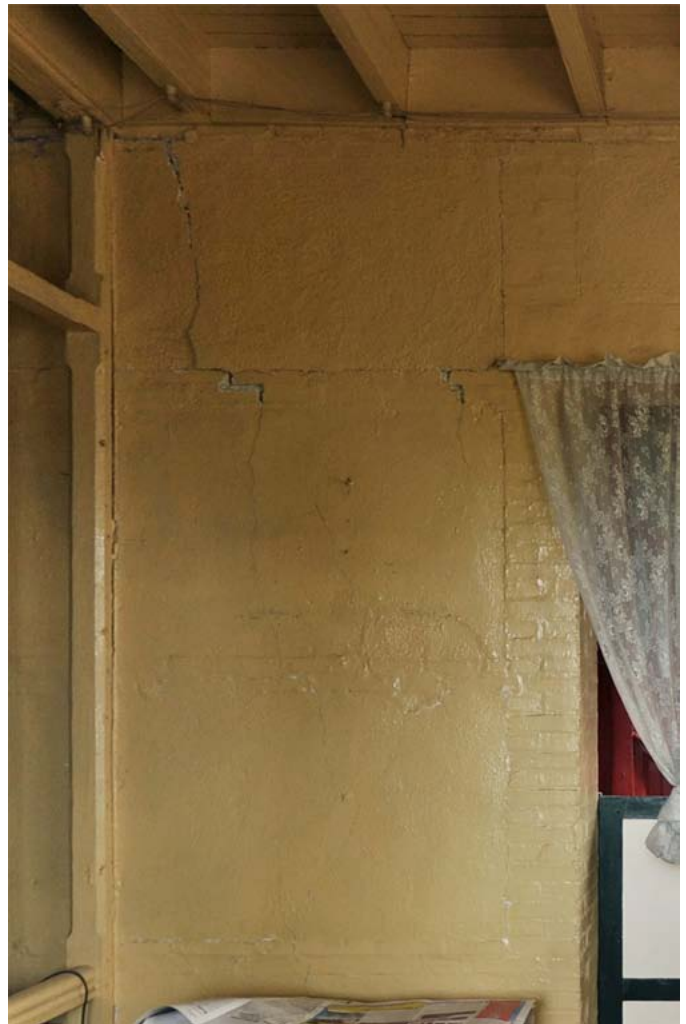
**FIGURE 128** Interior and exterior examples of low levels of damage to rubble stone panels in masonry walls.

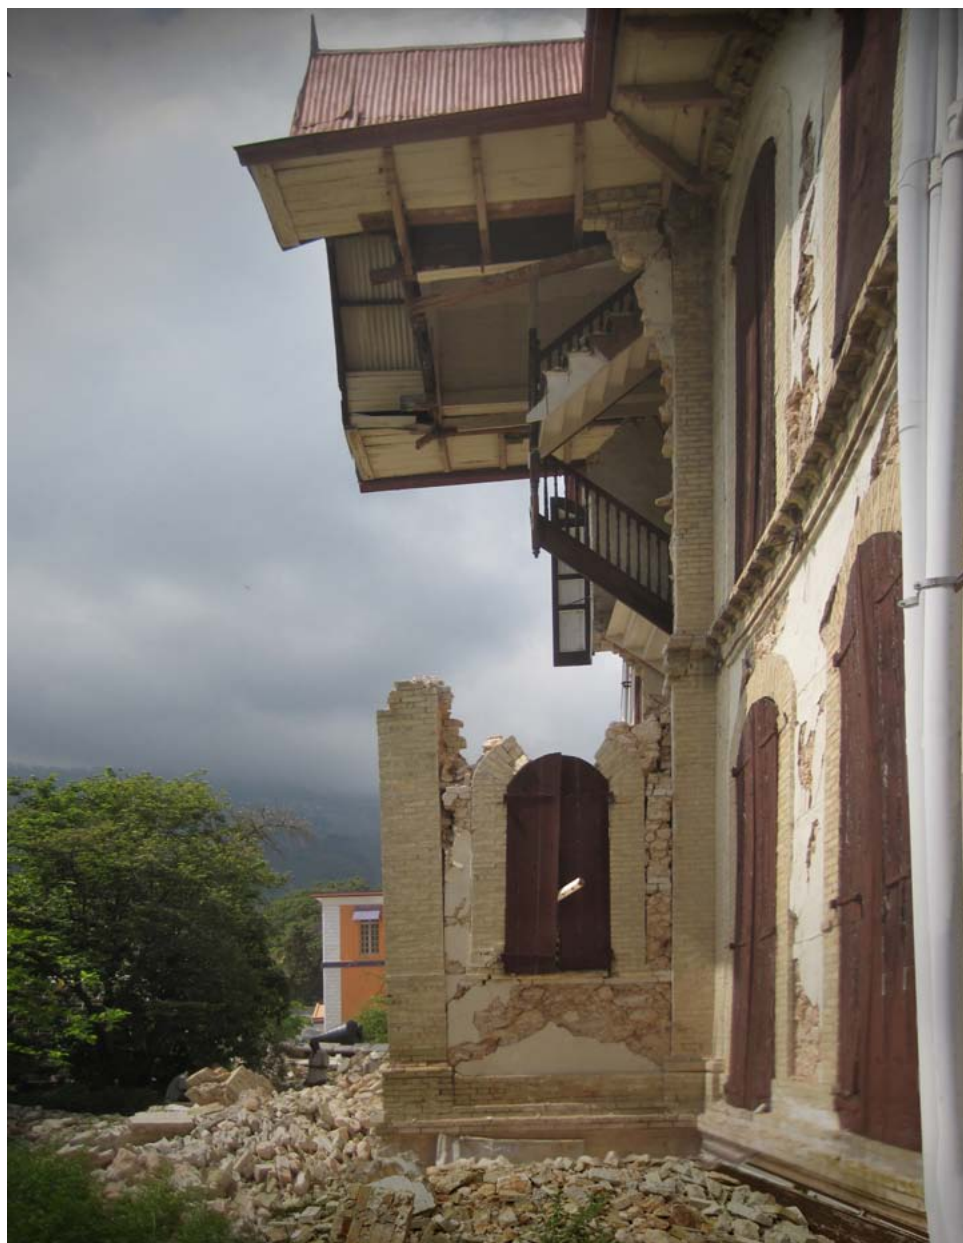
**FIGURE 130** *below left* A rubble panel on the second floor of the Villa Castel Fleuri that collapsed showing the displacement of the bottom of the brick pier into the doorway which resulted from the expansion forces from the panel. *below right* Le Manoir on Avenue John Brown showing a heavy level of disruption of the masonry walls caused by the rapid degradation of the rubble stone panels during the earthquake.
