THE ALEXANDER PALACE

TSARSKOE SELO, ST. PETERSBURG, RUSSIA

PRELIMINARY ASSESSMENT REPORT
FOR RESTORATION AND ADAPTIVE RE-USE

June 1997

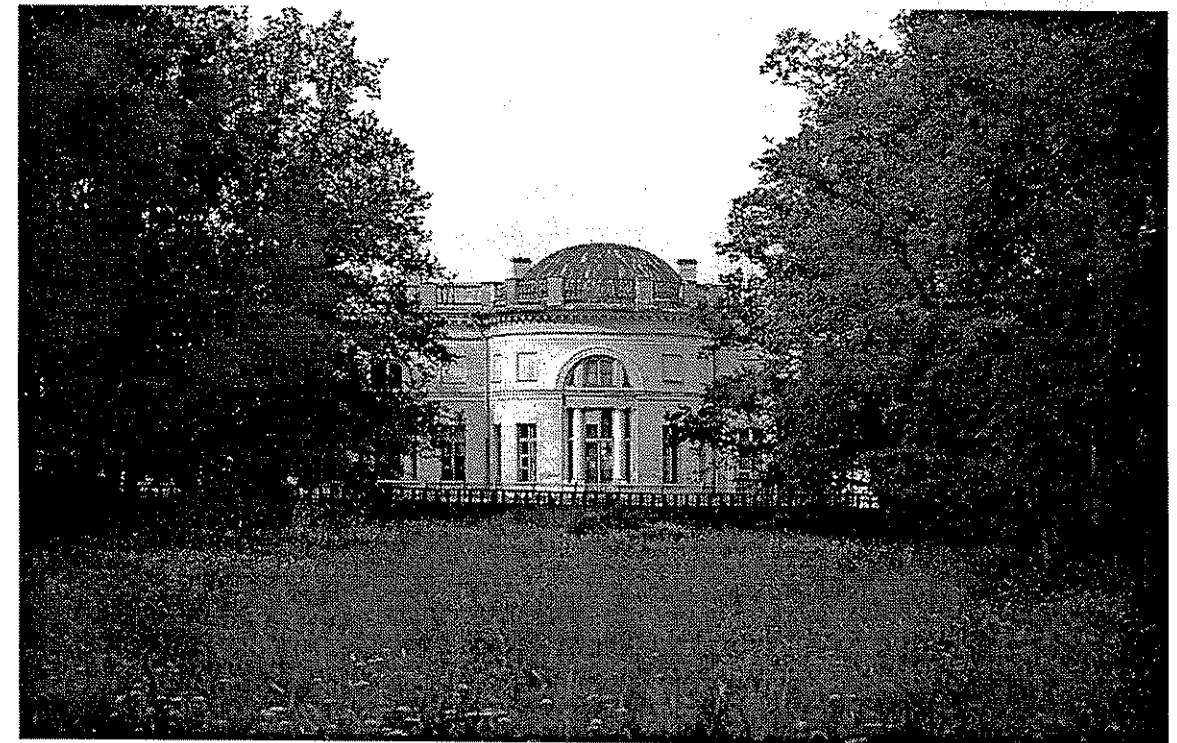
Alexander Palace garden elevation photo, circa 1995.

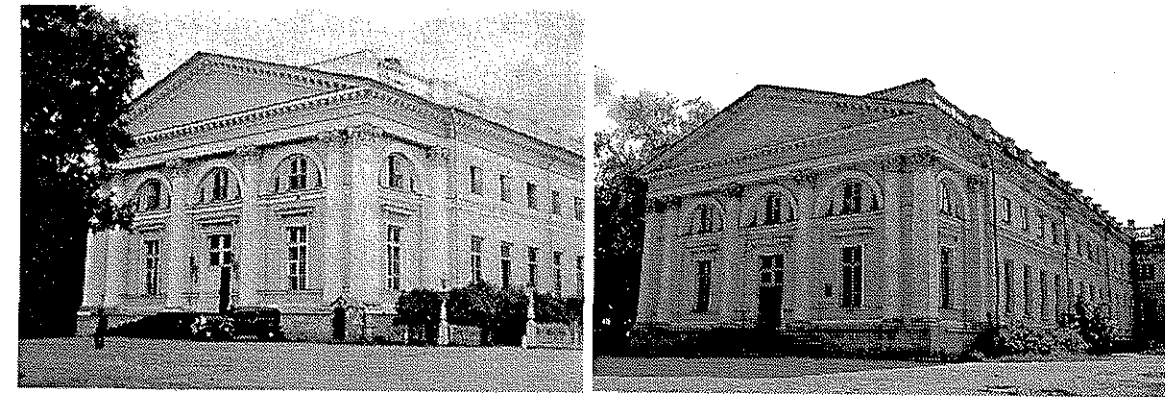
(left) Entrance to the Imperial (southeast) wing. Photograph ca. 1910 by Anna Vyroubova. Reproduction courtesy of the Beinecke Rare Book and Manuscript Library, Yale University.
(right) Entrance to the Imperial (southeast) wing. Photograph 1996.

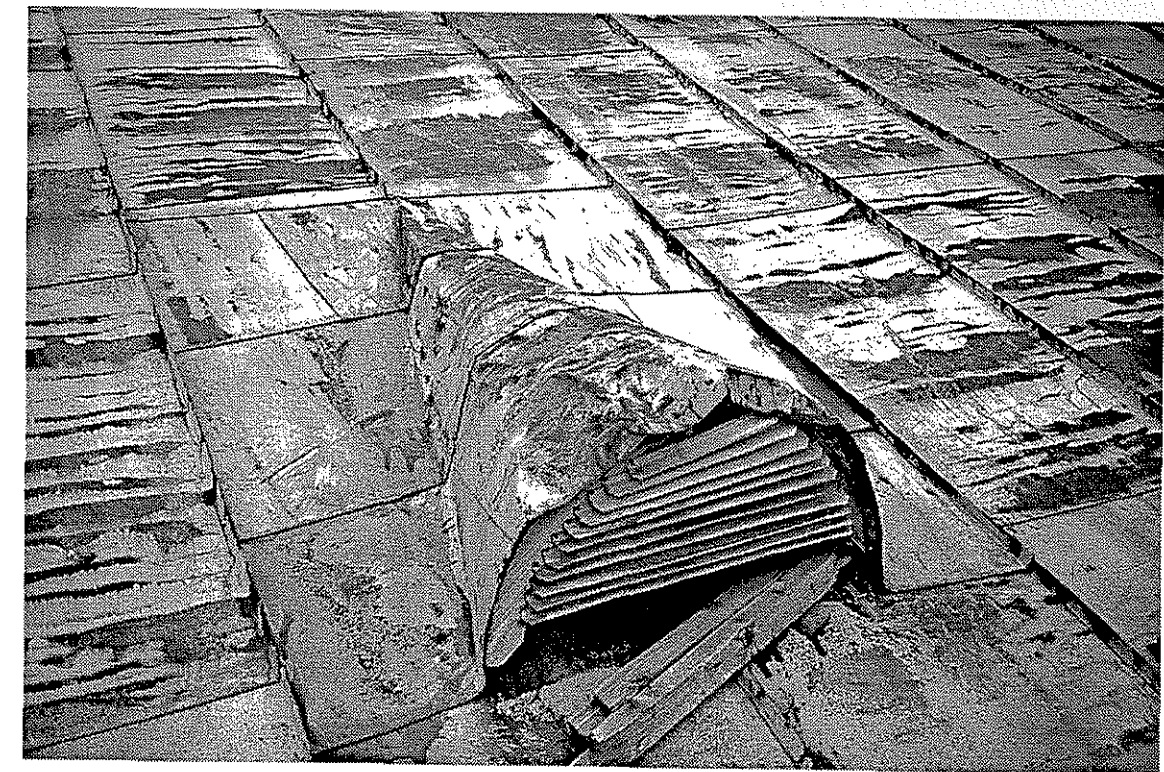
Typical damaged pressed tin vent prior to repairs on Alexander Palace roof, circa 1995.

Numerous small semicircular layered roof vents occur at regular intervals in the roof. Most were somewhat deformed, probably a result of snow-shoveling operations. Steam piping is poorly insulated, and a relatively minor amount of debris has accumulated in the attic areas. No household implements were noticed in the attic area, though a stalk of approximately 50 turned wooden balusters was noticed near the roof hatchway.

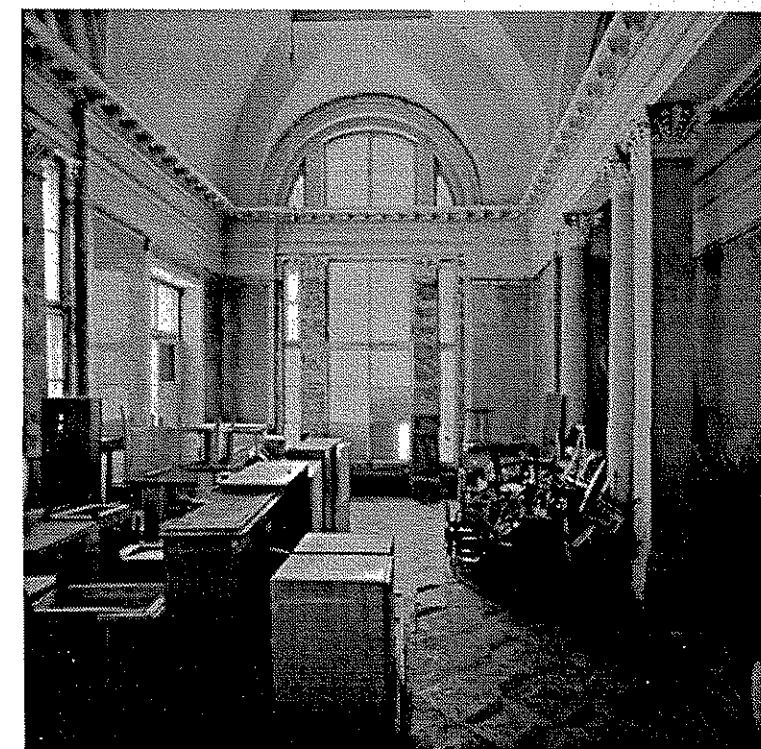
The Crimson Room, February 1995. Photograph by Kirk Tuck and Michael Larvey.

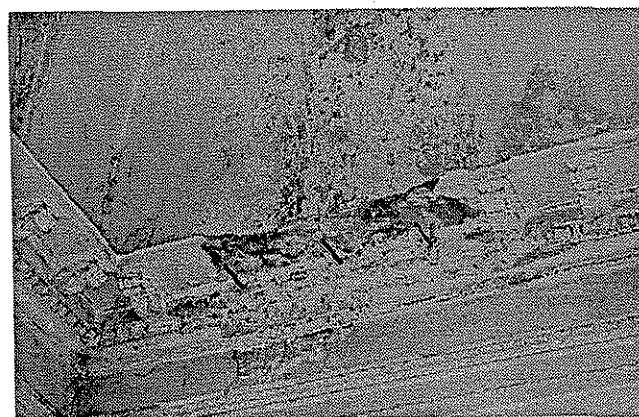
View of corner of the Crimson Room ceiling cornice, which has suffered from water damage, February 1995.

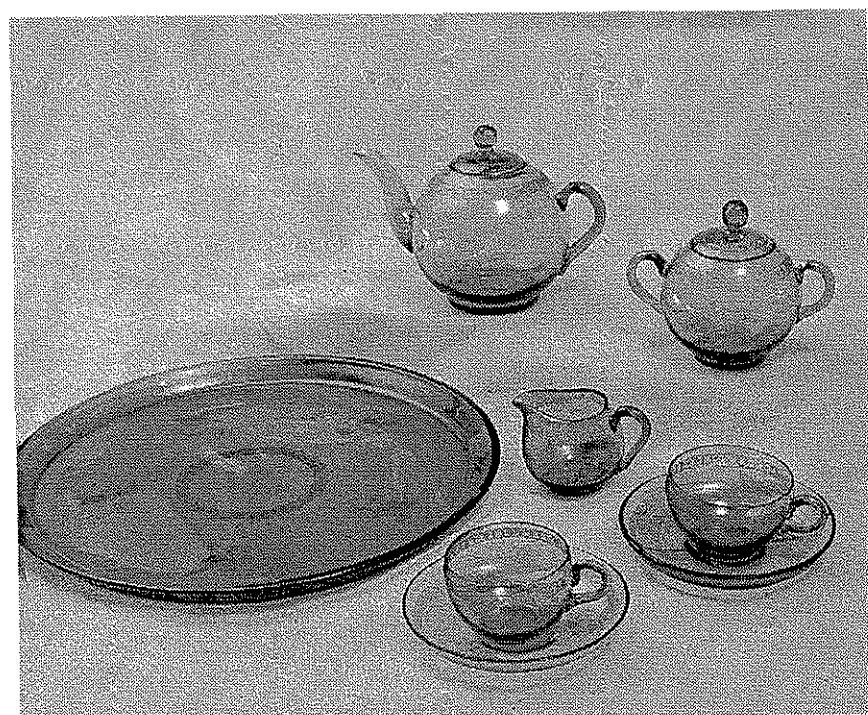
Historic tea service part of the Alexander Palace collection, in excellent condition. Photographs by Kirk Tuck and Michael Larvey, 1995.

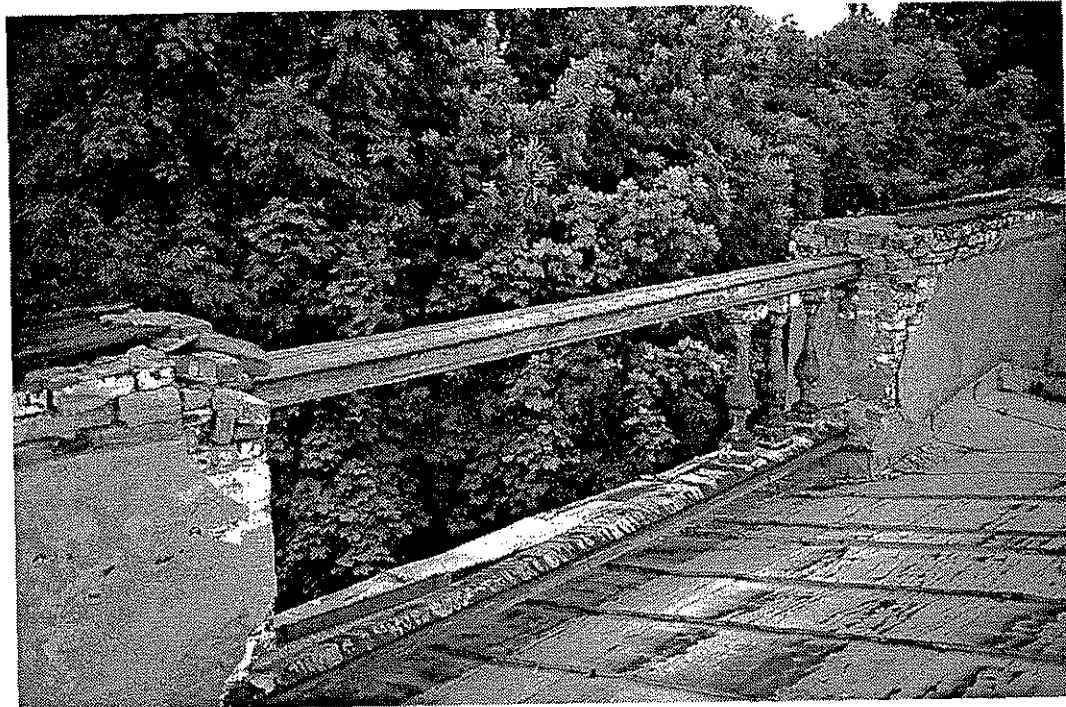
The roof of the Alexander Palace, briefly surveyed during the visit in July 1996, is vast and in poor condition. The wooden ornamental balustrade surrounding the roof, dating from roughly 1910, is severely deteriorated and missing altogether in certain areas (* 12); some repairs with galvanized straps were noticed. The galvanized standing-seam metal roof covering shows rust over approximately 40 percent of its exterior surface. Dents and bent-over seams are abundant and most likely result from careless shoveling of snow during winter. Small (approximately 60 cm. x 1.5 m) semicircular roof vents with wooden louvers are mostly flattened on their top edges, though they appear to be sound at their junctures with the roof surface. Glass covers are in place on a number of these vents.

Alexander Palace balustrade showing numerous damaged and removed turned elements, 1995.

Once the roof covering has been replaced, the uppermost portions of the exterior walls adjacent to the roof drains at the eaves project should be repaired. Work envisioned will require removal of the present stuccoed surface to the brick substrate. A three layer coating system should be re-applied and troweled level with surrounding surfaces. Where the repair work encounters materials to be retained, the cut should be clean and the patched area undercut so that the replacement layers are not feathered over existing material. This will reduce the possibility of cracking. Additionally, the use of pre-packaged cementitious coatings should be limited and, instead, a breathable masonry coating to match the existing wall color should be applied. As there is rising damp which is affecting the exterior paint and migrating through the walls, the base of the walls should be cleared of vegetation and wall drains installed to remove accumulations of debris at wall bases away from the building. If possible, a damp proof course should be inserted, preferably through-wall, or otherwise, by injection, to contain dampness in foundation materials. Stucco surfaces should be re-applied and expansion joints provided along the length of the wall in order to prevent cracking due to thermal expansion. The ashlar stone should also be repointed in its entirety, as there are many open joints. As with other re-surfaced walls, breathable paints and coatings should be applied to prevent moisture from being trapped within the walls.

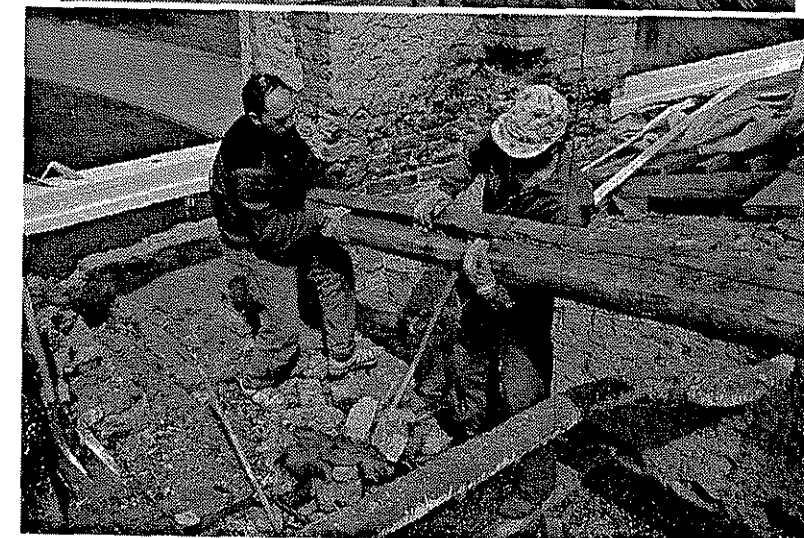
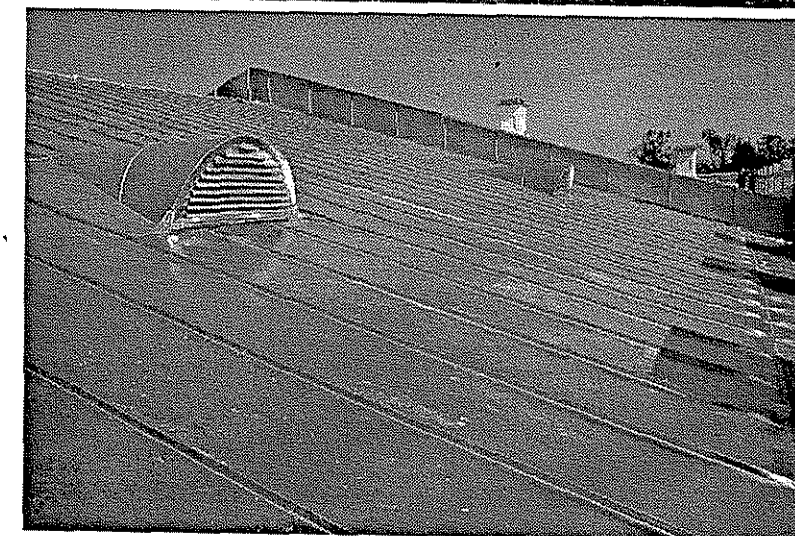
Recent repairs to the Alexander Palace roof undertaken with a grant from the World Monuments Watch program: before, during, after. photo 1995-97.

The following illustrations document the nature of the repairs being undertaken on the Alexander Palace roof.
