# Phnom Bakheng Conservation Master Plan

## Volume 1: Conservation Master Plan

# **Phnom Bakheng Conservation Master Plan: the conservation and presentation of Phnom Bakheng**

Phnom Bakheng is a 10th century temple mountain centrally located in the World Heritage site of Angkor, Cambodia

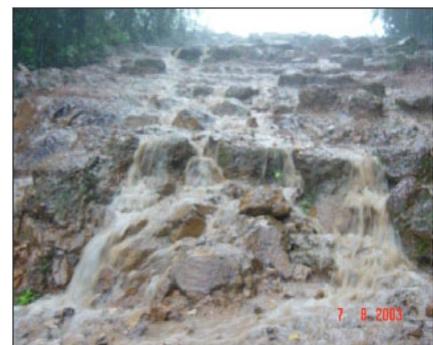
East *phnom* axial stairs and uncontrolled monsoon runoff, resulting in hydraulic erosion and loss of significant fabric. (APSARA Aug. 2003)

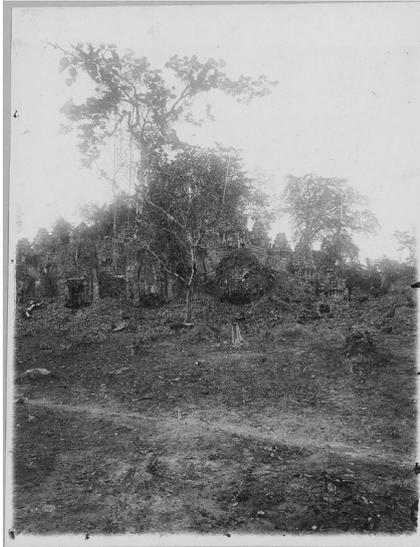
View of the extent of tree encroachment at Phnom Bakheng, just prior to being removed by EFEO. (EFEO 1915)

The disappearance of many of Bakheng's towers was caused in part by 16th century efforts to use the towers' sandstone to build a large seated Buddha. The encroachment of the forest followed, significantly destabilizing the temple-complex structures before being cleared completely in the 1920s.

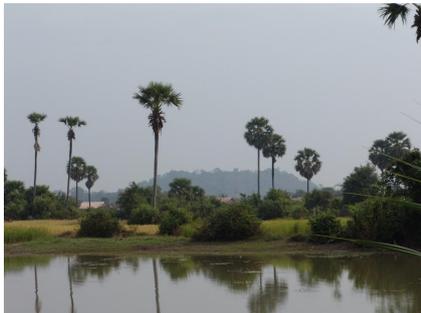
View from the south-southwest towards Phnom Bakheng. Note the artificial plateau of Phnom Bakheng and the central tower of the quincunx is clearly visible within the farming landscape even though its superstructure is absent. (CP Dec. 2004)

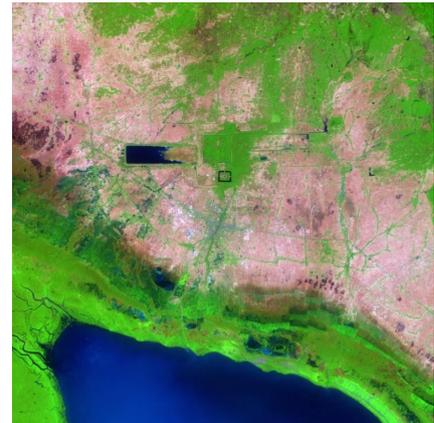
Advanced Spaceborne Thermal Emission and Reflection Radiometer color image of the northern part of Tonle Sap lake and Angkor, data acquired February 2004.

The extent the Tonle Sap recedes is evident by the color green around the lake that represents the swamp forest. When the lake is full the green color near the lake will show as blue/green due to the different reflection properties of water and vegetation.

The green in the upper right hand corner represents the forests of Phnom Kulen. The dark blue square in the center is the moat surrounding Angkor Wat.

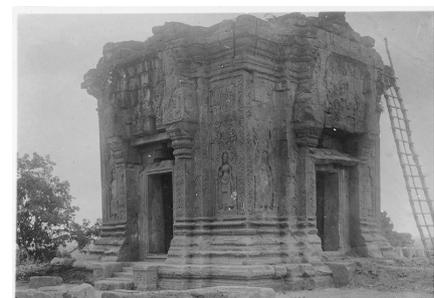
Historical view of the south and west elevations of the Central Tower at Bakheng. (EFEO 1924)

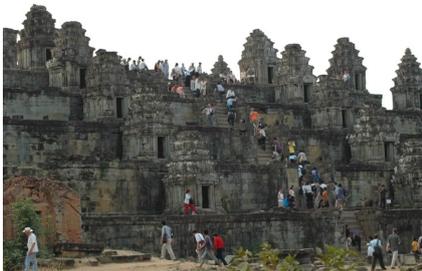
**View of the eastern elevation of Bakheng with visitors ascending the east stairs for sunset viewing; note the collective contribution the sandstone shrines make to Bakheng's form with their four upper tiers and one with a decorative sandstone crown silhouetted against the skyline. (ME March 2005)**

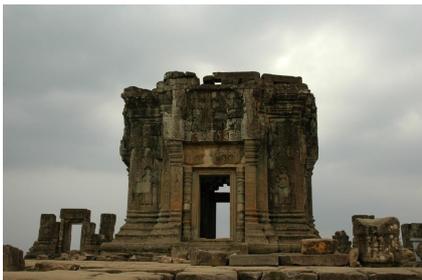
**View of western facade of the central prasat and remnants of the northeast prasat that formed the quincunx in the background, left side. (ME March 2005)**

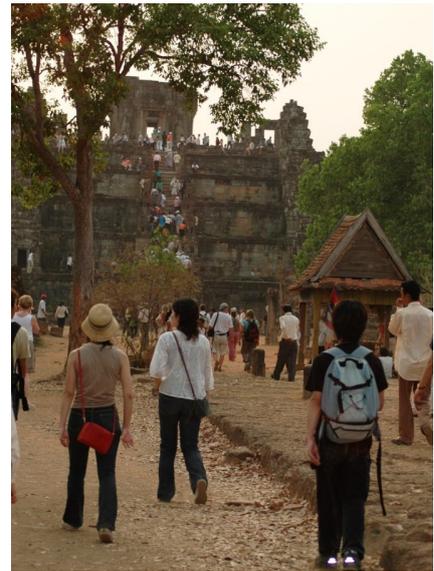
View of the ceremonial route along the plateau to the east axial stairs leading to the Central Tower; note the timber Vietnamese pagoda in the mid-ground which sits over the Buddha footprint and the stone bedrock remains raised above the surrounding plateau area. (ME March 2005)

**8.2.8 Buddha Footprint:** or Buddhapada was dug out of the ceremonial access route and a Vietnamese pagoda constructed over of which monks were noted as the guardians in the 1860s.<sup>12</sup> It is a working shrine with offerings made daily.

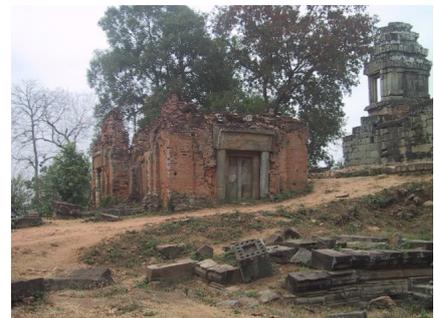
View of earth mound heaped around brick shire G4, which is used by tourists to obtain access to the 1st tier of the pyramid. (MS March 2005)

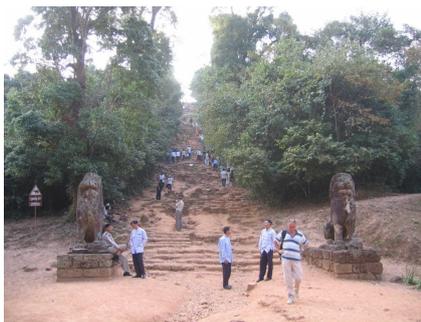
View towards the east *phnom* axial stairs flanked by a pair of lions at its base. (KK Dec. 2004)

**8.3.5 East Stairs:** the east *phnom* axial stairs is the principal tourist access forming part of the historical ceremonial processional avenue from the historic Approach Platform to Bakheng temple, a precursor to the long level processional avenues seen in post temple planning, for example – Baphuon and Banteay Srei.

The east stairs is the preferred tourist route to ascend and descend Phnom Bakheng, contributing in combination with hydraulic erosion near complete loss of the east stairs fabric. Due to public safety and heritage concerns the APSARA Authority will close the east stairs to the public in 2006.

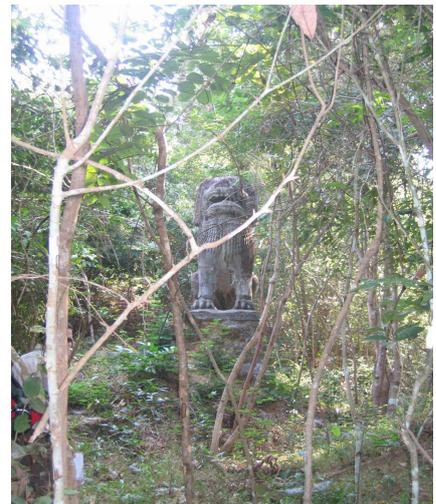
View at the base of the west *phnom* axial stairs, which are overgrown with vegetation, one of the Lions that flank the base of the axial stairs remains in its original position. (JPS March 2005)

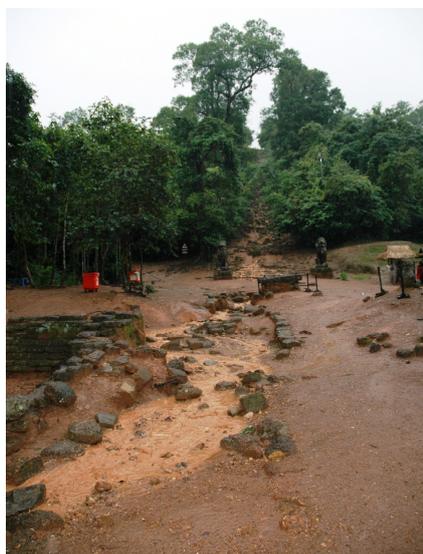
Approach Platform at the base of the east *phnom* axial stair has suffered from uncontrolled monsoon runoff and visitor access causing erosion and loss of significant historic fabric. (ME Dec. 2005)

Archaeological investigation is recommended to be carried out around the eastern base of the *phnom* in partnership with EFEO, prior to stabilization work to mitigate further loss of significant fabric from erosion.

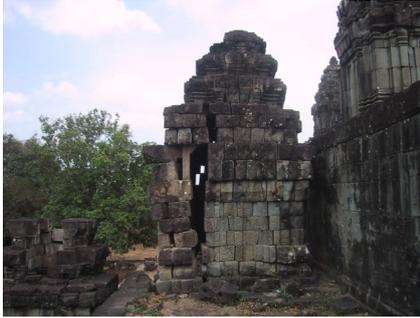
View of western side of sandstone shrine G10; note the vertical separation between the joints which align above each other. This has occurred due the movement of the platform veneer wall and the subsequent movement of the sandstone shrine footing which aligns parallel on or near the platform wall's outer (northern) edge. (MS March 2005)

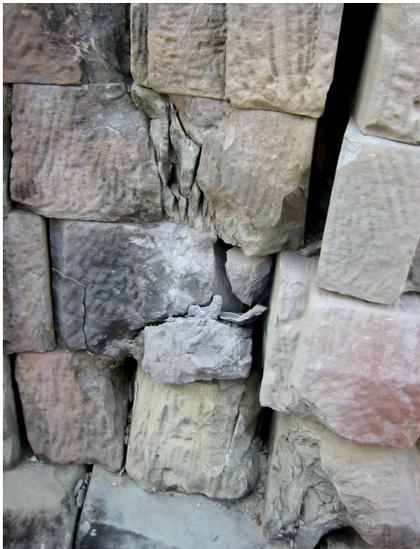
Dry joints have lead to weight concentration, point loading and shear cracks. (BW Dec. 2004)

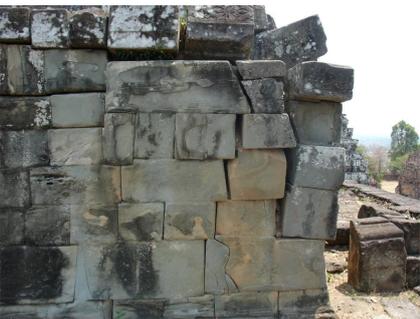
The displacement of the northwest corner of the platform wall was caused in part by hydraulic pressure behind the platform wall.

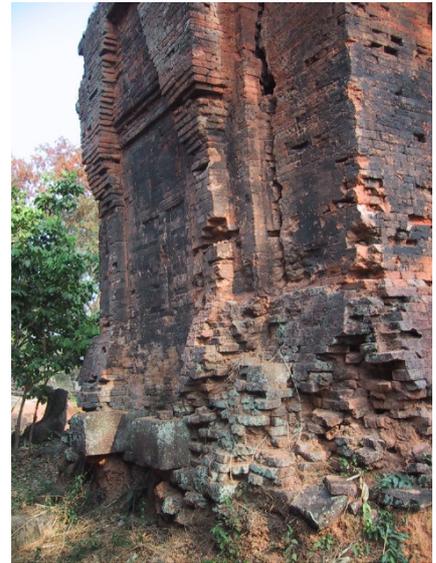
Detail view of the northwest corner of brick shrine G13; note the podium sandstone plinth is absent, the laterite foundation has completely disintegrated and the clay brick work is missing in parts. (MS March 2005)

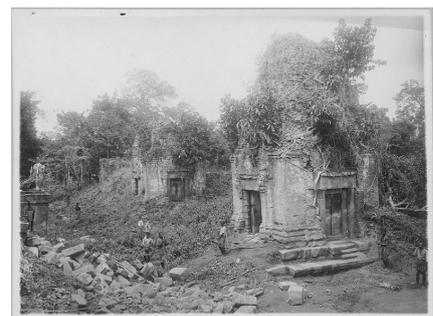
Northeast corner of Phnom Bakheng; note the overburden of soil and shrubs on the brick shrines which contributed to their obliteration in part. (EFEO 1930)

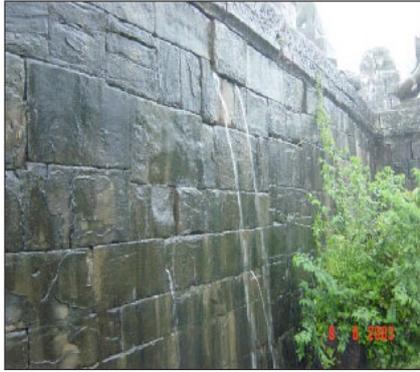
The façade wall of the lowest terrace during intense monsoonal rain. Note the water spouting from between the sandstone blocks, indicating the build-up of hydraulic pressure behind the façade. (APSARA Aug. 2003)

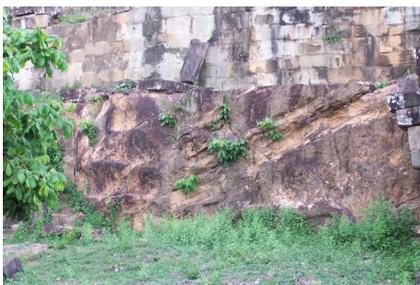
The bedrock cut-slope of the lowest terrace on the western face of the temple. Note the horizontal shelves cut in the bedrock to support the drystone façade, and the light-colored siltstone beds that dip at 300° to the north (upper right to lower left). (MM June 2005)

**9.5.3 Bedrock Analysis:** the edifice (temple mound) was hewn from the solid rock that lay at the core of the original hill (Phnom). The bedrock is a crudely bedded (layered) sequence of conglomerates (well-rounded pebbles and cobbles in a sandy matrix), coarse sandstones, and fine siltstones. The rocks dip at between 20° to 30° to the north. In general, discontinuities in the bedrock are tight, giving the rock a massive appearance. However, particularly at the corners, some discontinuities, including bedding planes and several sets of vertical and sub-vertical joints, have been widened by weathering and flushed by groundwater to produce major conduits for water and sediment movement. In addition, at certain locations, pipe-like features have developed along bedding planes and at joint intersections. Together, these pathways have resulted in sediment accumulating behind the façade.

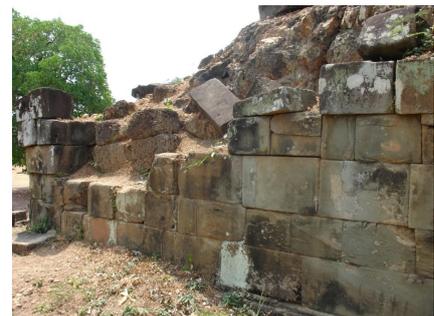
The northeastern corner of the lowest terrace, illustrating how the disintegration of the laterite blocks used to form the final profile has contributed to the structural collapse of the sandstone façade. This method of construction was used, to a greater or lesser extent, on all four corners of the structure. Deterioration of the paved terrace surfaces allowed water to accumulate behind the façade, and alternate wetting (saturation) and drying of the laterite blocks caused them to disintegrate (BW March 2005)

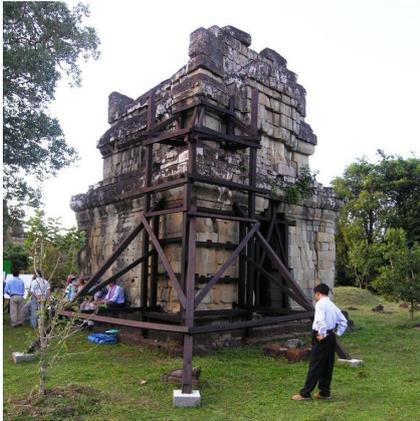
View of southeast corner of the north library with temporary emergency stabilizations works in situ. (JHS Dec. 2005)

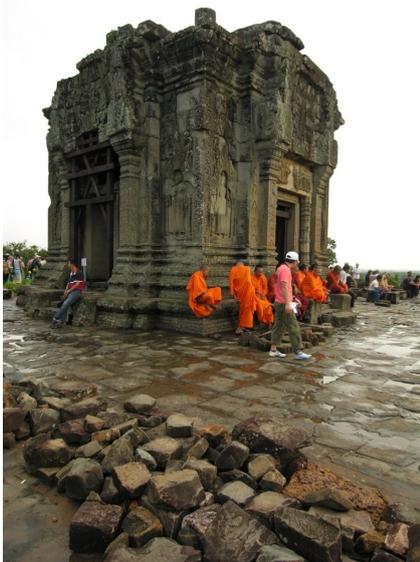
View of the Central Tower of the Quincunx where temporary supports have been provided at the four axial doorways. (JHS Dec. 2005)

**9.7.5 Central Tower:** absent of a superstructure a significant portion of the main Central Tower of the quincunx remains, but has suffered damage. All lintels are in critical condition. Lintels are either: entirely collapsed, propped with a stack of stones, or propped with a concrete beam. Emergency stabilization was carried out to provide full support to the remaining structure in late 2005.

Location	Repair No.	Notes	Repair Type
Entry lintels, all elevations	1	All lintels are in critical condition. Lintels are either: entirely collapsed, propped with a stack of stones, or propped with a concrete beam. Stabilization is required to provide full support to the stone above.	Immediate
Corbels over entries, all elevations	2	Large portions of some corbels are collapsed; others are cracked. Support of stones above is questionable.	Immediate
Tower walls	3	Some displacement, cracks, and isolated mortar repairs exist.	No repairs

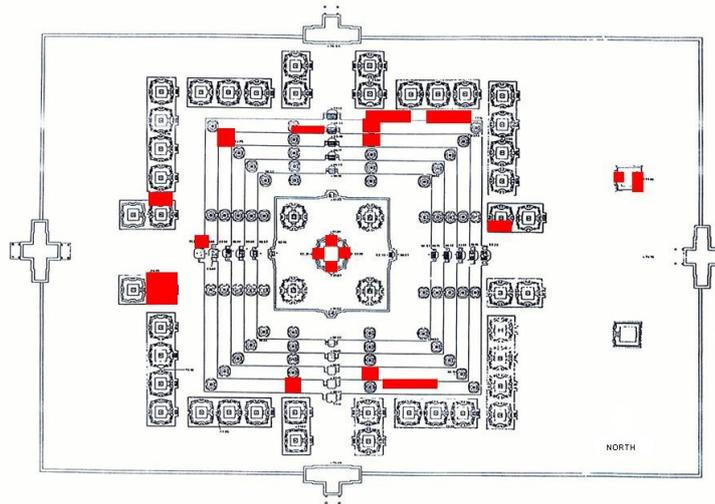
Map of the 12 locations where 'emergency' stabilization works have been implemented. (MS 2005)

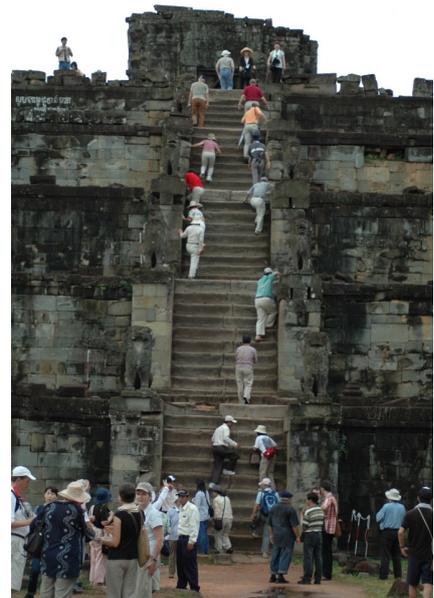
View of eastern temple stairs and their integral buttresses with lions on top. Note the Central Tower at the top, which is absent of a superstructure. (ME Dec. 2005)

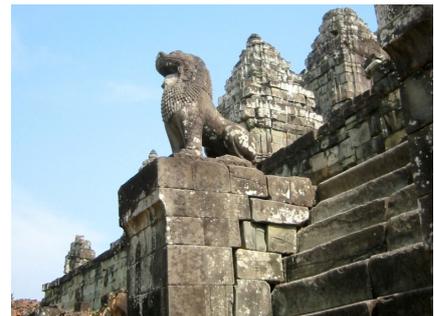
View of the west axial stair and buttress, that has been displaced outwards by past vegetation growth, which was removed in the early 20th century. (ME Dec. 2004)

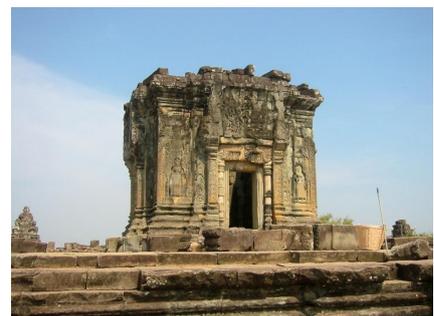
View of the eastern side of the central tower with its superstructure missing and remains or one of the Prasats of the quincunx in the background to the left. The condition of the platform is poor in parts; note the missing sandstone paving in the foreground has exposed the laterite block fill. (BW Dec. 2004)

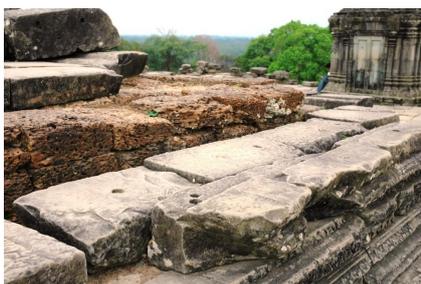
Detail of the Platform of the Quincunx's northeast corner; note the laterite block core has been exposed. (ME March 2005)

**9.7.6 Platform of the Quincunx and Tier 5 Platform:** in parts, the platforms are in good condition, notably where the towers of the quincunx and sandstone shrines stand or stood, the paving still exhibits the exquisite craftsmanship of the finely jointed and interlocking paving joints. In other areas probably where shrub and tree roots became established there has been considerable dislodgment of the sandstone paving allowing the monsoon rain to infiltrate the structure and laterite block core beneath.

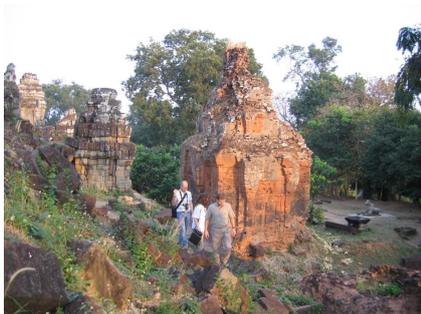
View of a heavily deteriorated and completely obliterated brick shrine. (KK Dec. 2005)

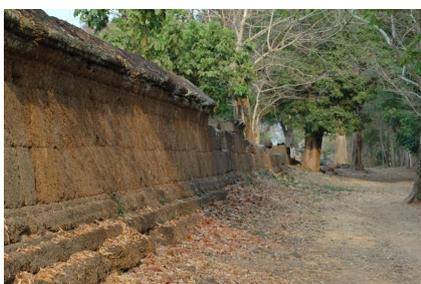
Detail of southern laterite enclosure wall, which in part has collapsed or are missing laterite blocks. (ME March 2005)

Laterite is prone to disintegrate with cyclical wetting and drying; parts of the enclosure wall are missing, have been obliterated from hydraulic erosion or crushed when trees took root.

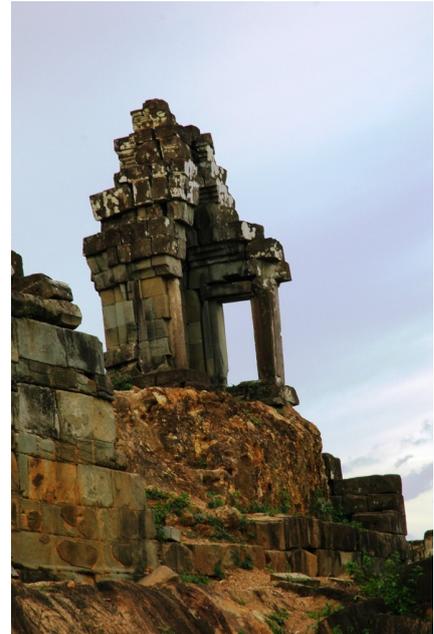
View of the southwest corner of the sandstone shrine E2, which has been identified as needing immediate repairs in the Structural Risk Map, see Figure 9. (ME May 2005)

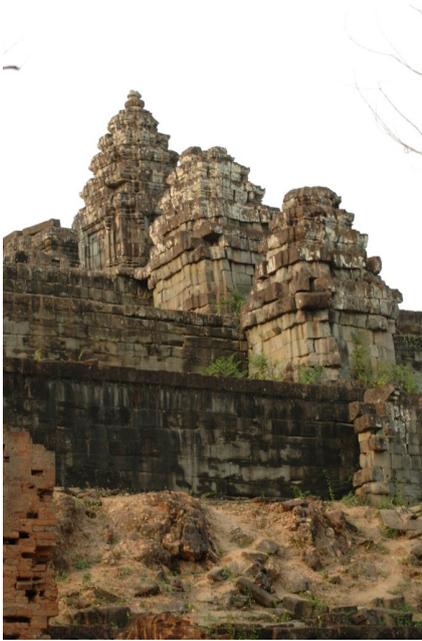
View of the Sandstone Shrines B4, C4 and D4; note that the shrine capping stones are missing on C4 and D4, although capping stones have been identified among the displaced stones artifacts at the site. (ME March 2005.)

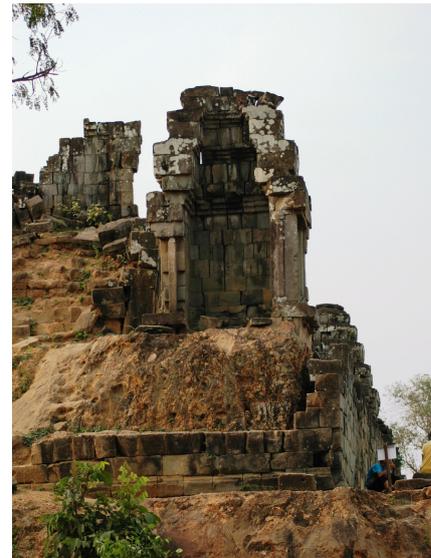
View of the south elevation of sandstone shrine C2 (southeast corner of Bakheng); note the south facade of the shrine has completely collapsed due to the collapse of the platform wall on which its footing was resting. (ME March 2005)

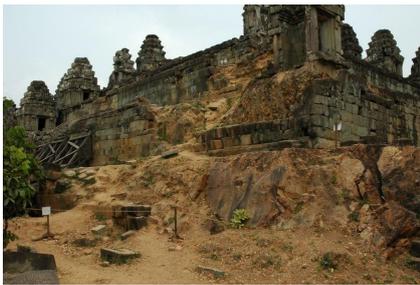
**View of southeast corner of Bakheng where collapse of platform walls has exposed the laterite infill and bedrock, and lead to loss of fabric. (ME March 2005)**

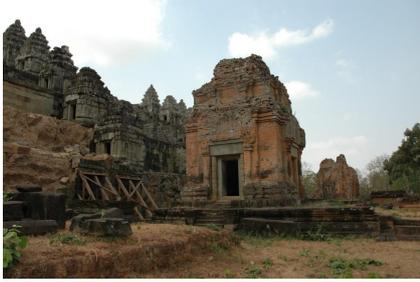
View of brick shrines along the western side of the temple. The shrine in the foreground, G25 has collapsed and the fabric has been obliterated or removed, in the mid-ground the shrine, G23 has been assessed as needing deferred repairs, while the shrine in the background, G21 requires immediate repairs. (ME March 2005)

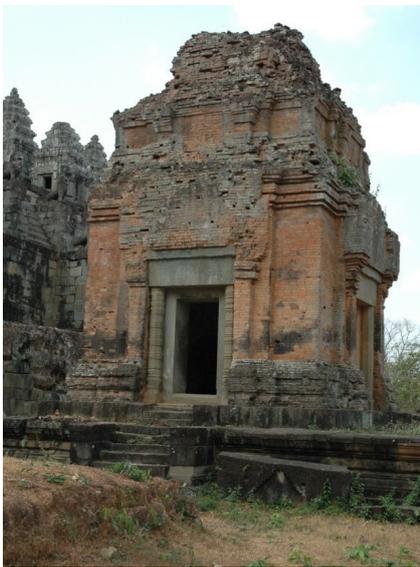
Detail view of brick shrine G23, identified as requiring deferred repairs. (ME March 2005)

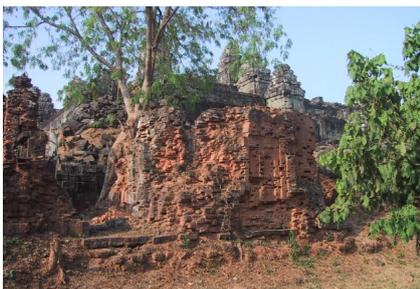
View of brick shrine G15; note the tree which has become entangled with the brick shrine. Analysis will be required to determine whether the tree should be removed on structural ground or remain on the basis that it contributes to the sites significance. (MS March 2005)

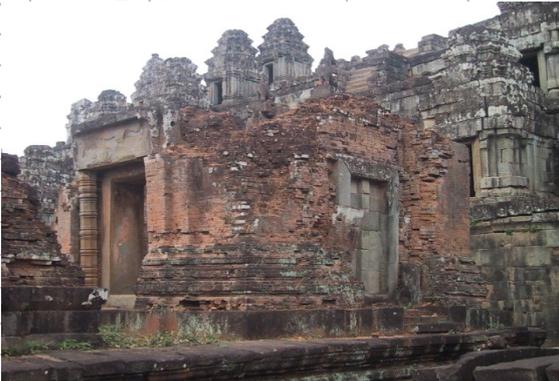
<p style="text-align: center;">NORTHEAST EL.</p>				
<b>STRUCTURAL/FND DAMAGE (% DAMAGED)</b>					
	WALLS	FRAMES	FND		
INSIGNIFICANT	10	35	70		
MODERATE	10	10	0		
SEVERE	20	40	25		
COLLAPSED	40	15	5		
Damage Index	0.25	0.45	0.30		
<b>LEANING/PLUMB (DEG. OUT OF PLANE)</b>					
ELEVATION	N	S	E	W	DEG.
	3	6	2	4	
<b>EXTERNAL INFLUENCE (X=YES)</b>					
	VEGETATION	X			
	ADJACENT COLLAPSE	-			
	UNDERMINING AT BASE	X			
<b>CRACKS</b>					
<b>REPAIR/STABILIZATION NOTES</b>					
Walls: severe leaning					
Door frames critical: severe leaning					
Foundation damage, some repairs needed

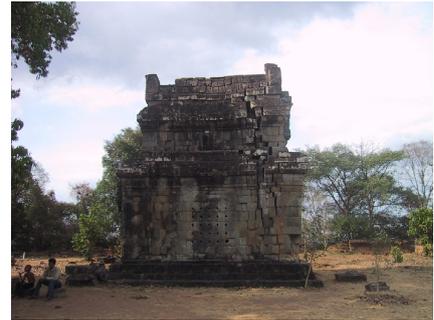
**View of the north library H6 prior to the emergency stabilization works; note the severe damage to the east end where the wall is ‘spreading’. Further assessment is required to determine the optimum conservation measures to be undertaken. (MS March 2005)**

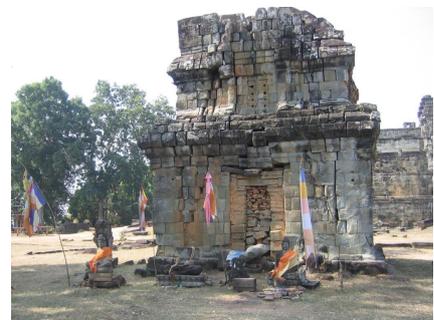
**View of the south library H2 east elevation prior to the emergency stabilization works; note the lintel has collapsed and is supported by stone rubble and block fill. Further assessment is required to determine the optimum conservation measures. (KK Dec. 2004)**

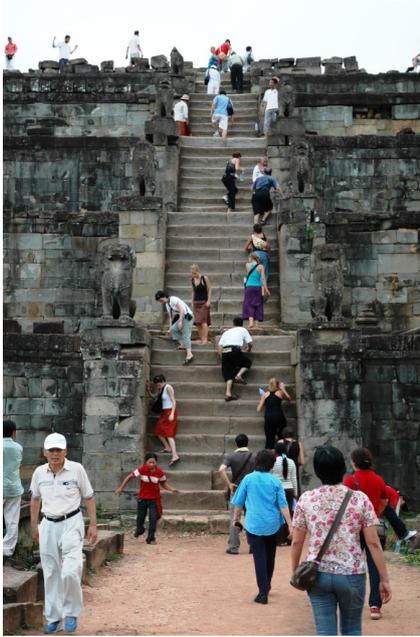
View of sandstone steps on the east cardinal axis. Repairs identified at C0.5 include: south buttress stone pushed out 6 - 10 cm at top 2 courses, which requires resetting. (ME May 2005)

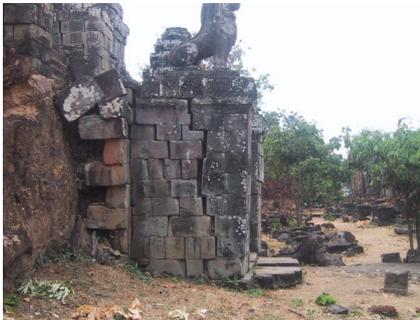
Sandstone step structure F6.5 is founded partially on bedrock and soil fill. Due to movement of the soil fill and collapse of adjacent walls severe movement has occurred. It is recommended that the north buttress be reset and at the same time repair the two steps with deep spalls. (MS March 2005)

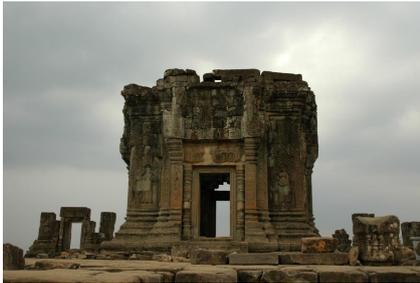
View of the quincunx platform; note part of the southwest prasat A3 remains in situ (left-hand far ground) while little of the original stone remains in situ for A2 and A4, parts of prasat A5 remain. (ME March 2006)

**9.8.6 Towers of the Quincunx:** the four minor towers are essentially collapsed with little of the original stone remaining in situ or on the platform itself.

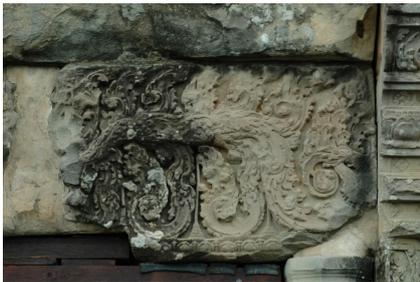
Detail of a stylized plant relief on the south door lintel of the Central Tower; note the rude cementitious repairs that detract from the aesthetic value evident in the exquisite execution of the plant relief. (ME Dec. 2005)

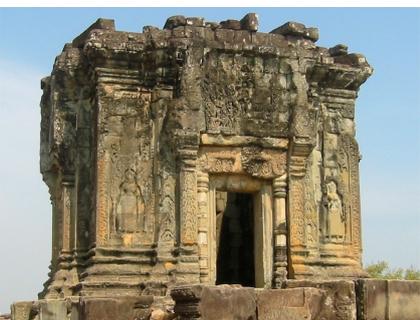
The Central Tower, the most significant element of the temple complex has suffered severe exfoliation and loss. Dec. 2004 (ME)

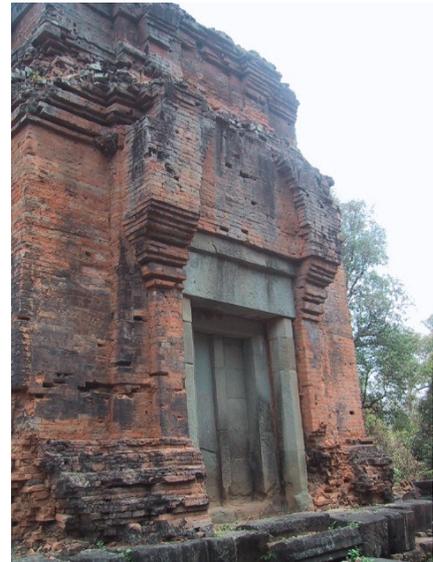
View of the south elevation of brick shrine G34. The majority of the brick shrines are in a state of ruin whereas G34 is relatively intact, proving a rare physical record of the external brick detailing. March 2005 (MS)

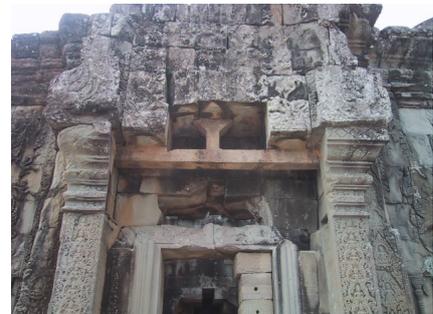
Detail view of the north elevation of the Central Sanctuary where past conservation efforts included inserting a concrete lintel. March 2005 (MS)

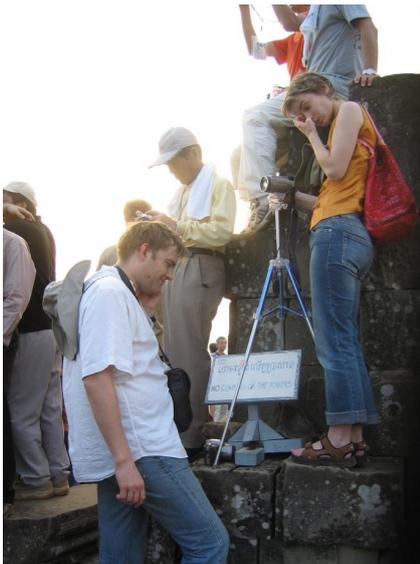
In their desire for the best vantage-point for sunset viewing tourists ignore the 'No Climbing on Tower' signage on the Platform of the Quincunx. (KK Dec. 2004)

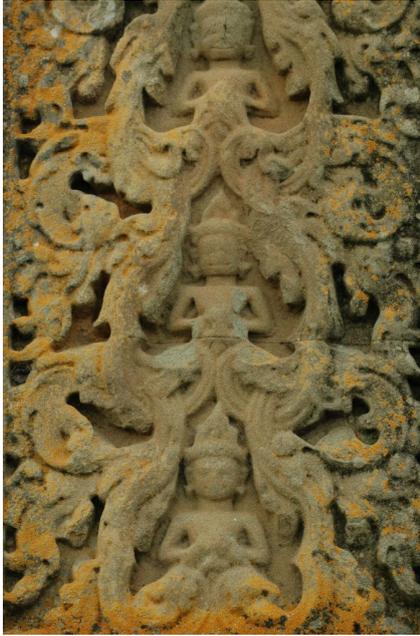
Detail of interwoven plant decoration on one of the south pilaster of the Central Tower. (ME March 2006)

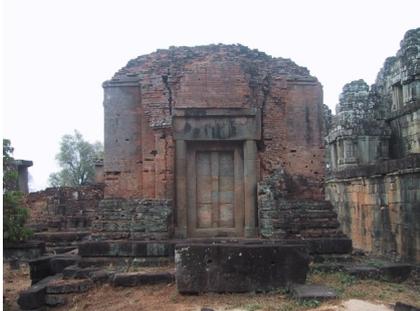
View of north elevation of brick shrine G43 with a sandstone blind door, the east elevation has a true door opening. (MS March 2005)

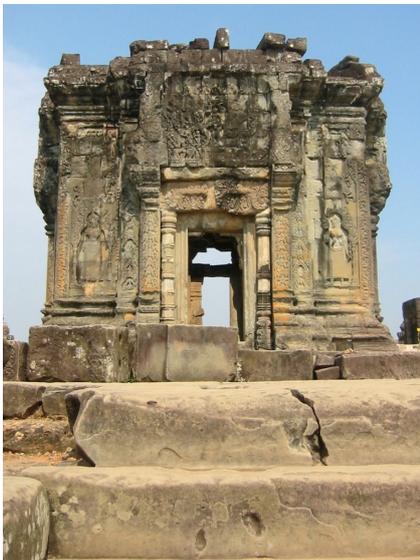
View of the east facade of the Central Sanctuary; note the colonnettes flanking the doorway. (BW Dec. 2004)

11.4.5 **Colonnettes:** were used as decoration on either side of doorways.

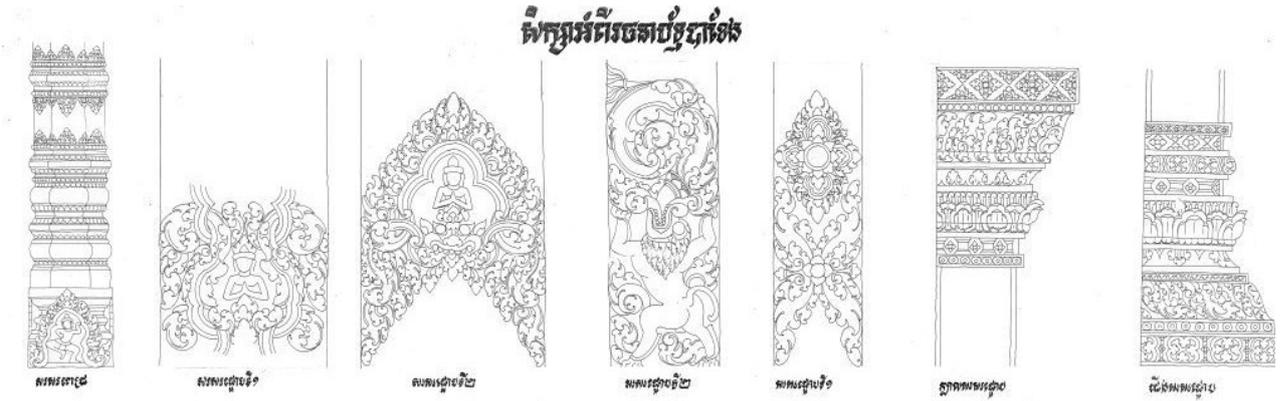
Figure 16 Artist concept of the architectural features at Phnom Bakheng, including from left, a colonnette, pilaster reliefs and capital and base relief details.

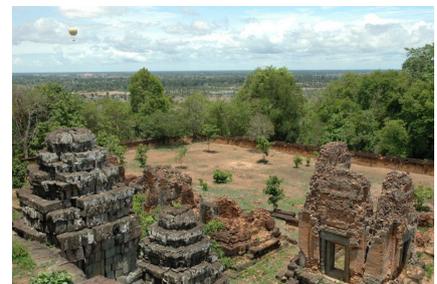
View from the top of Bakheng towards the southwest; note the laterite wall enclosure in the mid-ground, and the mature trees on the outside of the wall enclosure. (ME March 2005)

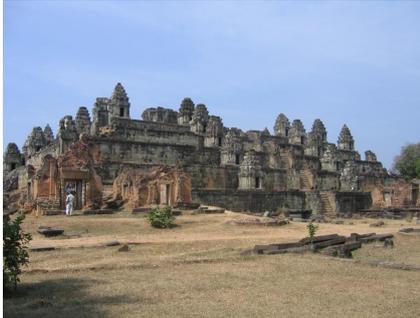
View of the southeast corner of Phnom Bakheng a temple mountain form which represents Mount Meru. (KK Dec. 2004)

**11.4.12 Temple Mountains:** took the form of representations of Mount Meru, home of the gods in Hindu mythology. The temples were built in a series of tiers, each shorter than the last to create an illusion of greater height. To further provide correct, although somewhat exaggerated optical perception, the height and width of the stairs at Bakheng became imperceptibly smaller towards the top as the architect applied the laws of proportional reduction. Each terrace of the pyramid is slightly recessed to the west, again to correct perspective.

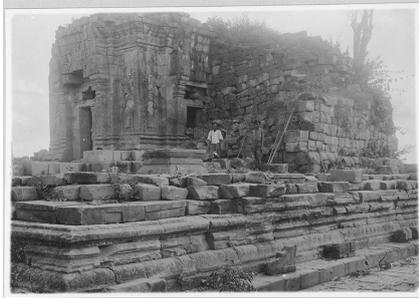
View of the central tower with remnants of sandstone blocks around the Central Tower used to form the Buddha prior to EFEO removing in the 1920s. (EFEO 1923)

Sacred deposits found under the Bakheng Buddha during the restoration process are also of note. In a sandstone receptacle at the bottom of a shaft under the central sanctuary were a number of Buddha statuettes measuring up to nine centimeters in height and made of silver or gold leaf molded around a resin-based substance. Other gold and silver statuettes were found in the masonry of the colossal image.<sup>43</sup>

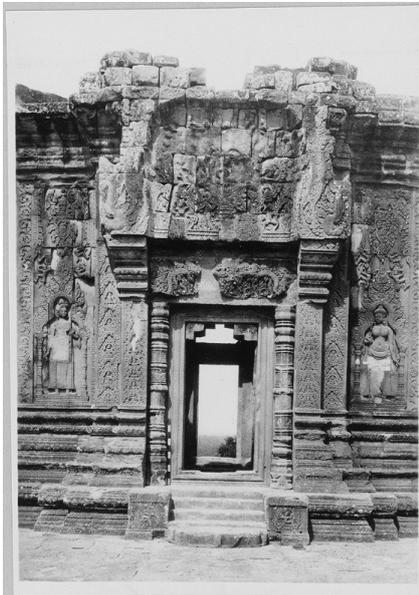
View of the west elevation of Bakheng's Central Tower. This EFEO documentary record will contribute to research and education by providing an opportunity for comparative analysis of the existing condition with the past condition of the Central Tower. (EFEO 1948)

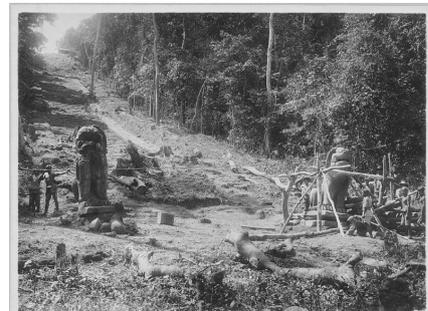
View of the north axial stairs during site clearing and conservation efforts by the EFEO in the early 20<sup>th</sup> century. (EFEO 1929)

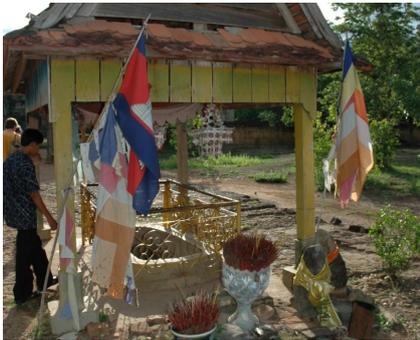
Detail view of the Vietnamese pagoda over the Buddha footprint with iron strapwork surround. (ME May 2005)

**13.6.2 Buddha footprint:** or Buddhapada was dug out off the ceremonial access route and a Vietnamese pagoda constructed over of which monks were noted as the guardians in the 1860s.<sup>49</sup> Today vessels for incense burning are present indicating daily religious use by the Khmer.

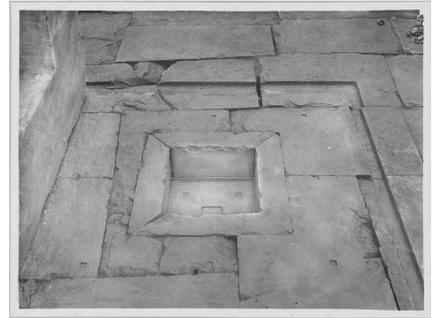
View of the foundation stone of a *linga* pedestal at Bakheng. (EFEO 1920)

The small square niches in the foundation stone would have contained precious stones associated with the navagrah, the nine planets of Hindu tradition, namely the Sun, Moon, Mars, Mercury, Jupiter, Venus, Saturn, Rahu, the demon of the eclipse, and Ketu, the personification of the node of the moon or the comets.

The small square niches in the foundation stone of the *linga* would have contained precious stones associated with the *navagraha*, the nine chief celestial beings of Hindu tradition: the Sun, Moon, Mars, Mercury, Jupiter, Venus, Saturn, Rahu, the demon of the eclipse, and Ketu, the personification of the node of the moon or the comets.

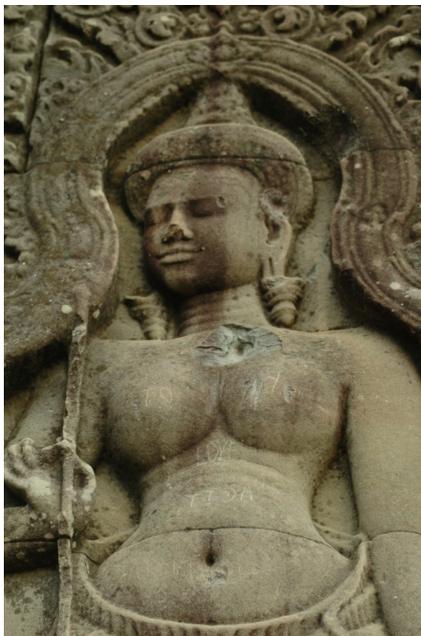
**Spalled loss with small central holes caused by gunfire above the breast of a devata in the stone relief on the Central Tower occurred when the site was under control by the Khmer Rouge. (ME Dec. 2005)**

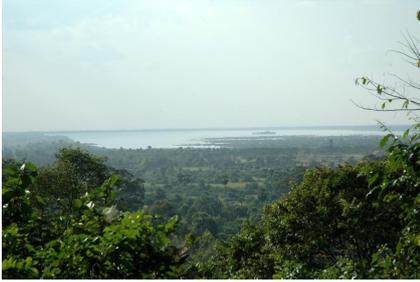
View from the North Trail to the West Baray, c1010. The West Melbon temple, which stood in the middle of the reservoir, has almost entirely disappeared. The artificial island which the West Melbon was constructed on is visible in this view. (ME Dec. 2005)

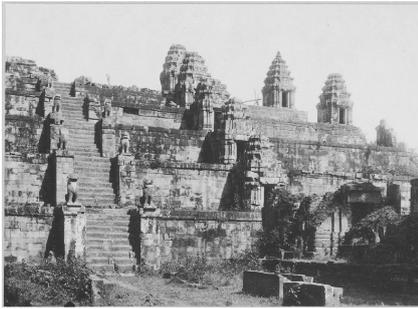
Extensive EFEO archival records of conservation efforts undertaken by EFEO in the early 20th century, provides a chronicle of outstanding research potential. (EFEO 1948)

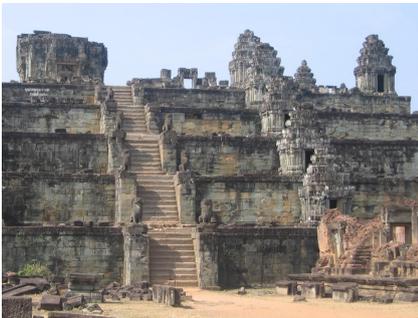
This view taken from a similar vantage point to the EFEO photograph above allows a comparative analysis of changes to the physical fabric, for example – it can be observed that the stone capping on the northeast temple on the 5th platform is absent. (KK Dec 2004)

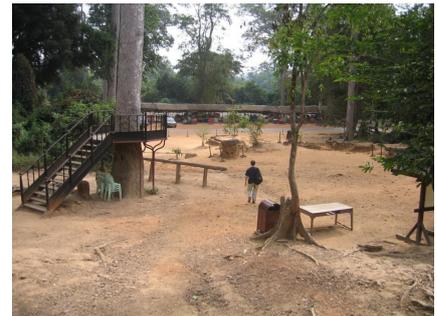
View from the North Trail towards the Vendor Stores which are sited over the historic east cardinal direction. Note the intrusive elephant station to the left in the mid-ground. (KK Dec 2004)

- Relocate both elephant stations to mitigate potential damage of historic fabric.

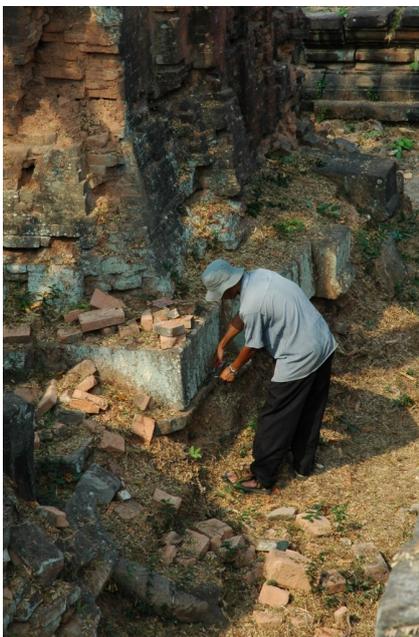
**Maintenance work being carried out by HCC to remove weeds from the base of a brick shrine on the south side of Bakheng pyramid. (ME March 2005)**

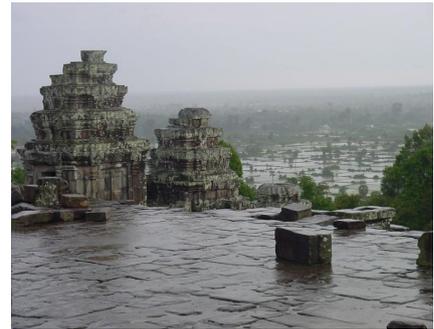
**View of the southwest corner of the Platform of the Quincunx in a monsoon downpour. (May 2005)**

The most complex hydrological issue associated with Phnom Bakheng is structural instability caused by infiltration storm water in the temple structure.

**19.2.1** The continuous infiltration of rainwater into the temple structure has resulted in decay of the laterite fill blocks which has contributed to the structural instability of the sandstone veneer walls. Centuries of abandonment, coupled with the encroachment of woody vegetation, has resulted in the displacement of many of the original well-fitting paving stones on the temple platforms. Additionally, many of the stones are missing, resulting in sizable gaps in the pavement. The net affect is that the temple surface, while once fairly to very impermeable, now readily accepts incident rainfall.

**19.2.2** This rainfall, about 1500 mm/year, mainly concentrated in the wet season, infiltrates directly into the temple structure and upon reaching the underlying impermeable bedrock is forced outward to the side walls and corners of the temple mountain structure. Long duration storms have the potential to surcharge the spaces between the free-standing walls and the bedrock, creating substantial hydraulic pressure on the lower tiers of the structure. While the hydraulic pressure is not capable of displacing the platform walls on its own, it serves as a constant stress to the structure by depositing material, which overtime has contributed to the partial collapse of the platform walls.

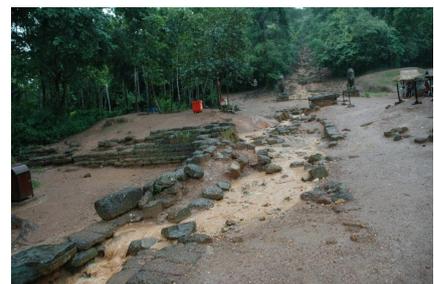
**View of hydraulic erosion at the historic Approach Platform during a monsoon downpour. (ME Dec. 2005)**

**19.3.1** Soil erosion undermines the stability of natural and manmade structures. It contributes to water pollution and impacts the health of humans and wildlife. Erosion at Phnom Bakheng is predominantly caused by uncontrolled water runoff, and vehicular and pedestrian traffic. The CMP seeks to develop a sustainable visitor infrastructure that enhances the sites conservation, interpretation and natural systems.

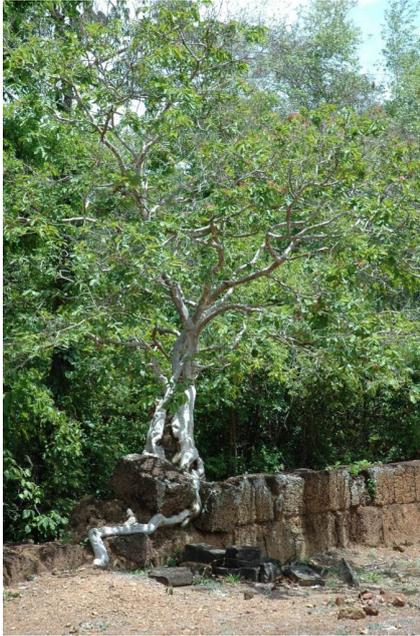
View of a tree contributing to the displacement and destruction of the southern laterite enclosures wall. (ME May 2005)

A detailed survey and assessment of the site is required to ascertain which trees are threatening the historic fabric.

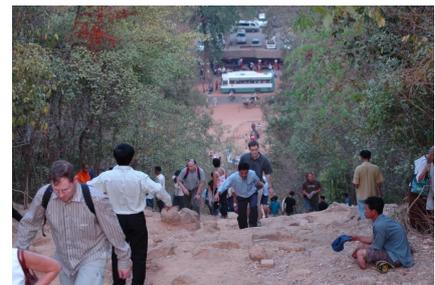
Tourists ascending Phnom Bakheng via the east axial phnom stairs for sunset viewing on top of Bakheng temple.

Note the loss of laterite stairs and one of the many organized tour buses that arrives between 5:00 PM and 5:30 PM for their customers to alight at the *parvi* near the base of Phnom Bakheng. (ME Dec. 2004)

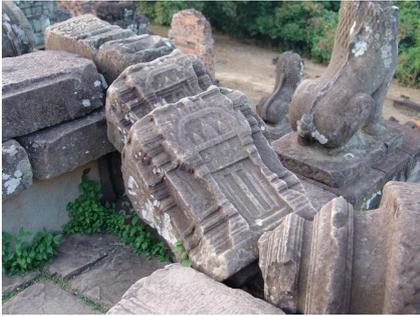
Displaced temple stones are scattered over the temple, in parts the decorative stones have been arranged to prevent access to areas of the temple; note the shrine crown stone, bottom right. (KK Dec. 2004)

The arbitrary use and placement of the displaced shrine stones has contributed to visitors not respecting the temple structure and displaced stones.

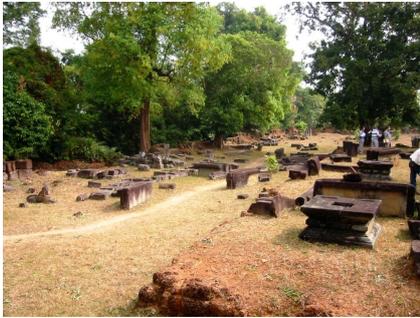
View between Bakheng and the southern laterite wall; note the displaced temple stones throughout the site. (BW Dec. 2004)

**19.7.1** Protection and conservation of the displaced temple stones are central to the maintenance of the Site's values. They are non-renewable, and damage or loss can only be superficially repaired or replaced.

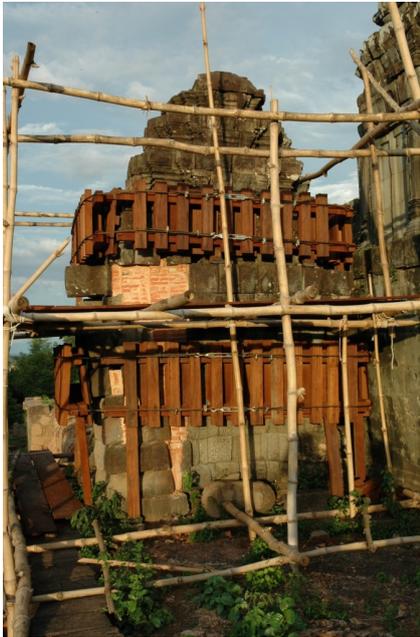
Permanent stabilization works are obscuring the form of Bakheng and diminishing its authenticity. (ME May 2005)

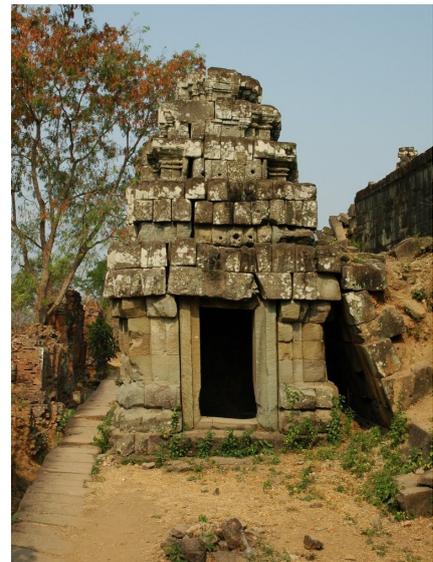
This view includes a sandstone shrine which requires minor restoration; it has been displaced and deformed by the pressure of the collapsed sandstone veneer wall on its south side. To rectify the displaced components major reconstruction of the veneer wall will be required. (ME March 2005)

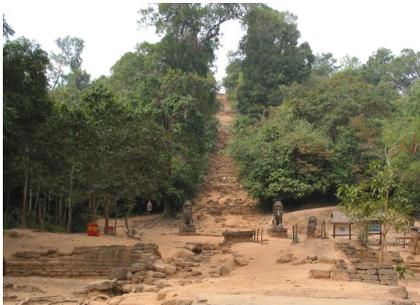
View of Approach Area at the base of the east phnom axial stairs. (ME Dec. 2004)

This area has been identified as an area which may yield substantial knowledge and is considered to have high archaeological potential.

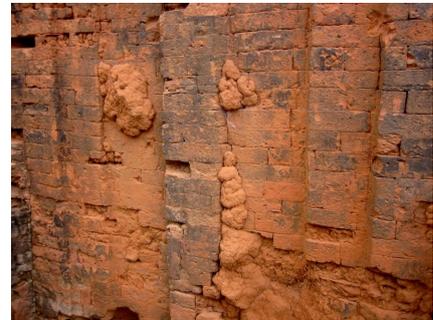
**View of termite nest structure in the brick shrine wall, which can be extremely hard and may cause accelerated decay of building materials and structural instability due to gradual forced separation of units and loss of bearing ground. (BW Dec. 2004)**

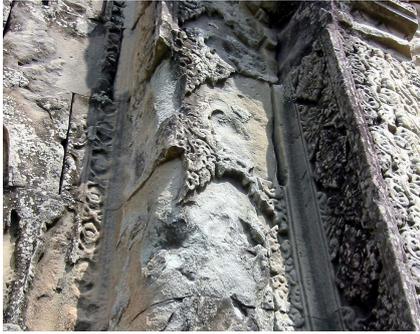
View of irregular peeling, scaling, and flaking off of the stone surface on the Central Tower, resulting in unevenly layered loss of the finely carved stonework. (BW Dec. 2005)

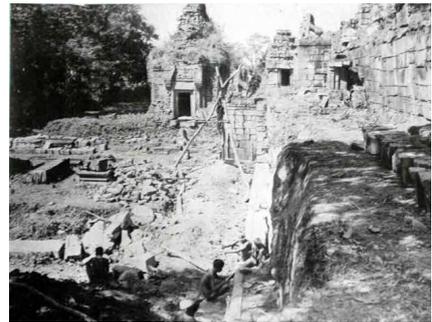
**View of north side of Phnom Bakheng showing conservation efforts in progress in the early 20th century. (EFEO 1915)**

**Historic photographic records can contribute to comparative analysis of structural changes.**

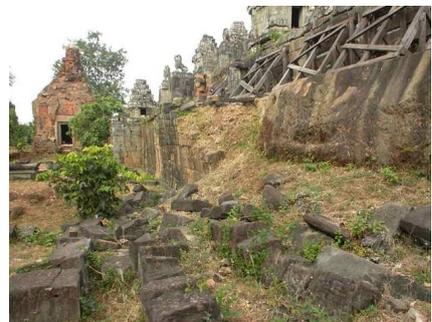
**View of north side of Phnom Bakheng showing conservation efforts in progress at the beginning of the 21st century. (AAA)**

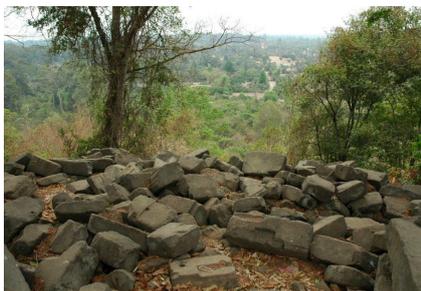
View of displaced temple stone on the south edge of the plateau at Phnom Bakheng. (ME March 2005)

These stones and others within Area 1 and Area 2 have been identified to be recorded, catalogued and stored for possible future *anastylosis*.

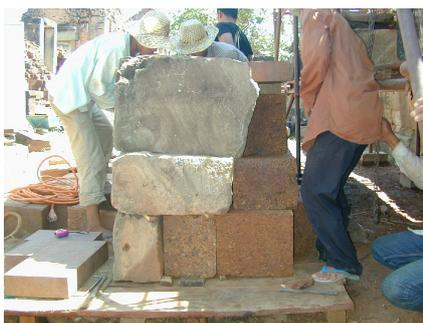
A mock-up showing a sectional profile of the sandstone casing wall with laterite block backing, for the purpose of analysis and guide the reconstruction at the platform wall corners. (MS June 2006)

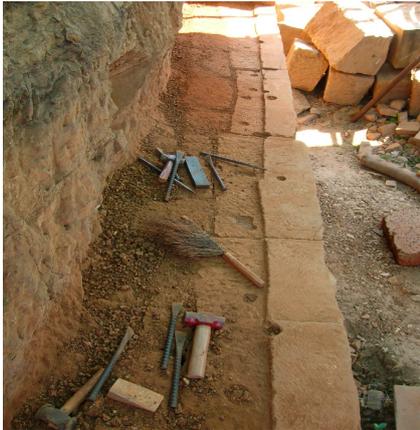
View of the southwest corner during dismantling; note the first two courses of sandstone and laterite backing material still in situ. (MS Feb. 2007)

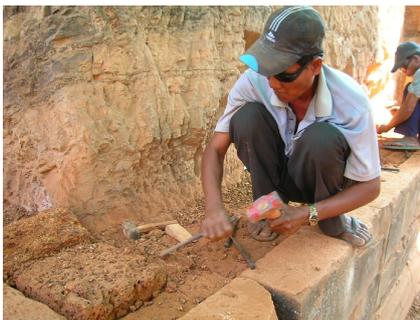
Tooling new laterite block in situ at the southwest corner to enable accurate keying in. (MS Feb. 2007)

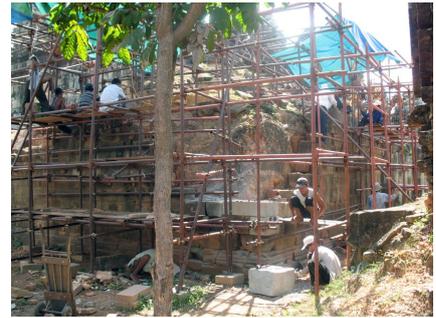
**New sandstone block being positioned into place at the southwest corner. (SK March. 2007)**

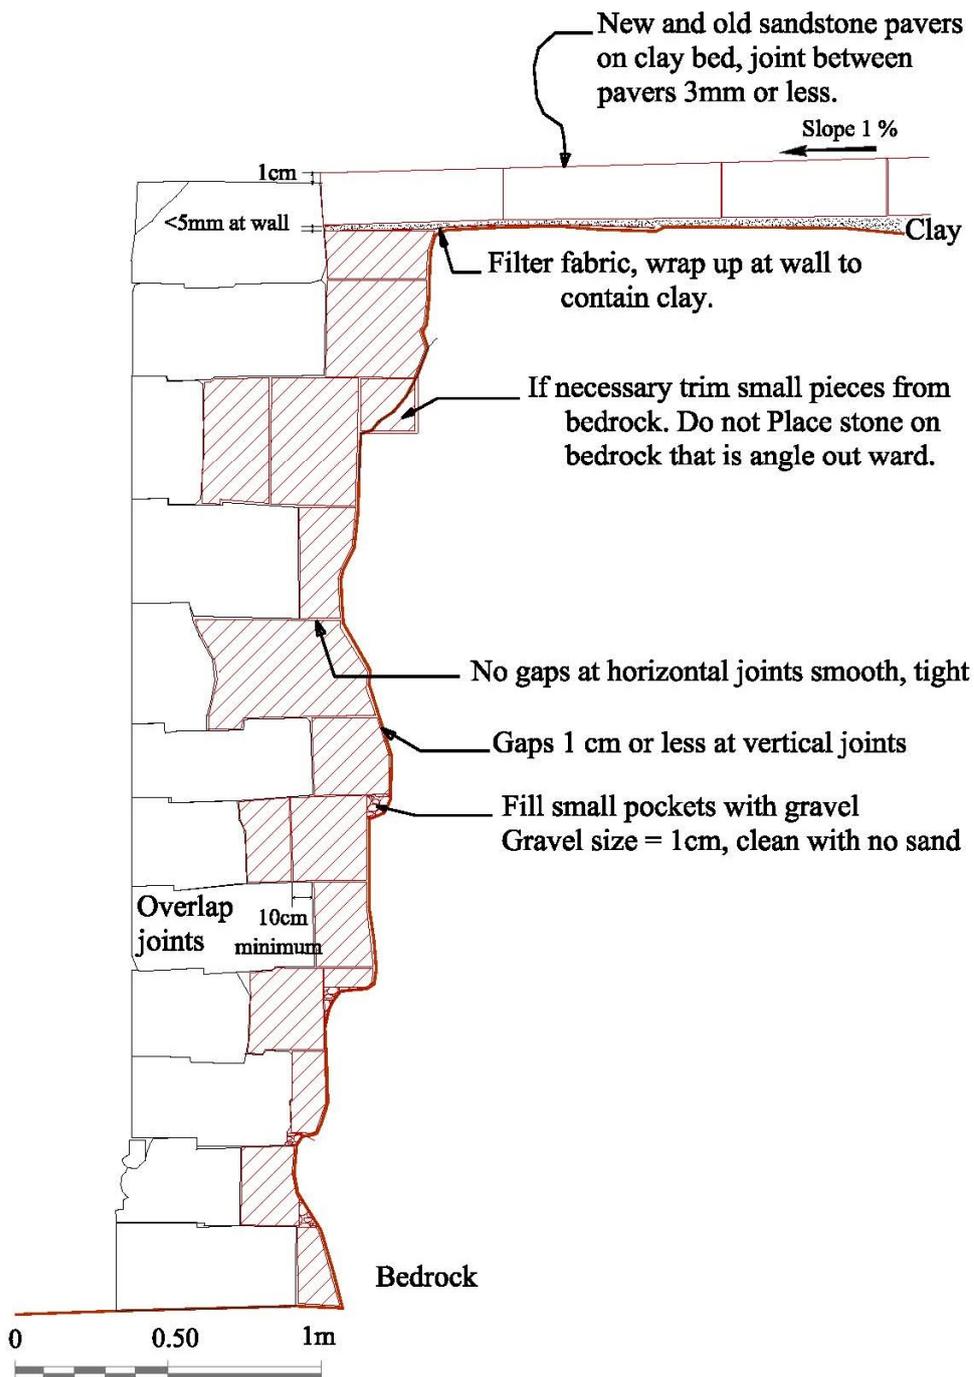
Proposed construction methodology for the Level III Intervention of the southwest corner of Phnom Bakheng (MS Feb. 2007)
