**PREAH KHAN CONSERVATION PROJECT
HISTORIC CITY OF ANGKOR**

**REPORT III
CONSERVATION PLAN**

New York
September 1992
Revised

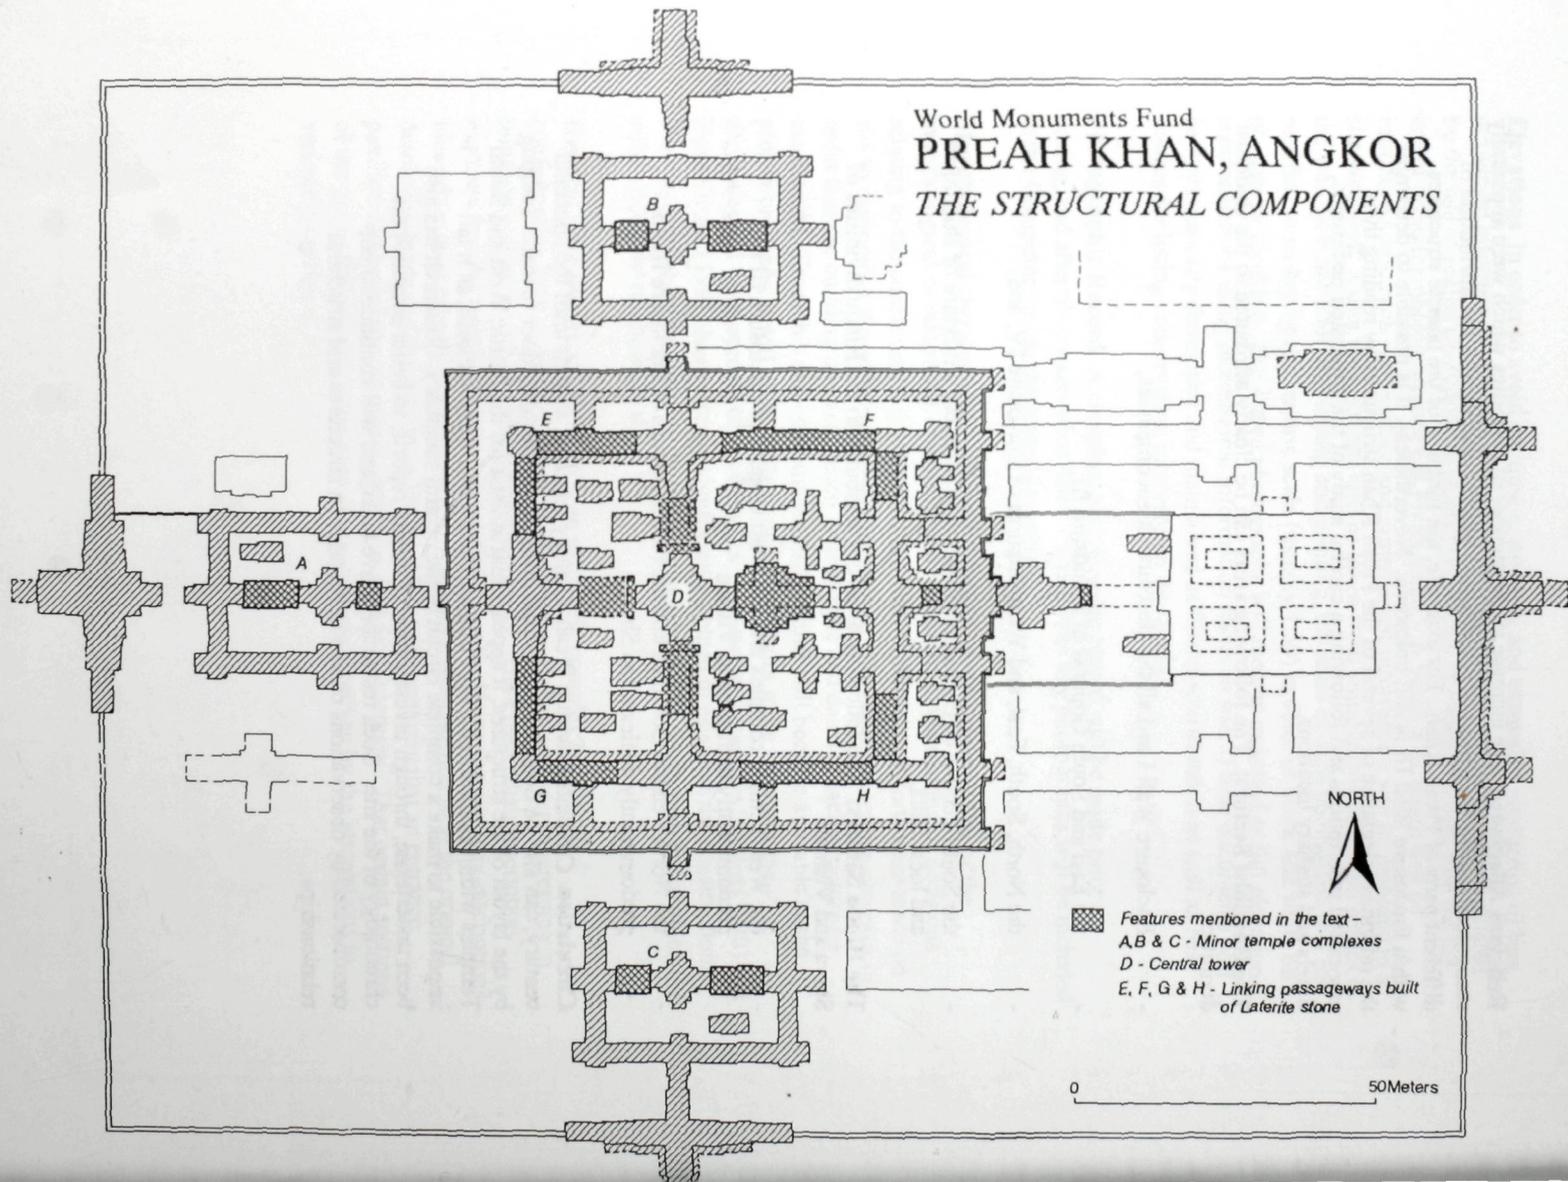
World Monuments Fund
PREAH KHAN, ANGKOR
THE STRUCTURAL COMPONENTS

- ▨ Features mentioned in the text –
A, B & C - Minor temple complexes
D - Central tower
E, F, G & H - Linking passageways built
of Laterite stone

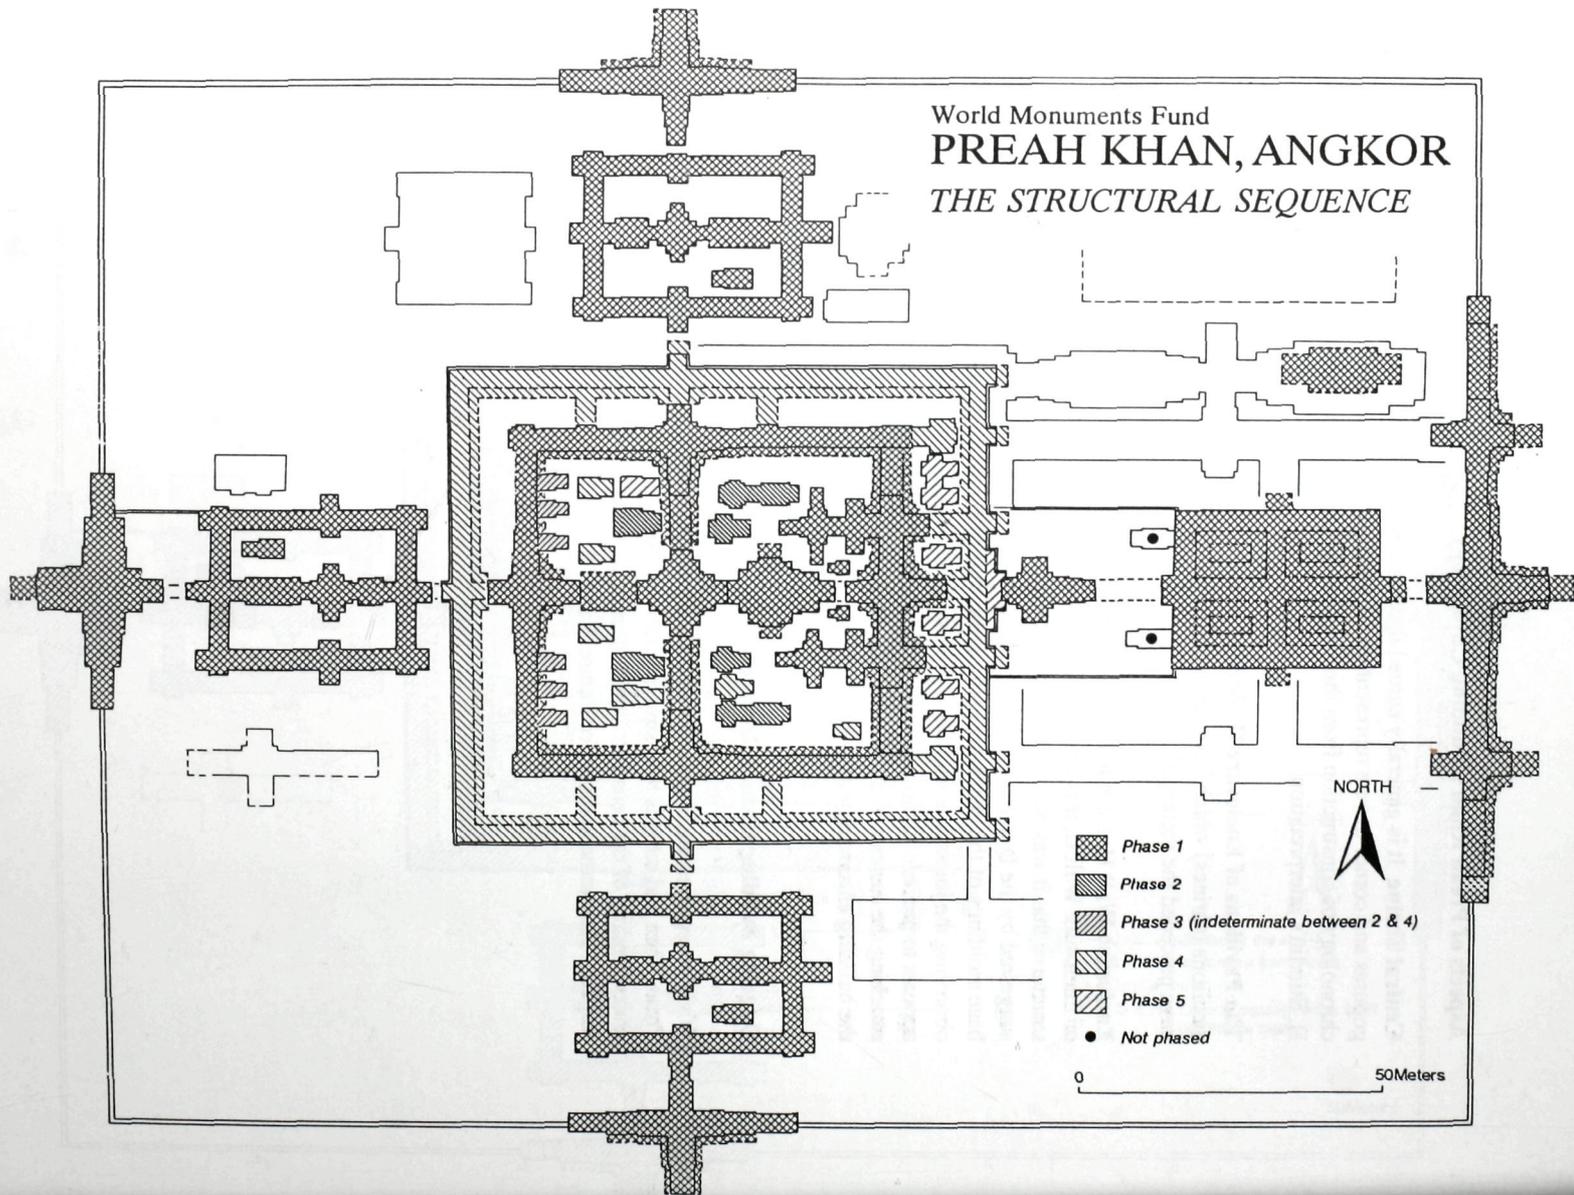
World Monuments Fund
PREAH KHAN, ANGKOR
THE STRUCTURAL SEQUENCE

Enclosure Wall II Despite earlier contentions relating to the period of construction of Enclosure Wall II, it is apparent from close examination of the foundation structures that it was built later than the North and South access corridors. This is suggested by the fact that the base moldings of the corridors are interrupted by the base moldings of the enclosure wall. Despite it being difficult to determine by observing the joints, the section of the passage from the Northeast laterite terrace appears to precede Enclosure Wall II. It also seems that the link construction attaching the eastern cruciform pavilion to the enclosure wall was the final addition in the building chronology of this section.

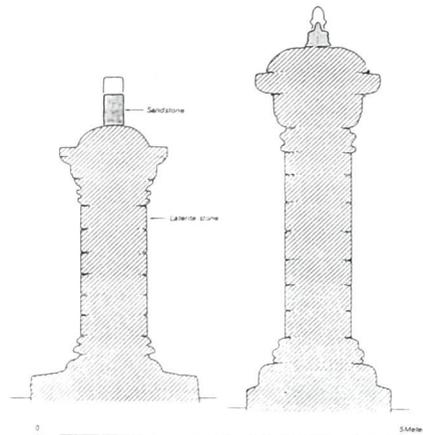
Sections Through the Outer (left) and Inner (right) Boundary Walls at Preah Khan

In most instances, the dry laid sandstone masonry at Preah Khan is tightly joined and is occasionally tied by stones cut in wedge or butterfly shapes. Some of these unusual details appear to be later insertions. It appears that the walls are set on minimal foundations set directly onto laterite bedrock. More often than not, the sandstone veneer is backed by a laterite structure. The methods of bonding structurally distinct wall surfaces, as found in two faces of the stone wall, appear to be somewhat arbitrary. There is occasional through-linkage using stone keys from the outer sandstone skin.

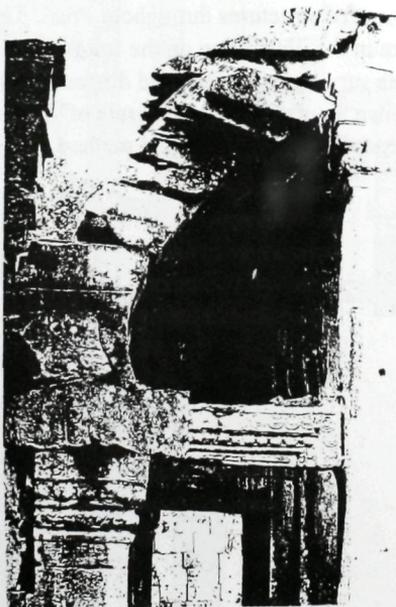
Roof Construction - Vaults In the typical cross section taken on the west side of the inner enclosure, just to the south of the main east-west axis, large sandstone lintels span between pillars to provide support for the corbelled vaults above. These lintels are frequently linked with interlocking joints along their edges. Roofs over the galleries are formed by the corbelling of massive stones which project one third of their width until the opening is finally capped with a large sandstone bridging stone. Each stone is structurally keyed to provide lateral stability and specially lipped and grooved to shed precipitation from the upper to the lower stone courses.

Detail of Quarter Vault

Vaults - Structural Failure A vaulted structure is completely stable only when it is intact. Stones used in construction are dependent upon one another for structural support. In the event of partial collapse or failure, there usually is little to prevent the entire structure from falling to the ground. The loss of structural integrity of a vault can also occur due to the collapse of adjacent structures.

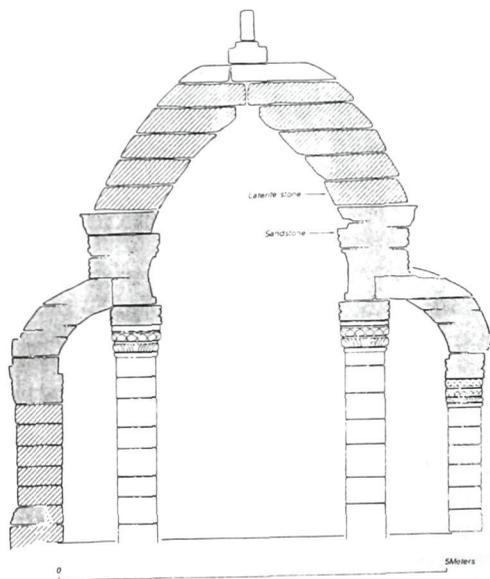
Section Through East Gallery, Preah Khan

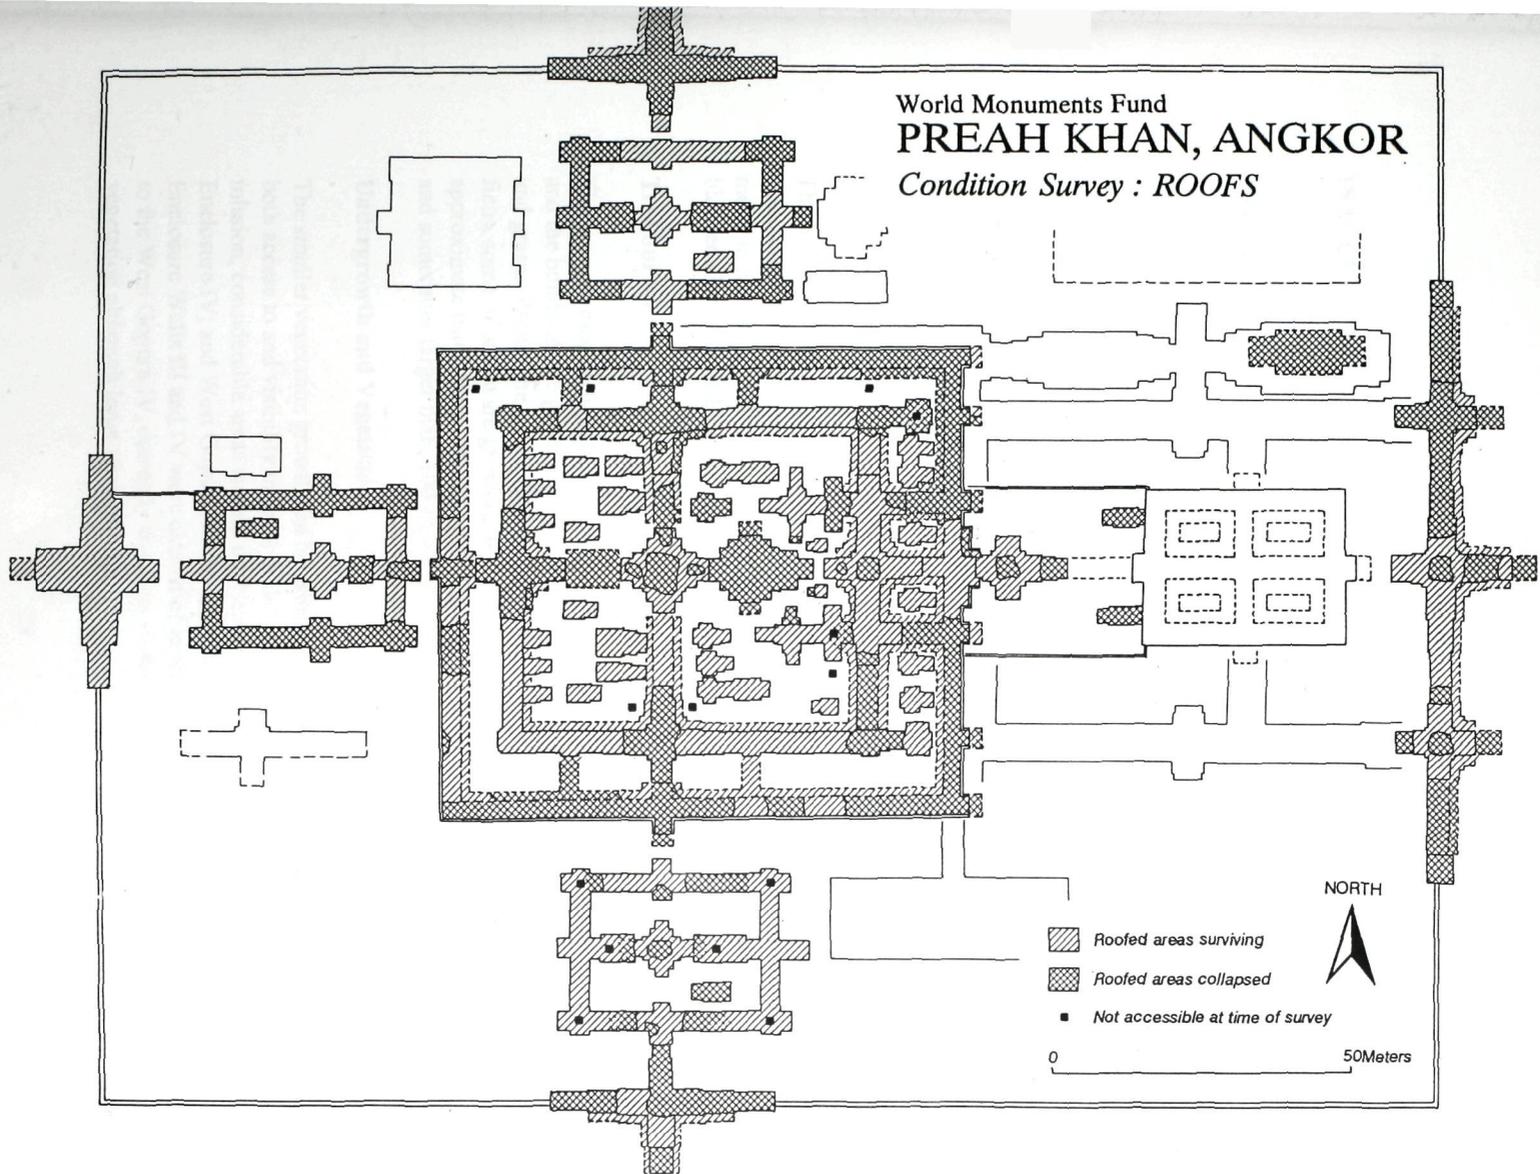
World Monuments Fund
PREAH KHAN, ANGKOR
Condition Survey : ROOFS

During the March 1992 mission, a preliminary survey was made of the condition of the roofed structures throughout Preah Khan. It is presented here in diagrammatic form in the illustration on the following page. The plan distinguishes areas where the roofs survive intact (hatched diagonally) from the areas where they have collapsed (shown solid). The survival rate of vaulted roof construction at Preah Khan depends essentially upon the original method of construction.

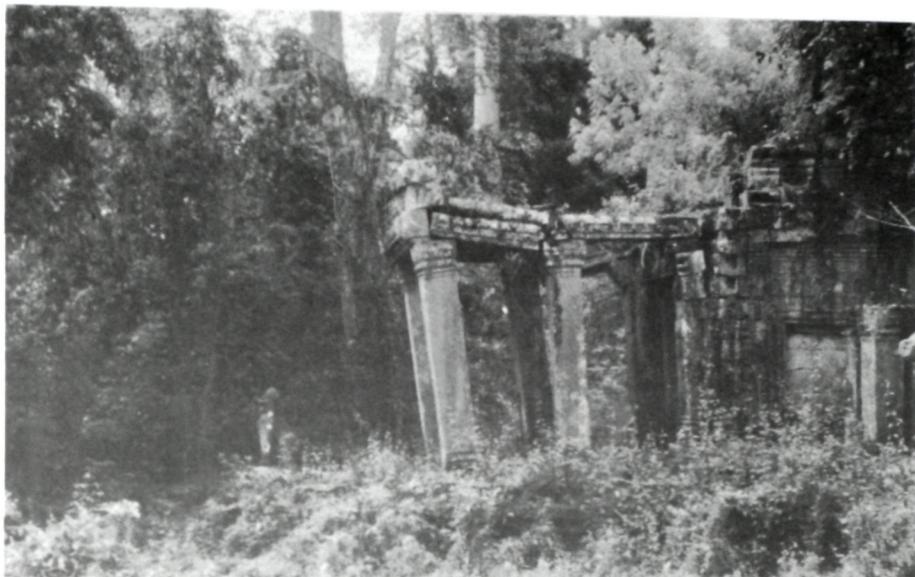
Structural Failure at
West Gopura III, South Porch

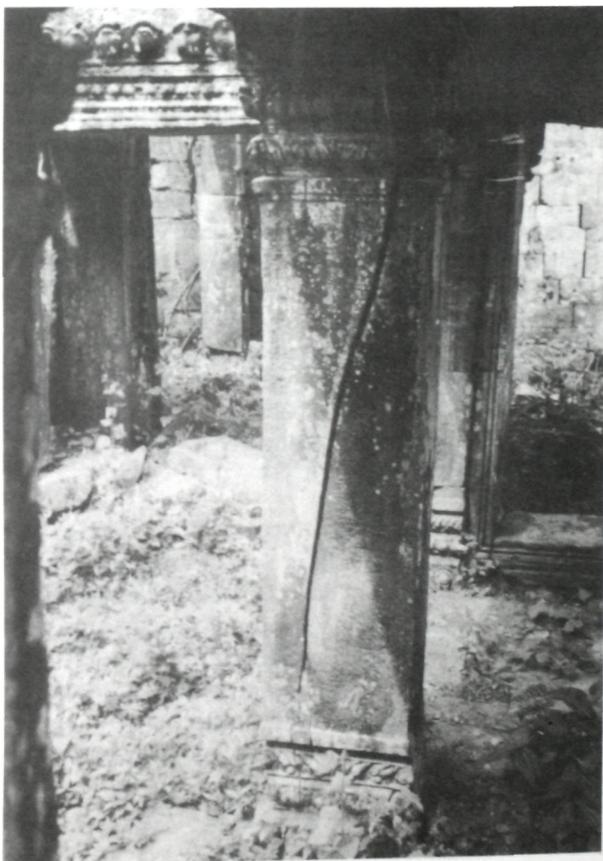
Vertical Fissure in Column,
West Gopura III

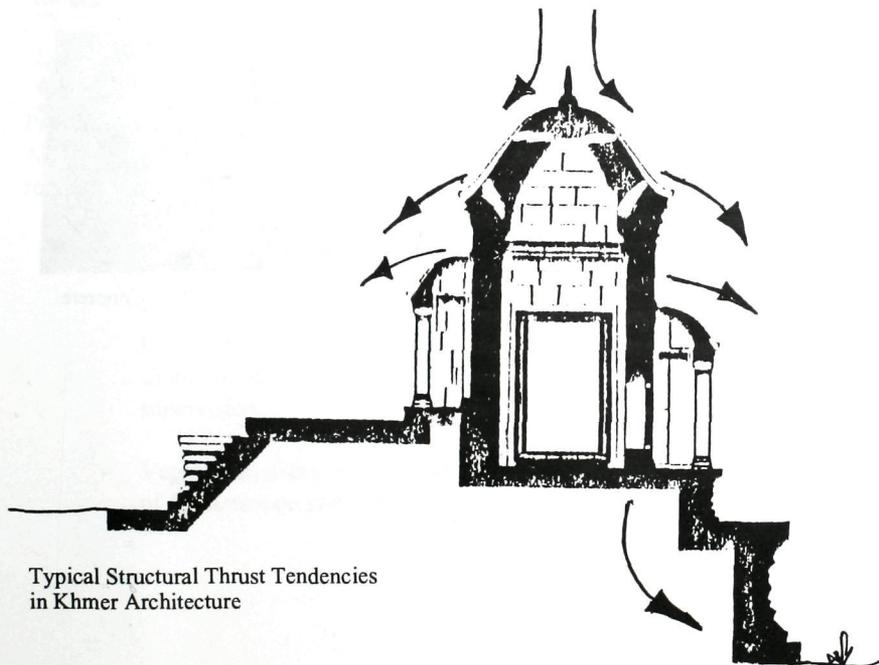
Typical Structural Thrust Tendencies
in Khmer Architecture

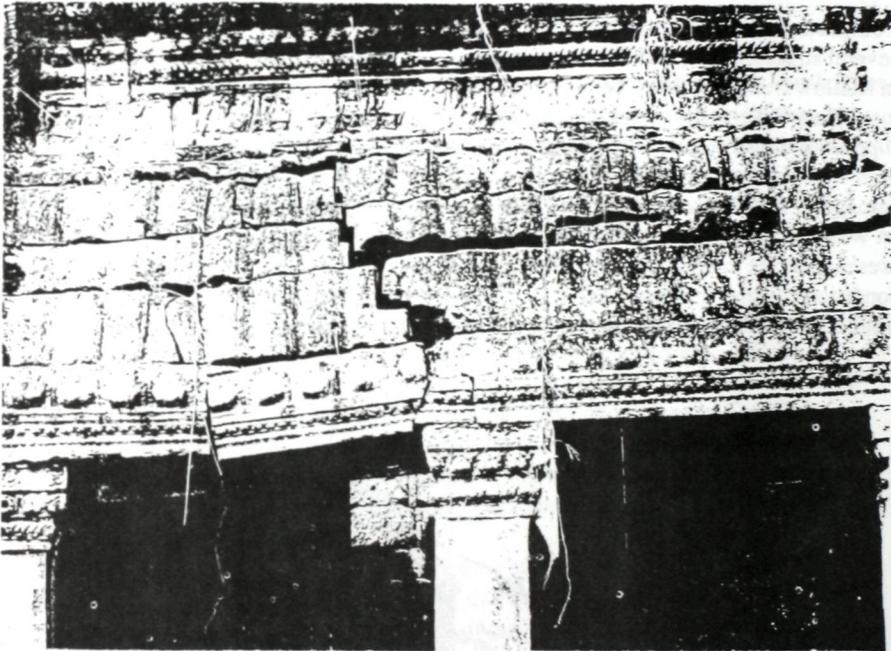
East Gopura III (Northern Section) Collapsing Vault Stabilized with Cast-in-Place Concrete

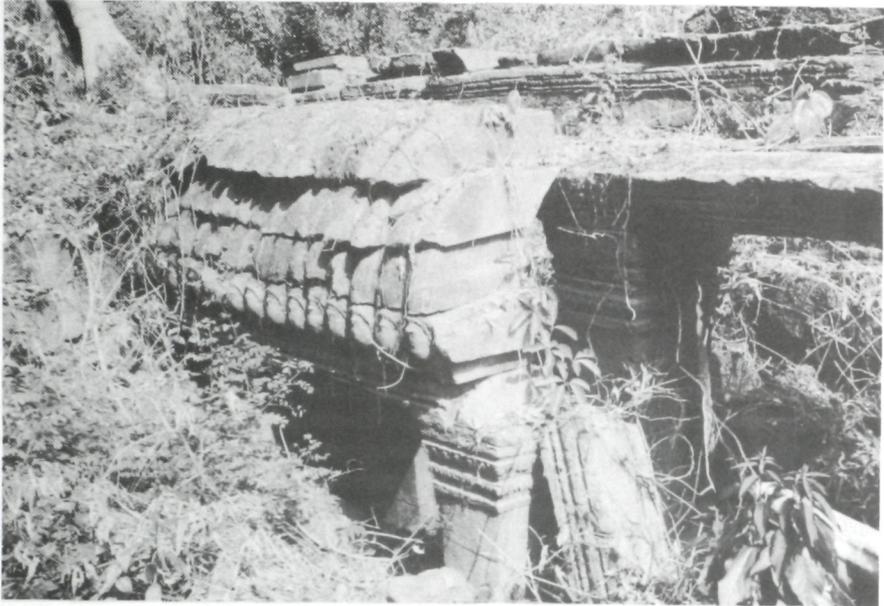
Typical Failure at a Quarter Vault

Resetting Vaults Using Centering/Cradling In many instances the main vaults and side vaults of corridors, arcades and porticos have collapsed or threaten to collapse. Some were structurally stabilized by the EFEO in the 1930s and 1950s in a manner that preserves their dislodged and misaligned "as found" appearance. It is planned to develop suitable techniques to reset the more precarious vaults and lintels using jacks and specially constructed cradles that will raise the vaults sufficiently to permit the repair of broken beams as well as the vertical resetting of columns.

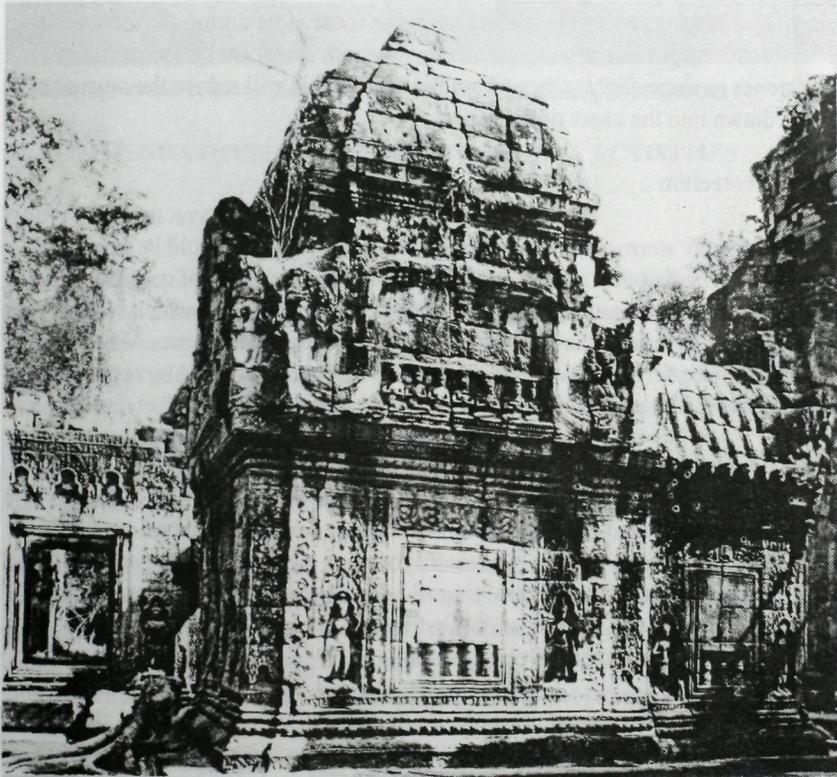
Open Stone Joints in Detached Shrine, Enclosure I

Weatherproofing of Joints A special study will be undertaken to ascertain the best alternatives for weatherproofing joints, especially in the roof vaults. The stone slabs were originally dry laid and their careful detailing effectively channelled rainwater off the roofs. Today many of the roofs display problems of leakage. A system using joint seals may be preferable to the standard remedy of mortar filling, which contravenes the original design principles and can cause stonework discoloration.

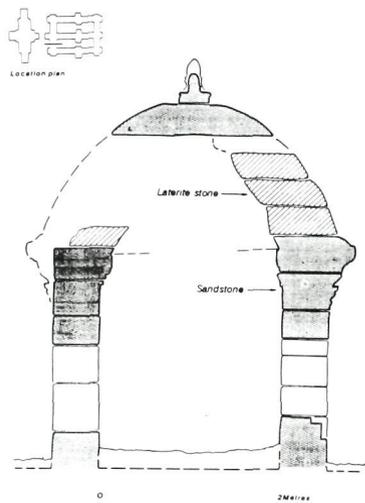
In the generalized cross-section taken on the west side of the inner enclosure, just to the north of the main east-west axis, it can be seen that the stone slabs capping the smaller side galleries span the entire space beneath them, whereas the roof of the high outer gallery is constructed of corbelled slabs which to some extent interlock laterally with rebated joints providing a stable structure only when it is complete. As soon as damage occurs at the top or on the side there is little to prevent the entire structure from falling.

Diagrammatic Section, Through the West
Minor Temple Complex

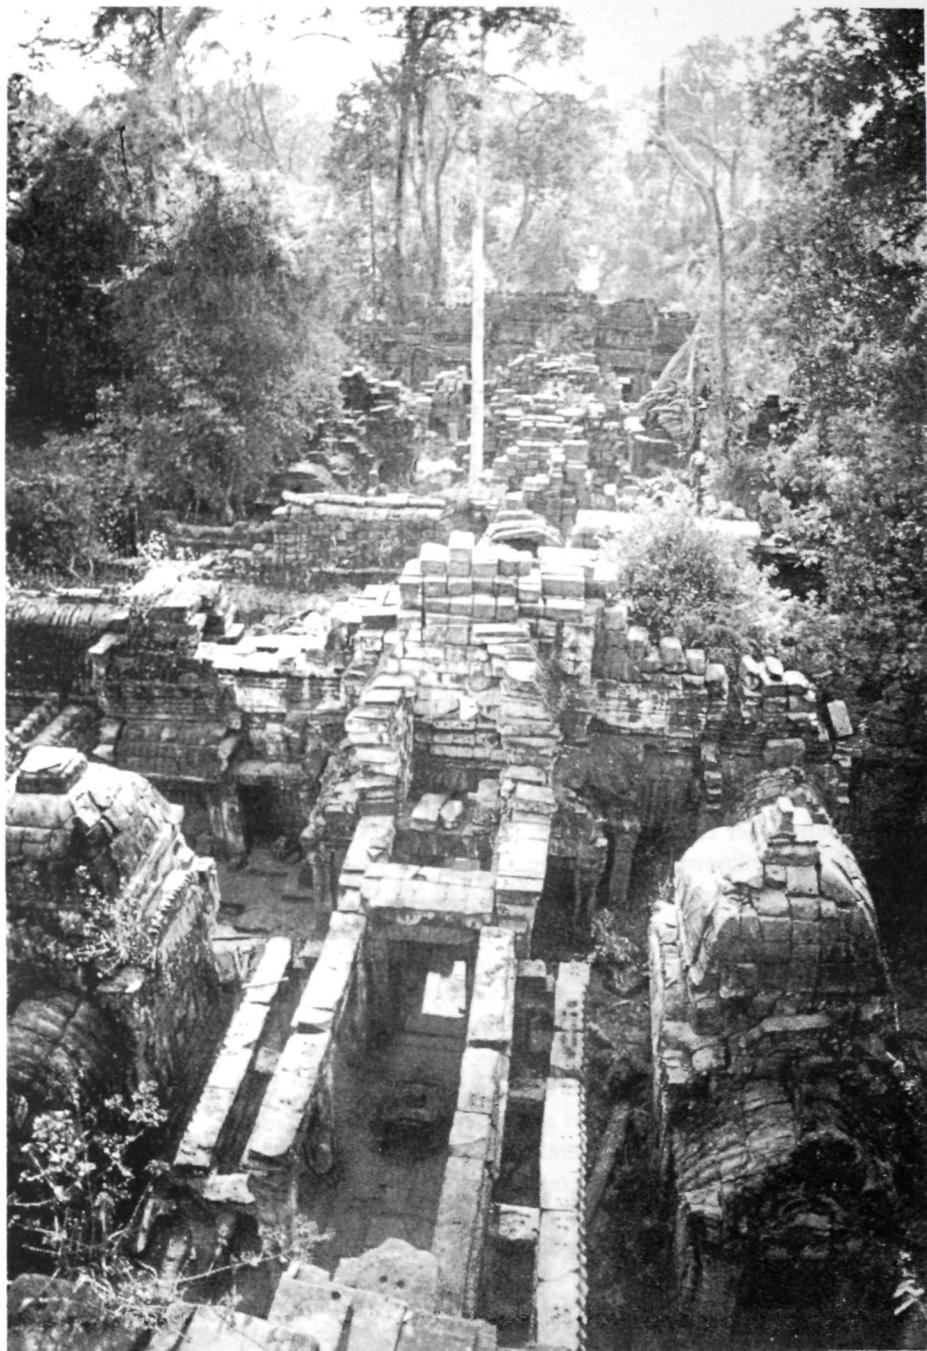
Roof Conditions Along East-West Axis of Preah Khan, (March 1991)

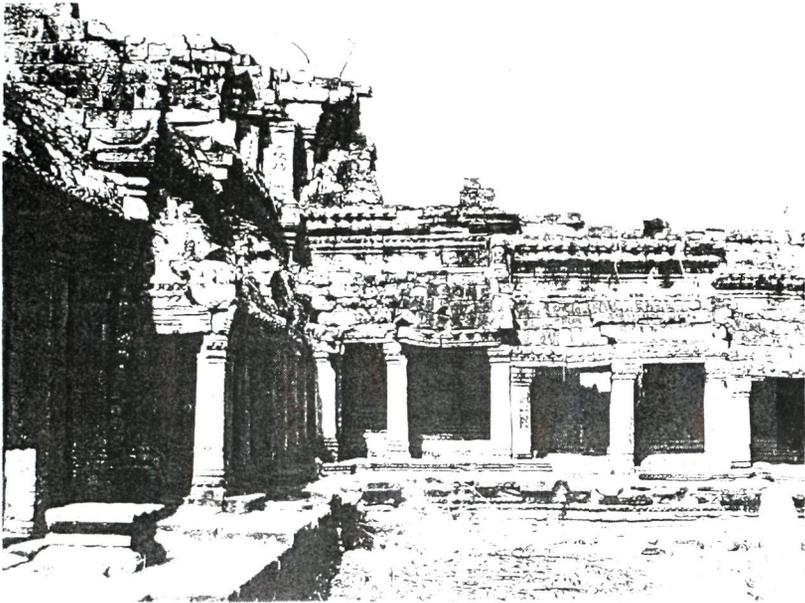
Roof Conditions at East Gopura

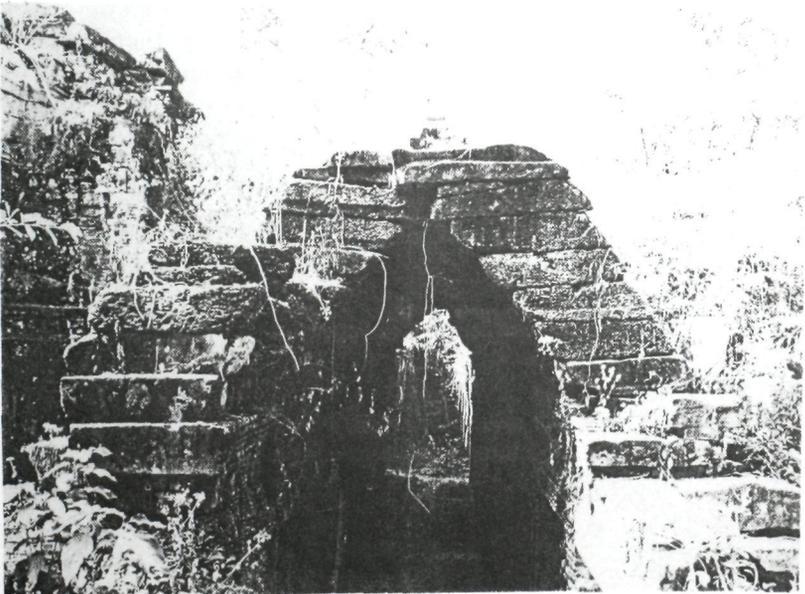
Roof of East Gallery

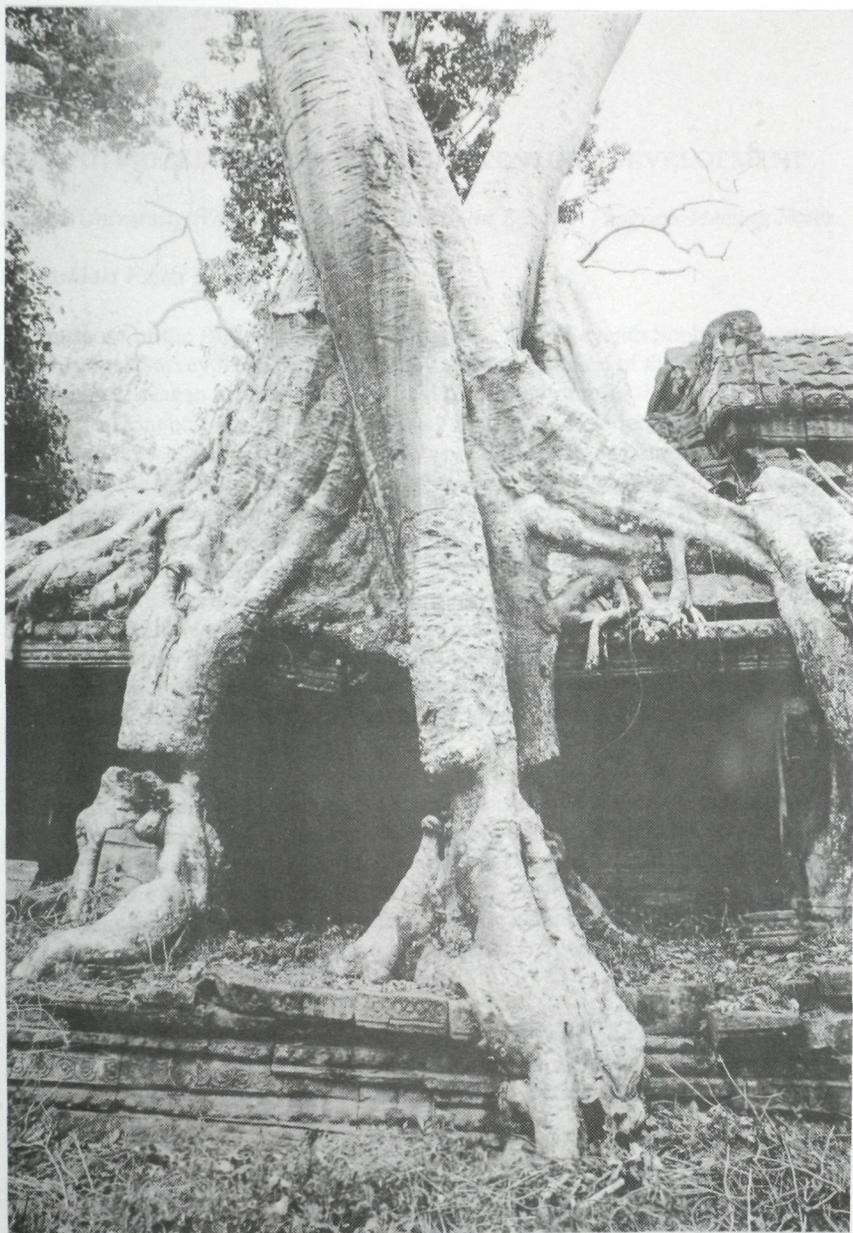
Ficus Tree on East Gopura, 1991.

The long term conservation and presentation of the site require that insecure *in-situ* masonry be made safe; collapsed masonry be cleared; and possibly that some mature trees be removed.

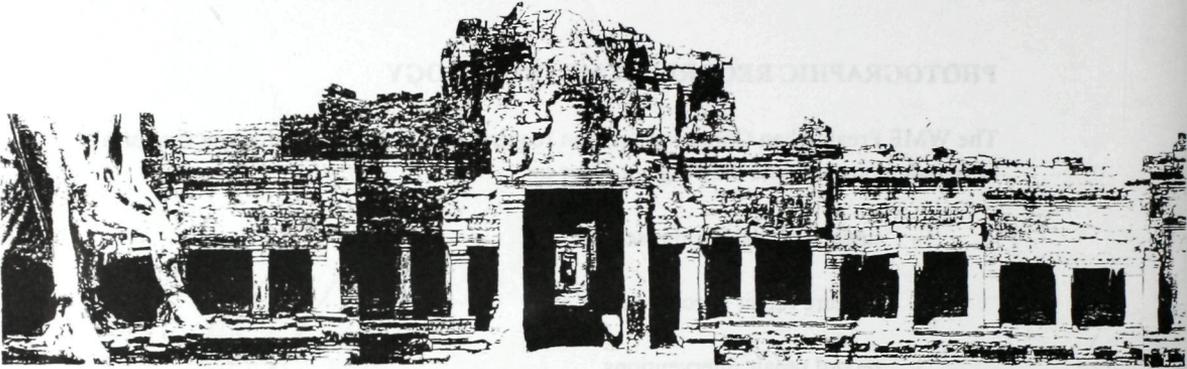
Composition of Scale Rectified Photographs Depicting East & West Elevations of East Gopura III (1992)
