# PREAH KHAN CONSERVATION PROJECT

REPORT VIII  
FIELD CAMPAIGN V

Report VIII  
Field Campaign V

October 1996 - September 1997

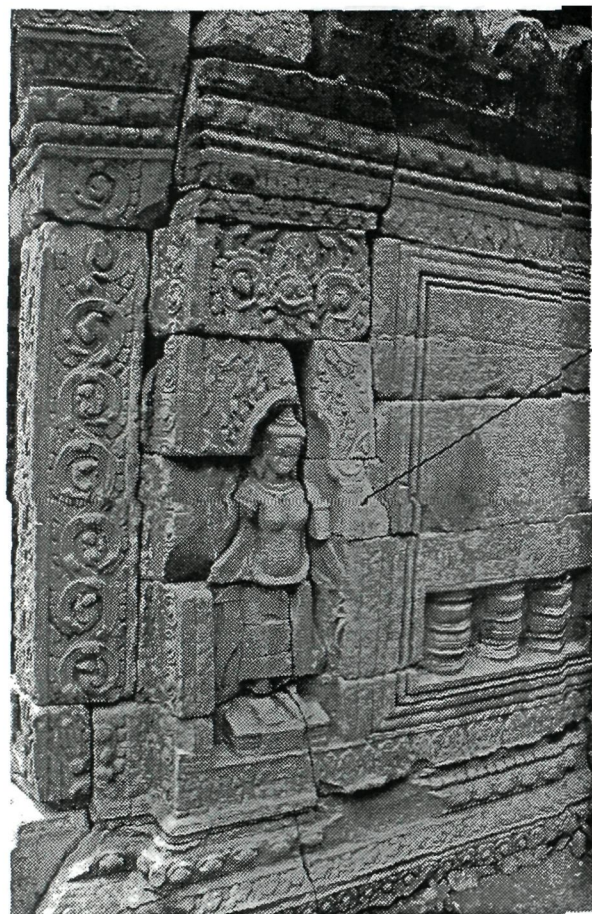
replacement stone carved to match but  
distinct in color, marked "WMF 1997"

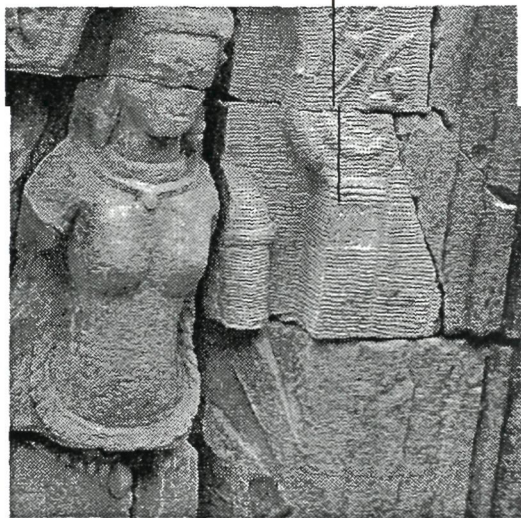
carved stone repair at small shrine

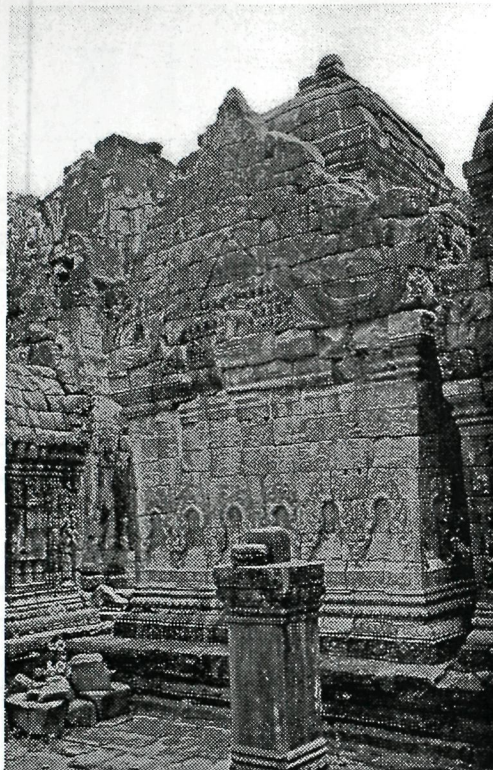
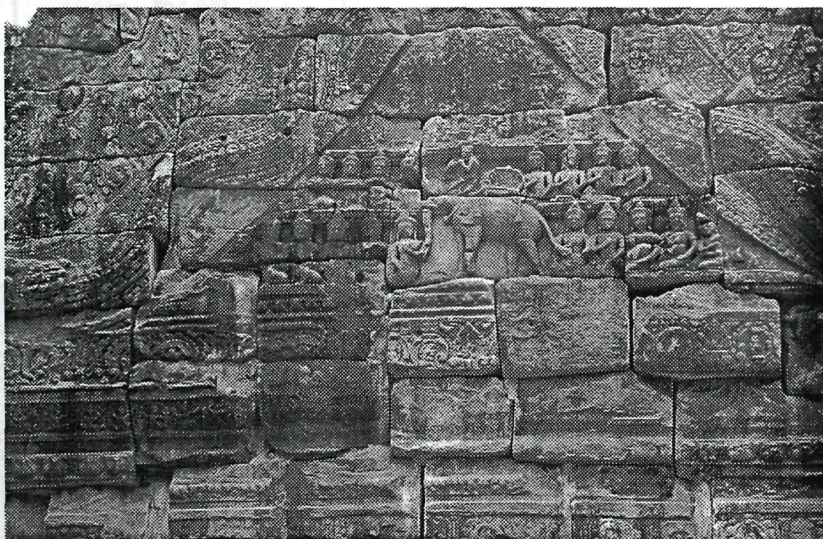
*left:* repaired elephant fronton,  
damaged by tree fall,  
general view

*below:* detail.

In January scaffolding was erected on the large freestanding shrine so that repairs to the roof vaults could be undertaken and the "elephant" fronton which had been knocked down by the tree could be relocated. Once the scaffolding was in place, it was found that the whole corbelled dome roof structure had been disturbed by the falling tree and that it was not possible to reassemble the fronton safely. It was therefore decided to undertake the careful realignment of the displaced roof stones and to replace one shattered bondar fusing a precast reinforced concrete implant to the end of the bonding stone. The scaffolding had to be strengthened to carry the extra load of the partially dismantled vaulted dome.

During February, forty three stones consisting of defective roof vaults have been dismantled and realigned, the damaged stone bearer has been replaced and the structure reconstructed to completion. The fronton was replaced on a sound base. The defective stone bearer was found to be a weak link in the structure. The masonry group is to be commended for the skilled way in which they have completed a complex job in a clean and efficient manner.

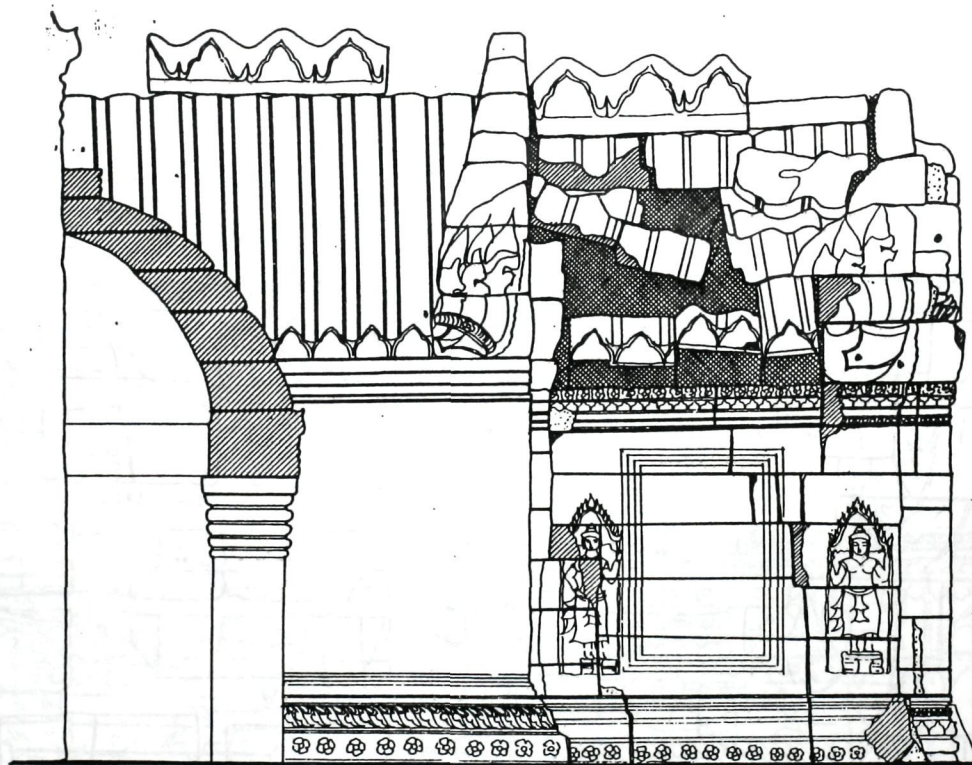
SOUTH ELEVATION

SHRINE TEMPLE SECTION AA  
PRĒAH KHAN CONSERVATION PROJECT  
WORLD MONUMENTS FUND  
JULY 1996  
BY MCHEAM PALL

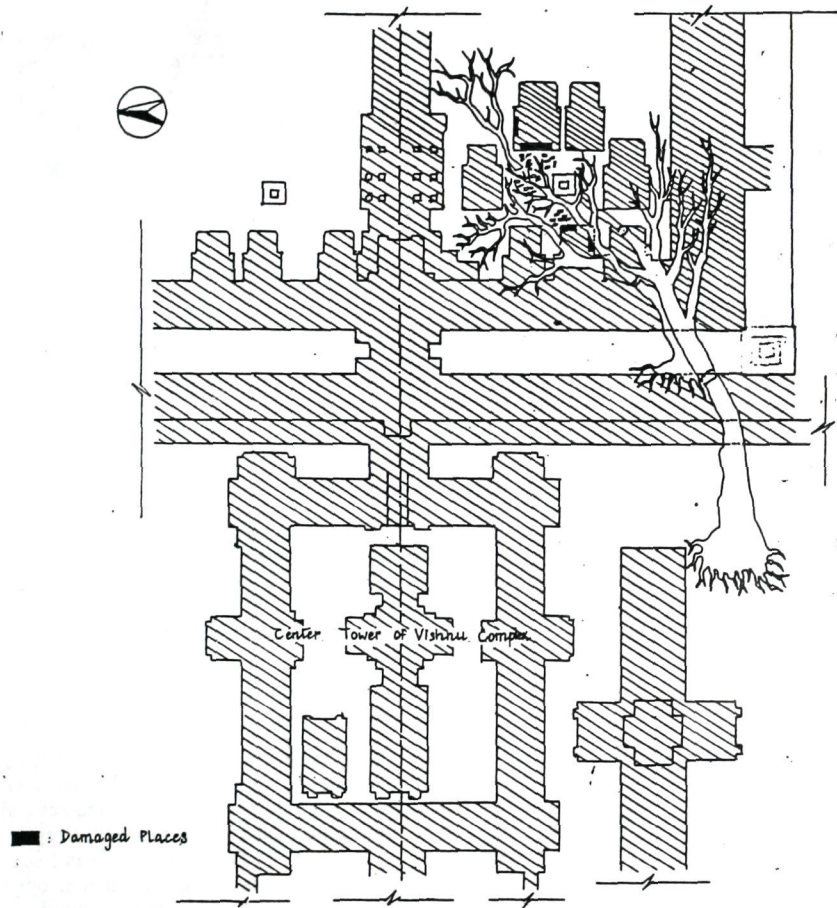
LOCATION OF FALLEN DOWN TREES  
 SHOWING DAMAGED PLACES  
 PREAM KHAN CONSERVATION PROJECT  
 WORLD MONUMENTS FUND  
 MAY 1996 — By Mr. Sam Kimheng

On the 8th June at approximately 19:00 hrs, following a small amount of rain, a large "Fromagere" (*tetrameles nudiflora*) uprooted itself and fell across the South West sector of Enclosure Wall I and Enclosure Wall II, causing a second tree growing on the structure to also collapse and cause damage to the structure. The small shrines and the vaulted circumambulatory passages which are located to the South West of the Central Tower were not in the direct line of the collapse so that truly disastrous results were avoided.

The large tree fell in a north-easterly direction hitting a second large tree that was growing around the vaulted roof structure of Enclosure Wall II. Both trees crashed onto the vault of Enclosure Wall I causing minimal damage to the vault itself. Two large holes were punched through the vault but it did not collapse. The branches of both trees caused some superficial damage to the two large free standing shrines and to two of the smaller shrines attached to the South West sector of Enclosure Wall I. The upper section of the tree fell between the two free standing shrines and the central tower. An initial examination of the damaged sections showed that most of the disturbance to the stonework was superficial.

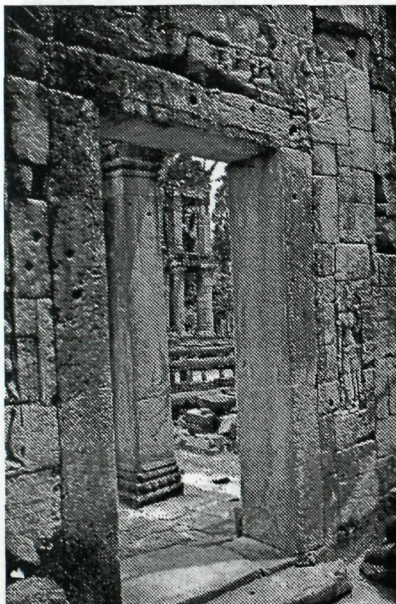
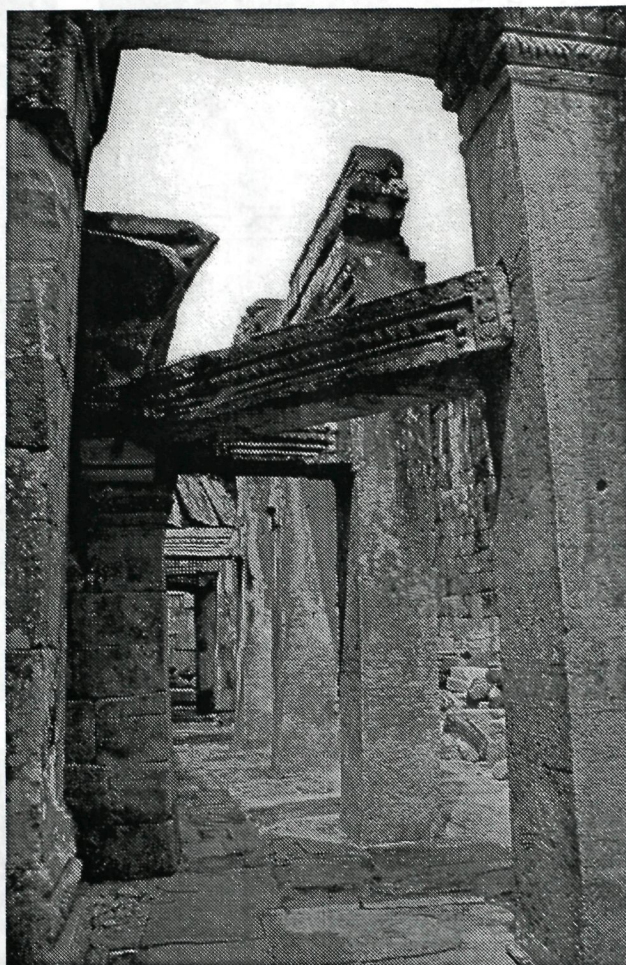
*above:* Northwest sector repairs

*left:* Northwest door repaired

Work started at the beginning of January to repair and consolidate the North West sector of the Hall of Dancers. A total of 112 stone blocks have been carefully dismantled to enable the

foundation blocks to be leveled as undue point loading caused distortion of several centimeters to the foundation. Twenty Four paving slabs were also reset and leveled using a dry concrete fill where a lift of more than 2 cm was required; in other places the stones have been leveled using lead wedges. Two fractured beams have been repaired and reset using stainless steel dowels and epoxy glue. A cornerstone brace has also been repaired by doweling and gluing and a stone tenon has been inserted to replace one damaged. The repair to this sector was completed within two months and is an example of skillful repair techniques.

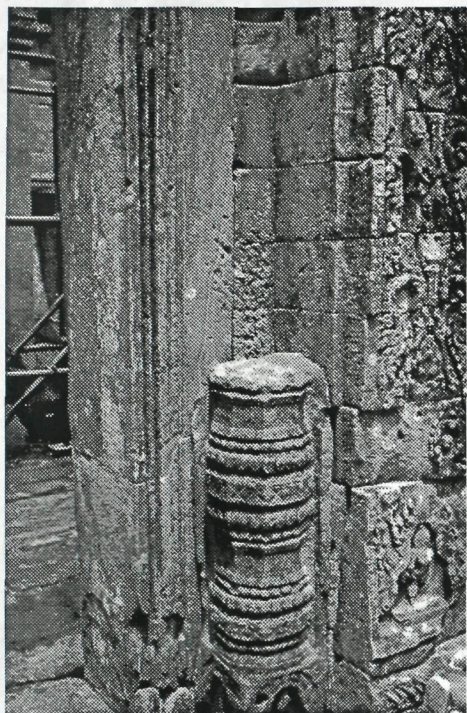
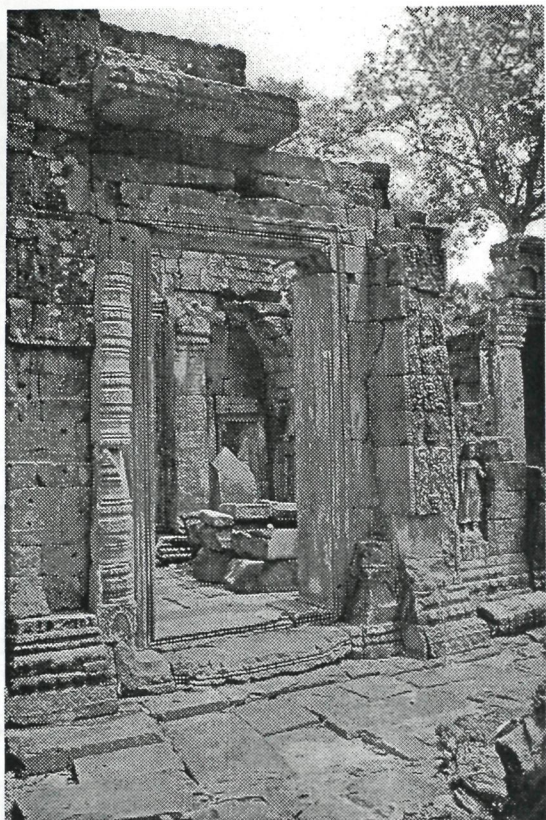
*above:* East door repaired,  
detail & general

*right:* Southeast sector repairs

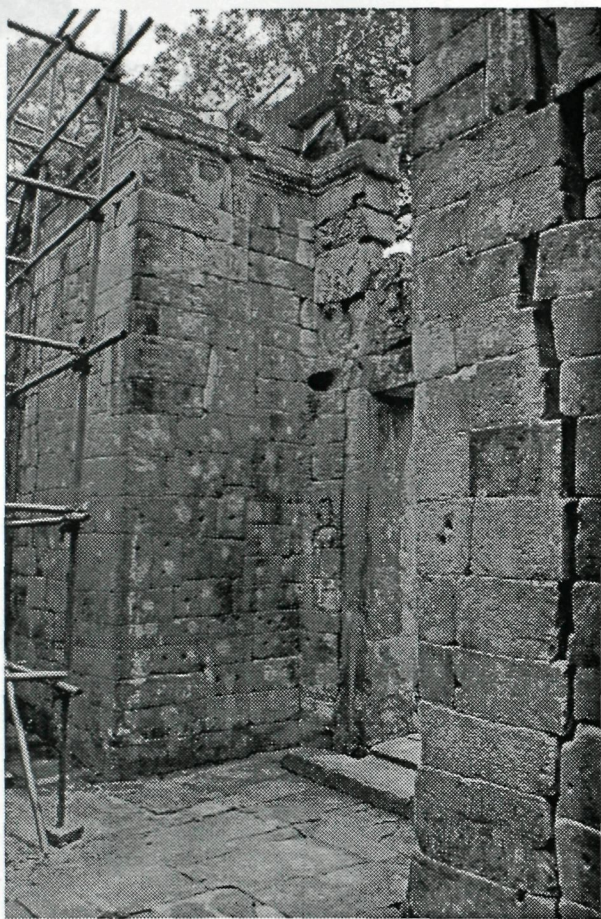
*left:* East door, northwest wall reconstructed

*right:* detail of North door repair

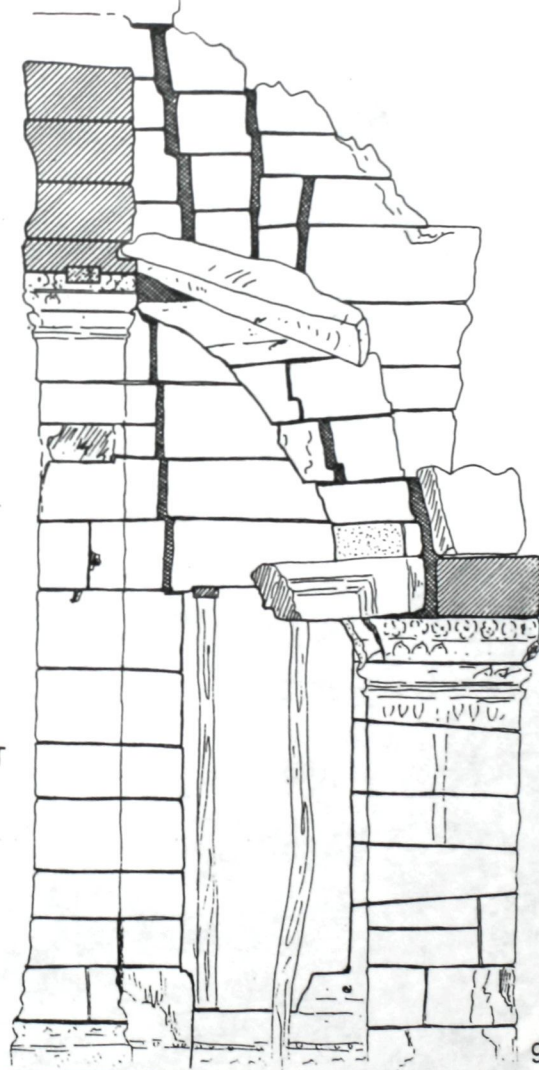
HALL OF DANCERS-NORTH WEST  
SECTOR  
ELEVATION NORTH VIEW  
PREAH KHAN CONSERVATION PROJECT  
WORLD MONUMENTS FUND  
December 1996  
By Miss Cheam Phally

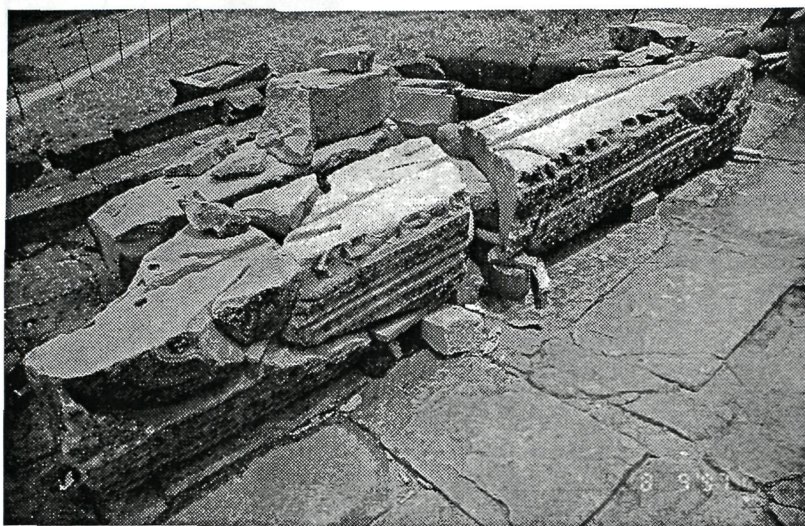
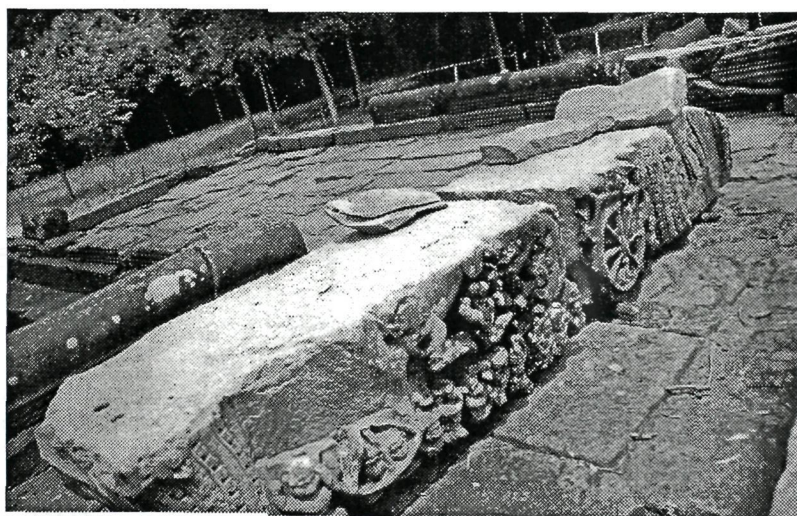
*above:* West lintel broken in 5 pieces

*below:* part of fronton beam

At the time of writing, detailed survey drawings have been completed. A work plan has been worked out with the consultants, the site architects, and the work force. Dismantling of the vaults, lintels, and all later concrete interventions has been completed. The repairs undertaken by the EFEO have been checked for structural integrity. A strong working steel scaffolding was erected around the defective area with suitable lifting gear, space and strength to carry the roof vaults and the defective lintels; repairs can be undertaken on the scaffolding rather than having to lower the stones to ground level. The defective vault stones have been removed and stored on the scaffolding. The lintels have also been lifted and placed on the scaffolding.
