Umbrian Frescos Reborn

THE RENAISSANCE MURALS OF PIEVE DI SAN BRIZIO

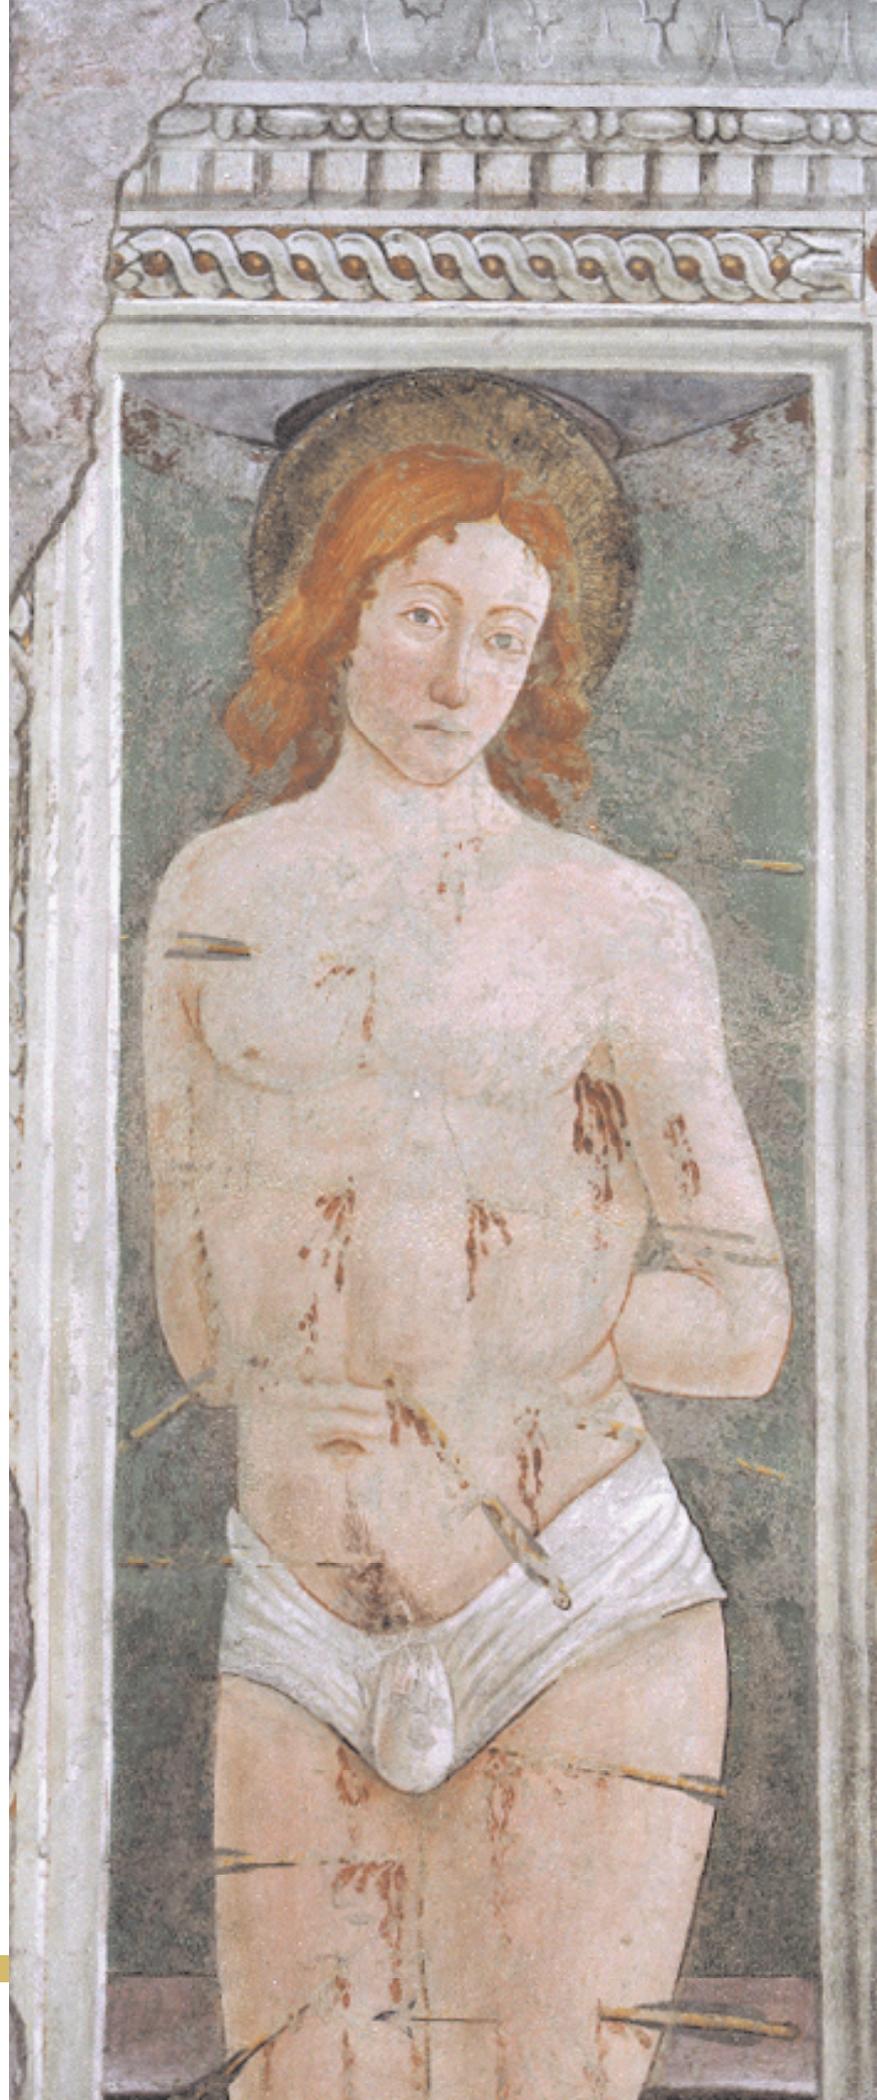
THE LOWER PORTION OF THIS PAINTING OF SAN SEBASTIAN, ATTRIBUTED TO BERNARDINO CAMPILIO AND EXECUTED IN BUON FRESCO, HAD BEEN SEVERELY DAMAGED BY RISING DAMP, RESULTING IN TOTAL PAINT LOSS. THE UPPER PORTION, HOWEVER, WOULD HAVE BEEN IN EXCELLENT CONDITION HAD IT NOT BEEN FOR A HARSH CLEANING IN THE PAST. THE LUMINOSITY OF THE IMAGE AND THE INTENSITY OF THE GREEN BACKGROUND HAVE BEEN ENHANCED BY CLEANING. SMALL AREAS OF PAINT LOSS WERE FILLED IN NEUTRAL TONES.

To the right of the *Madonna and Child Enthroned with St. Anthony, Abbot, and St. John* is a depiction of St. Sebastian that appears to be part of the same suite of murals authored by Campilio. Executed in buon fresco, the lower half of the image is completely missing.

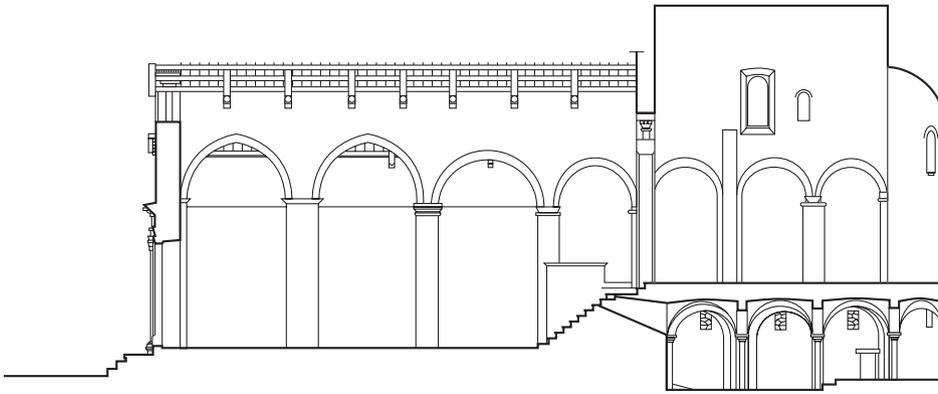
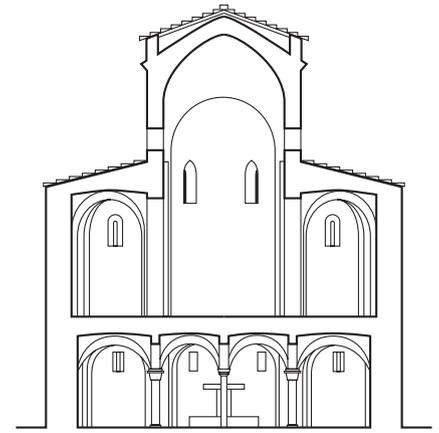
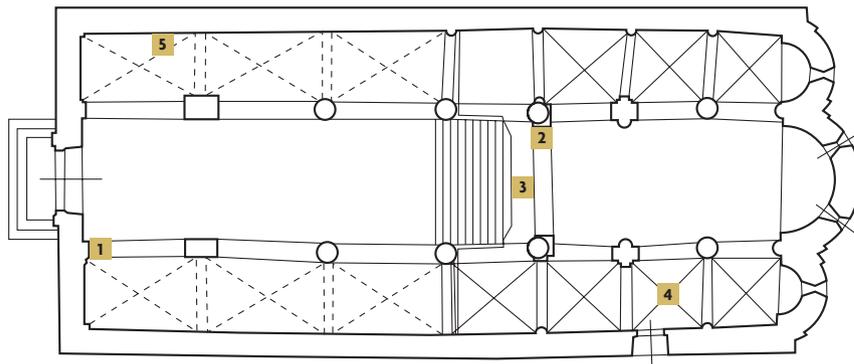
THE NUMBER BY EACH FRESCO IDENTIFIES ITS LOCATION ON THE SITE PLAN ON THE FOLLOWING PAGE.

BUILT ON A BASILICA PLAN WITH THREE NAVES, THE PIEVE DI SAN BRIZIO ATTAINED ITS PRESENT FORM SOMETIME IN THE TWELFTH CENTURY. THE LOCATIONS OF THE RECENTLY RESTORED FRESCOS ARE NOTED ON THE DRAWING.

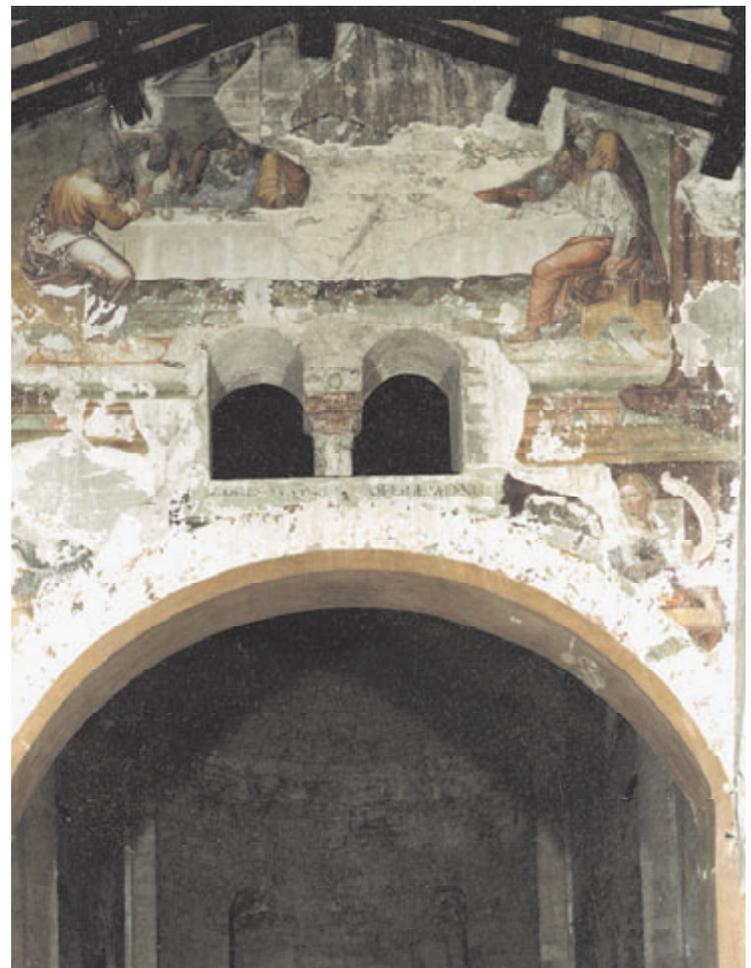
A 1541 RENDERING OF THE LAST SUPPER BY JACOPO SICULO, BELOW, GRACES THE ARCH LEADING INTO THE PRESBYTERY. THE UPPER PORTION OF THE COMPOSITION WAS DESTROYED WHEN THE CEILING WAS LOWERED, FOLLOWING THE EARTHQUAKE OF 1767. THE BIFORA, OR DOUBLE-ARCHED OPENING, NOW EXPOSED, ONCE HAD BEEN FILLED TO ACCOMMODATE SICULO'S PAINTING.

The fresco had been partially uncovered in the past. A double-arched opening, or *bifora*, part of the original church plan and now exposed, had been filled in to accommodate Siculo's composition. The background scenery in the painting, perhaps depicting a loggia or window, was lost when the ceiling of the entire structure was lowered, following the 1767 earthquake. Removal of layers of whitewash revealed many details of the composition, including the elaborately patterned floor and flanking columns, and much of the two lovely sibyls. To our surprise, *tromp l'oeil* marble and grape vines, and a tondo bearing the monogram of Christ, also came to light on the arch itself.

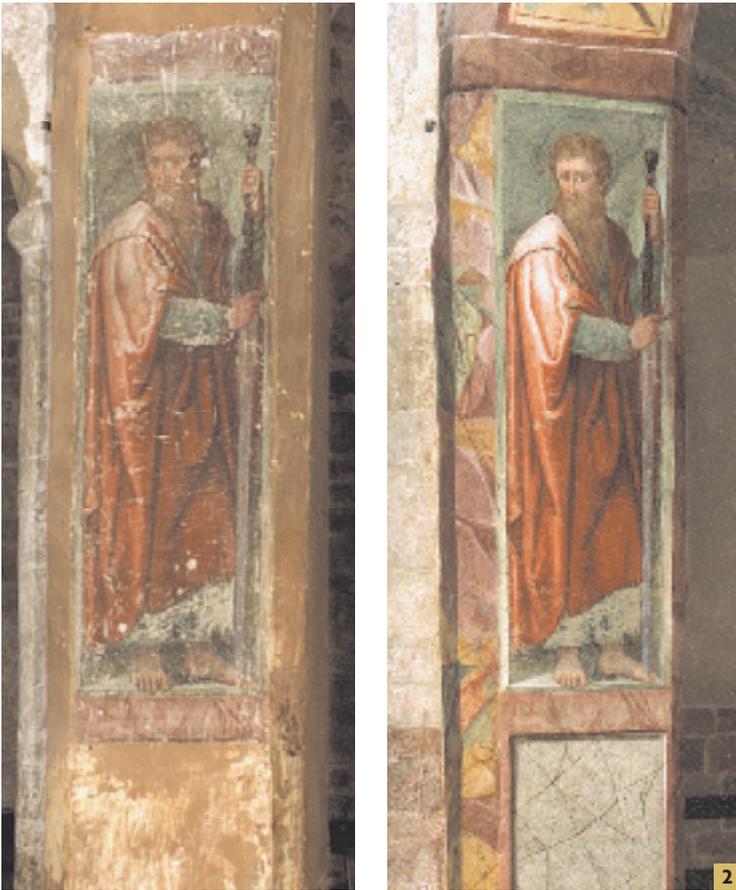
A FIGURE OF ST. PAUL, WHICH GRACES THE INSIDE OF THE ARCH LEADING TO THE PRESBYTERY, IS BELIEVED TO BE THE WORK OF JACOPO SICULO. THE GREEN BACKGROUND WAS EXECUTED IN MALACHITE, APPLIED A SECCO.

A full-length figure of St. Paul, also by Jacopo Siculo, was visible inside the arch on the right before the restoration. It is in true fresco and had survived in good condition, except for scrapes left by an inexperienced cleaner in the past. It simply needed a careful cleaning to remove centuries of soot and conservative retouching with neutral tones to emphasize the well-rendered folds of his red mantle. His head, hands, and feet were well preserved. The green background and dress, probably in malachite applied *a secco*, were, however, considerably worn. An image of St. Peter, of which only a portion of the head has survived, graces the opposite side of the arch and is believed to be by Siculo as well.

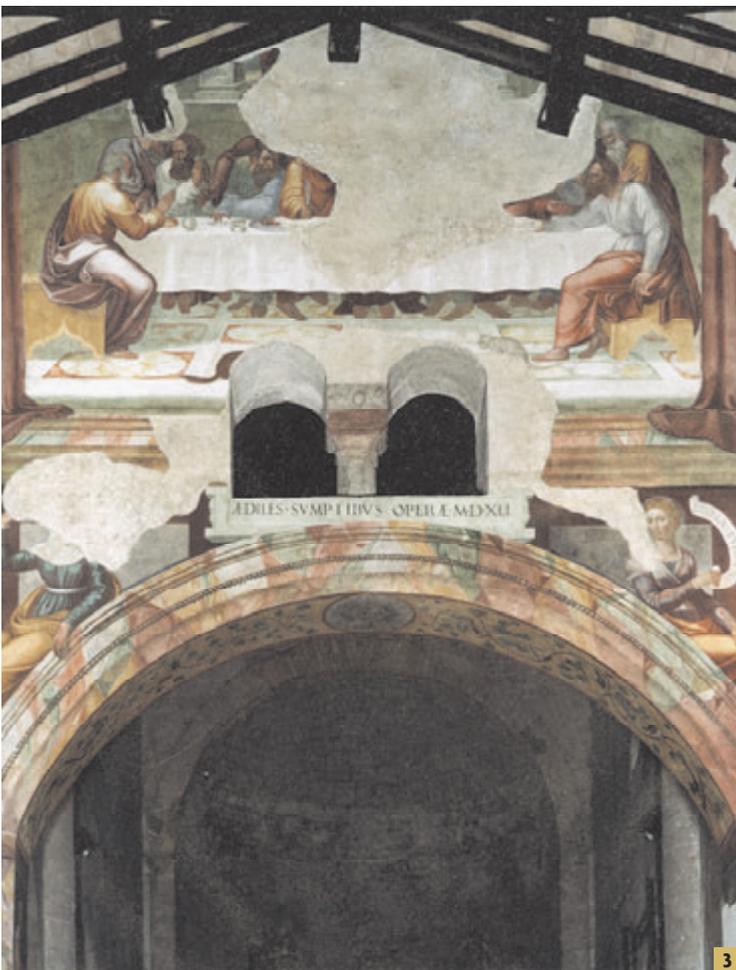
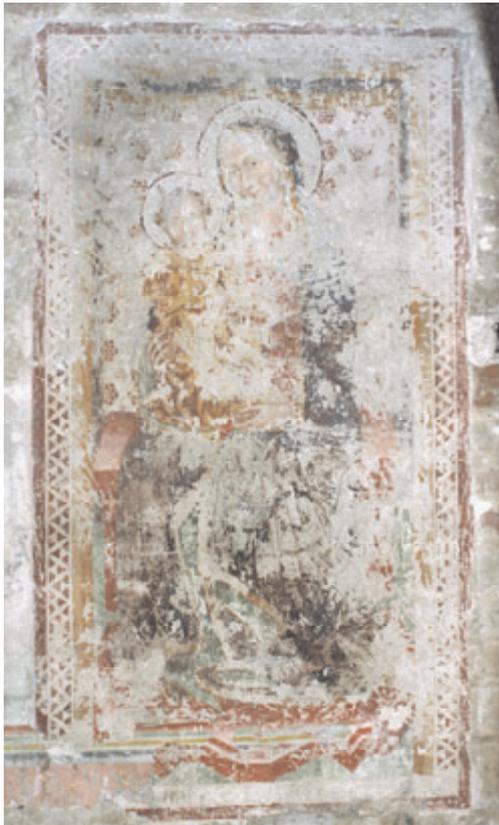
AMONG THE EARLIEST WORKS IN THE PIEVE DI SAN BRIZIO—SHOWN BEFORE AND AFTER RESTORATION— IS A POORLY PRESERVED PAINTING OF THE MADONNA AND CHILD. BELIEVED TO BE OF MID-FIFTEENTH-CENTURY DATE, BOTH HAVE BEEN ATTRIBUTED TO THE MAESTRO DI EGGI.

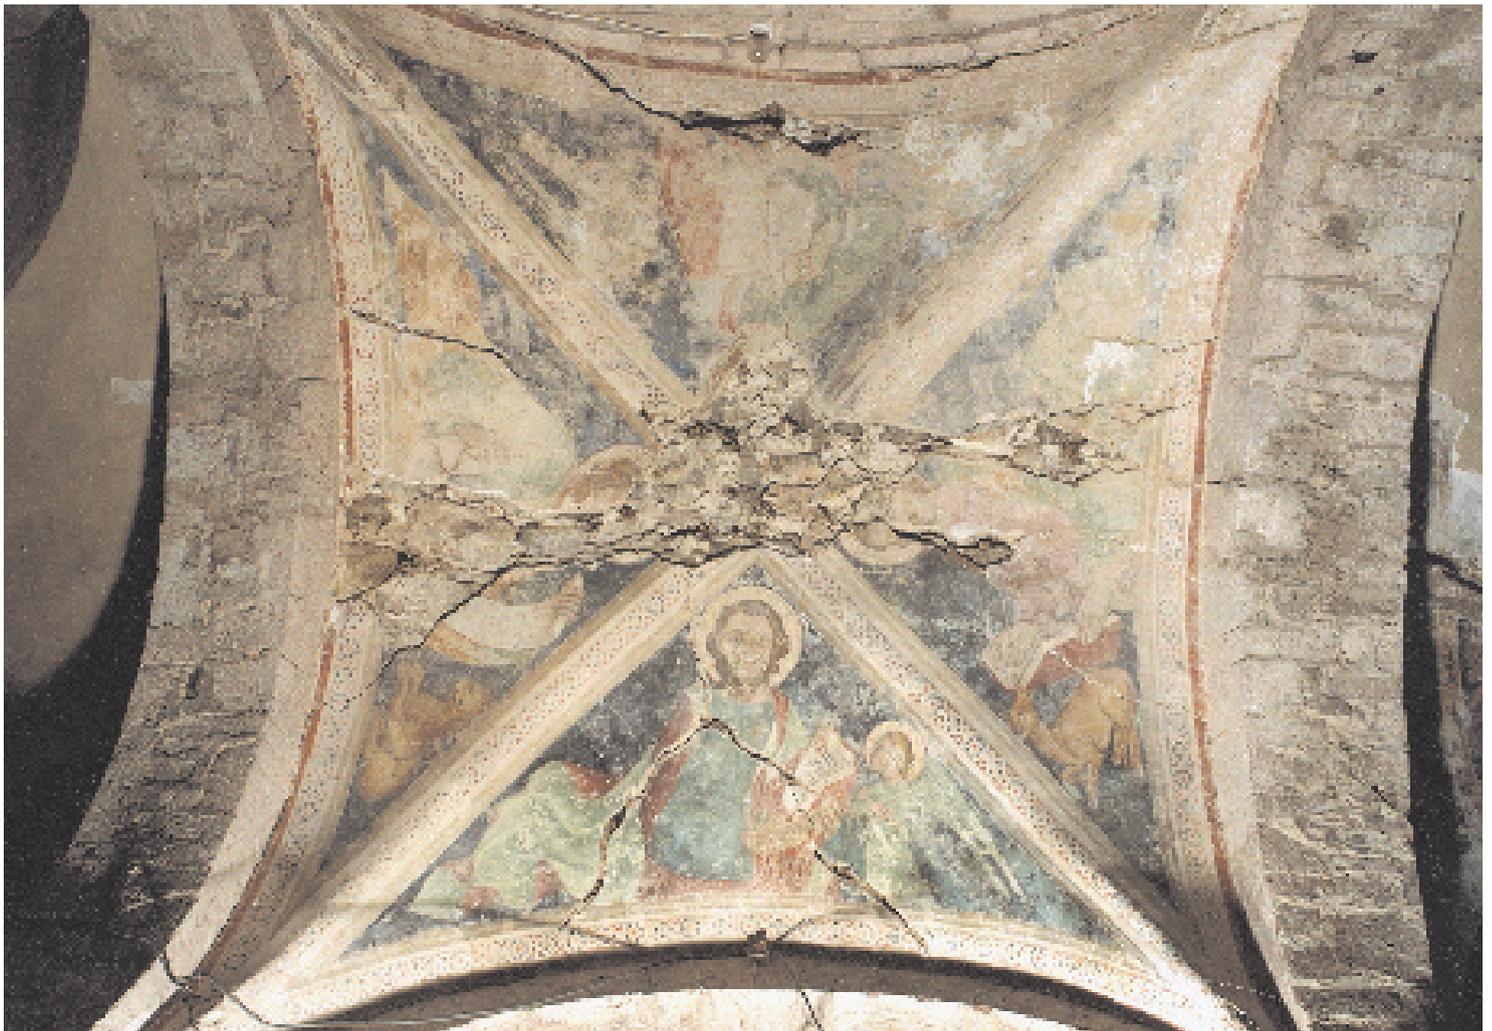
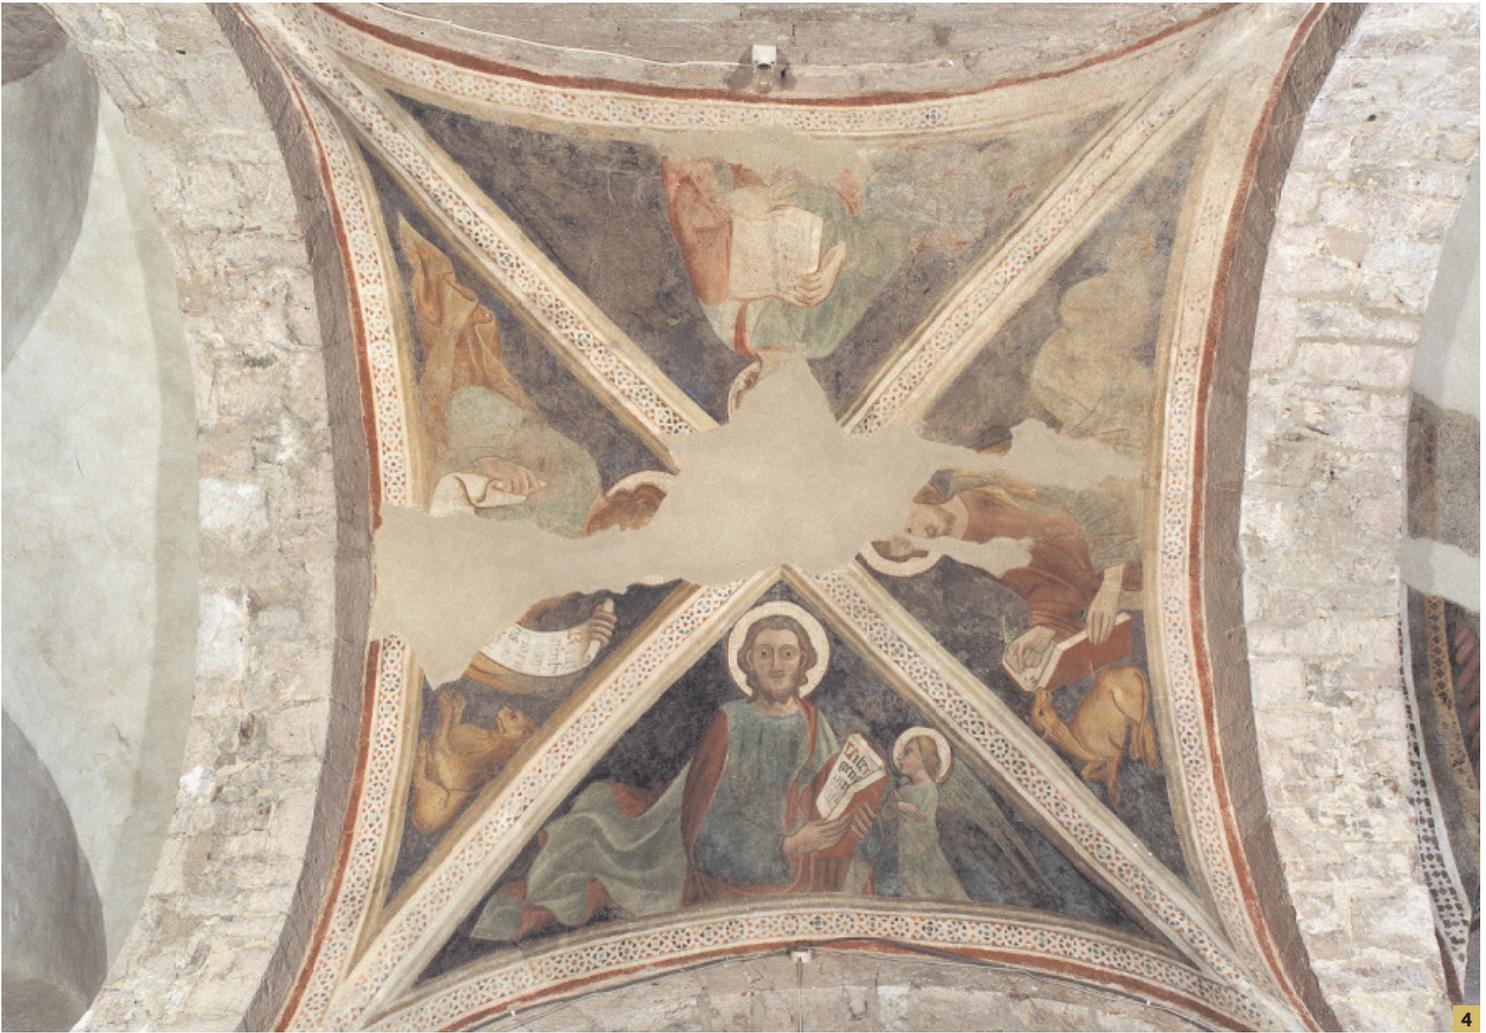
A RENDERING OF FOUR EVANGELISTS, WHICH GRACES ONE OF THE PIEVE'S CROSS VAULTS, WAS MARRED BY A LARGE CRACK, POSSIBLY THE RESULT OF AN EARTHQUAKE CENTURIES AGO. THE CRACK WAS STABILIZED AND FILLED DURING THE RESTORATION. THE PAINTING HAS BEEN ATTRIBUTED TO A FOLLOWER OF THE MAESTRO DI EGGI.

The adjacent bay depicts the four evangelists. This, too, had been hidden under layers of whitewash and had sustained severe damage through the center of the cross vault sometime in antiquity. However, the painting is rather well preserved, with all four evangelists and their symbols legible. The painted frame, of a stamped, geometric design, differs from that on the cross vault bearing the four archangels. Toscano believes the paintings of the evangelists to have been done by a follower of the Maestro di Eggi, a few years after the archangels were painted. Yellow underdrawing on the intonaco, typical of the period, is still visible in some areas and the halos bear simple punching. Again, large areas of paint loss were filled slightly under the level of the original intonaco and retouching was carried out in watercolor.
