Chronicle in Stone

BUILT AS A MONUMENT TO PORTUGAL'S MARITIME PROWESS,
A MANUELINE MASTERPIECE SHINES AFTER A FOUR-YEAR RESTORATION

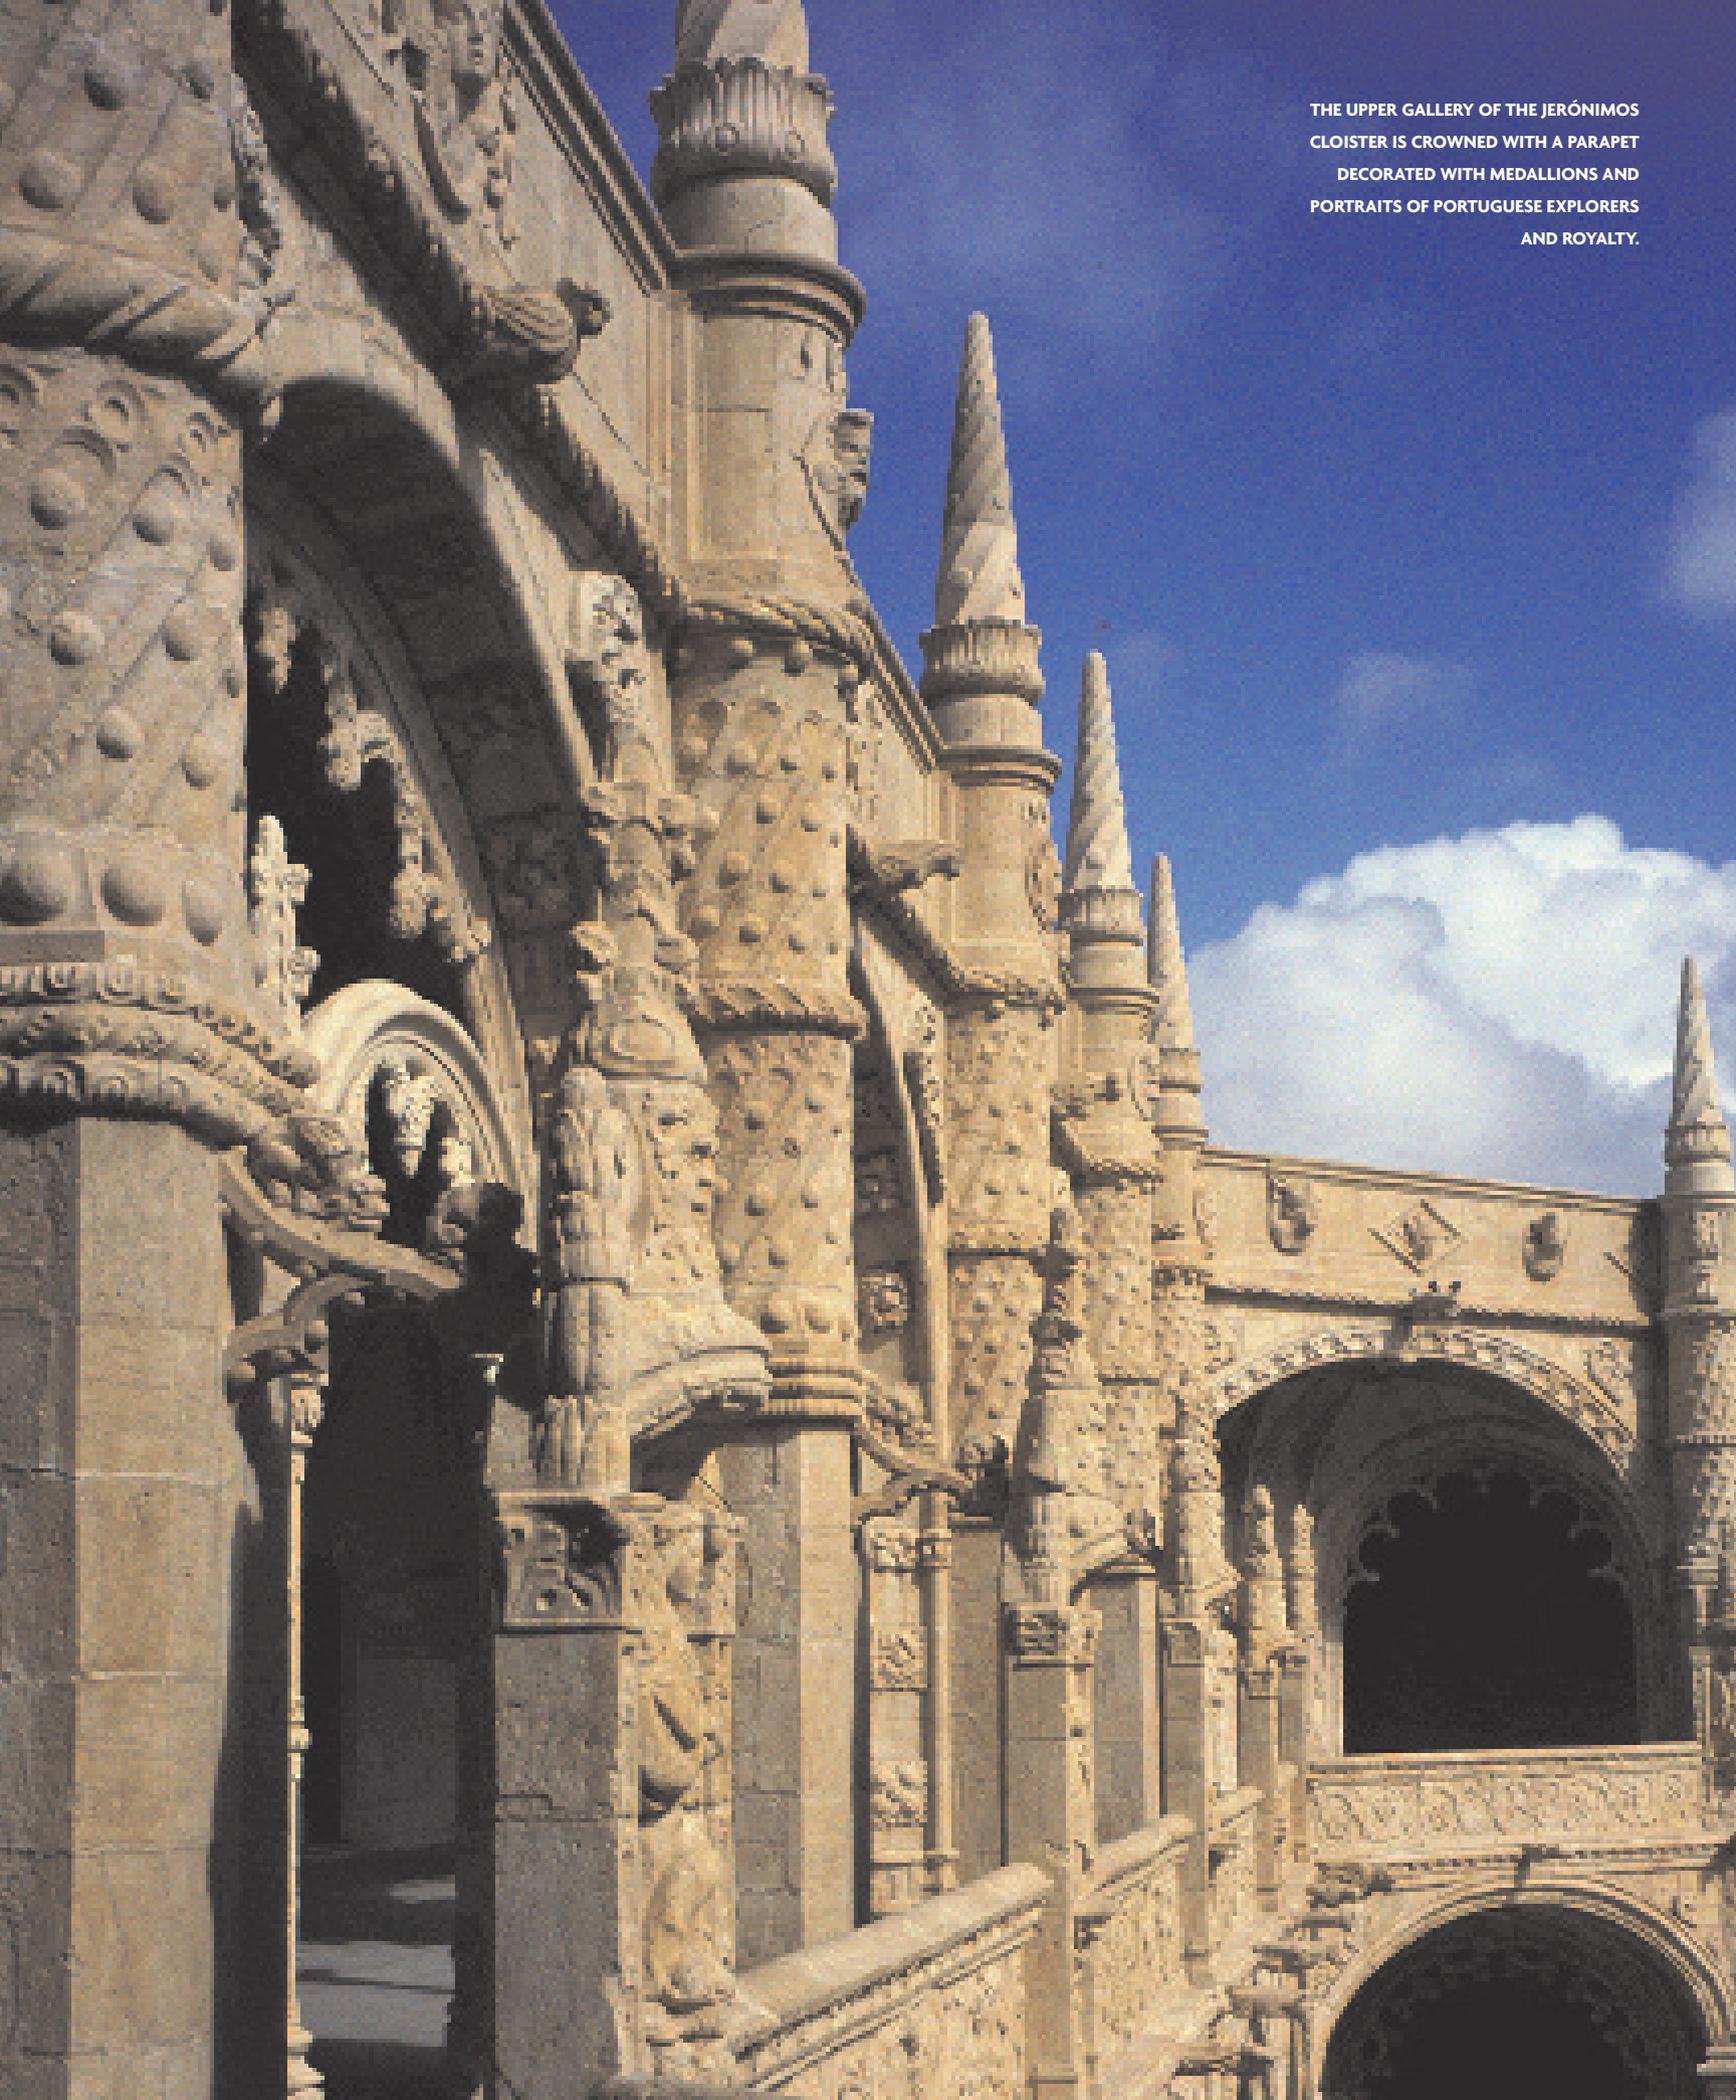
THE UPPER GALLERY OF THE JERÓNIMOS
CLOISTER IS CROWNED WITH A PARAPET
DECORATED WITH MEDALLIONS AND
PORTRAITS OF PORTUGUESE EXPLORERS
AND ROYALTY.

Two superimposed suites of vaulted galleries, each 55 meters in length, compose the cloister, which is built on a square plan with chamfered corners. The cloister is crowned by a parapet decorated with medallions, portraits of explorers and Portuguese royalty, and other ornaments in bas-relief.

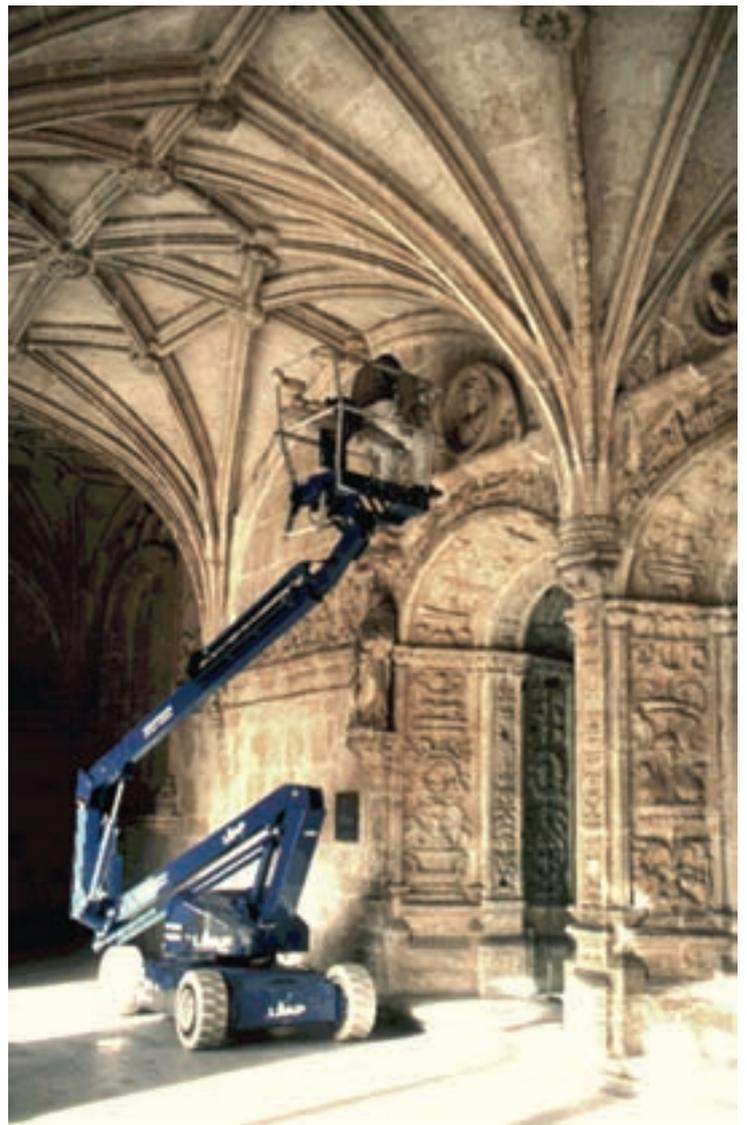
STATUES REPRESENTING SAINTS, ALLEGORICAL FIGURES, AND EVEN KING MANUEL HIMSELF, ABOVE, WERE PLACED IN NICHEs IN THE CLOISTER'S UPPER GALLERY. A MOBILE CRANE, BELOW, WAS USED TO SURVEY THE CONDITION OF THE CLOISTER'S 56 VAULTS. FACING PAGE, MEDALLIONS DEPICTING EXOTIC PLANTS AND SHIPS ARE AMONG THE BAS-RELIEFS ADORNING THE JERÓNIMOS MONASTERY AND CLOISTER.
