# Jupiter Rising

## RESTORING DIOCLETIAN'S DIMINUTIVE TEMPLE OF JUPITER AT SPLIT

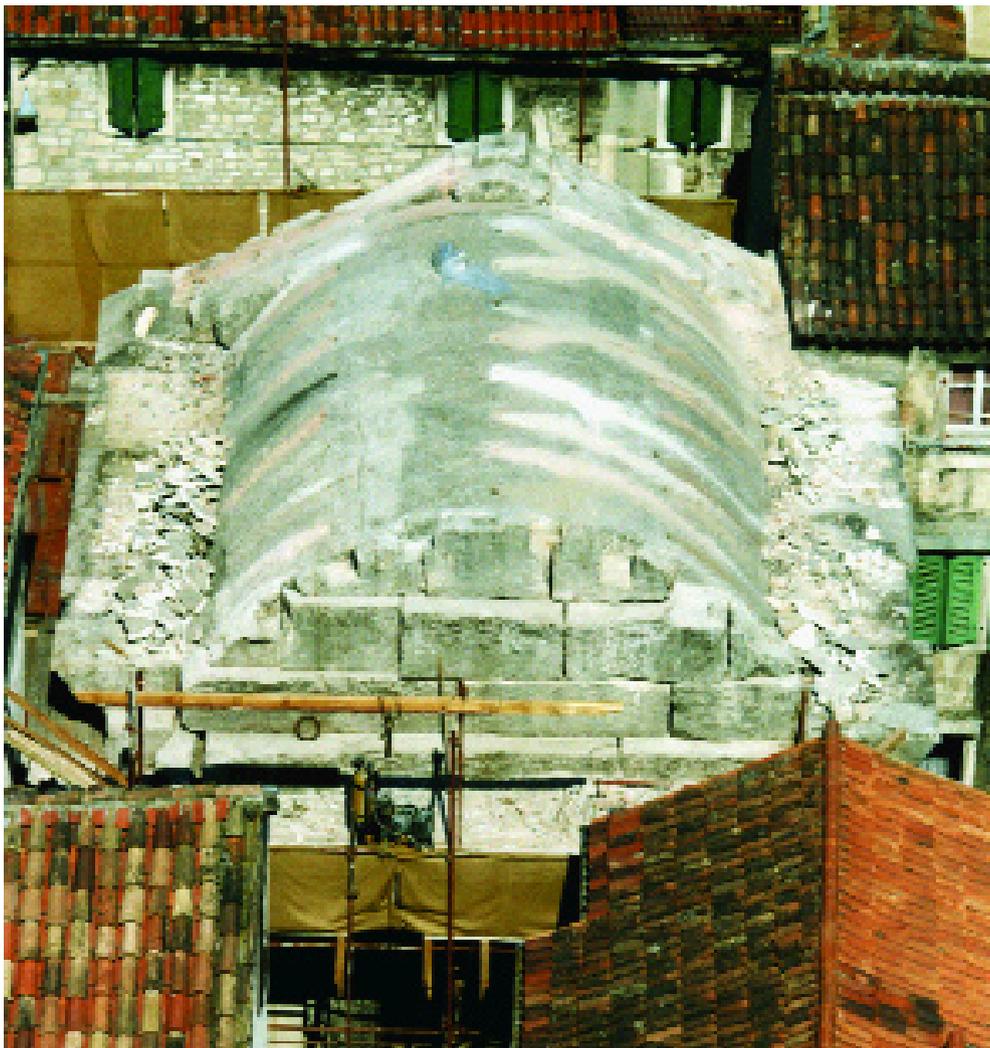
erosion, an accumulation of corrosive salts within the structure, and a rusting—and subsequent expansion—of the iron clamps and dowels used by the Romans to hold the ashlar together. As the clamps expanded, they caused substantial cracking, lifting, and rotation of much of the masonry. Several of the cornice blocks on the west pediment—each of which weigh between three and six tons—having been lifted up by expanding locator dowels had begun sliding down the pediment. The building was further compromised during the 1991 war. By the mid 1990s, the building, particularly its west pediment, was in imminent danger of collapse, secured in place with a network of steel cables.

**DISPLACED MASONRY IS REMOVED FROM THE CORNICE OF THE BARREL-VAULTED TEMPLE OF JUPITER DURING RESTORATION, LEFT. SWELLING OF THE RUSTING IRON CLAMPS AND DOWELS USED BY THE ROMANS TO SECURE THE ASHLARS CAUSED SEVERE CRACKING AND DISPLACEMENT OF THE WEST PEDIMENT BLOCKS, BELOW.**

Scaffolding was erected about the building and the interior vault was braced to support the structure as sections of it were dismantled to replace rusting iron clamps and dowels with ones of stainless steel and to consolidate, repair, and repoint its masonry. In the process, conservators enhanced the building's strength and reestablished its original distribution of structural loads. Portions of the exterior cornice and pediment deemed damaged beyond repair were replaced with newly carved stone. Because of the narrow streets surrounding the temple, a special crane had to be built to carry out the work. A second phase of restoration will include the installation of lead sheets to protect the structure from water infiltration and a laser cleaning of the stone.

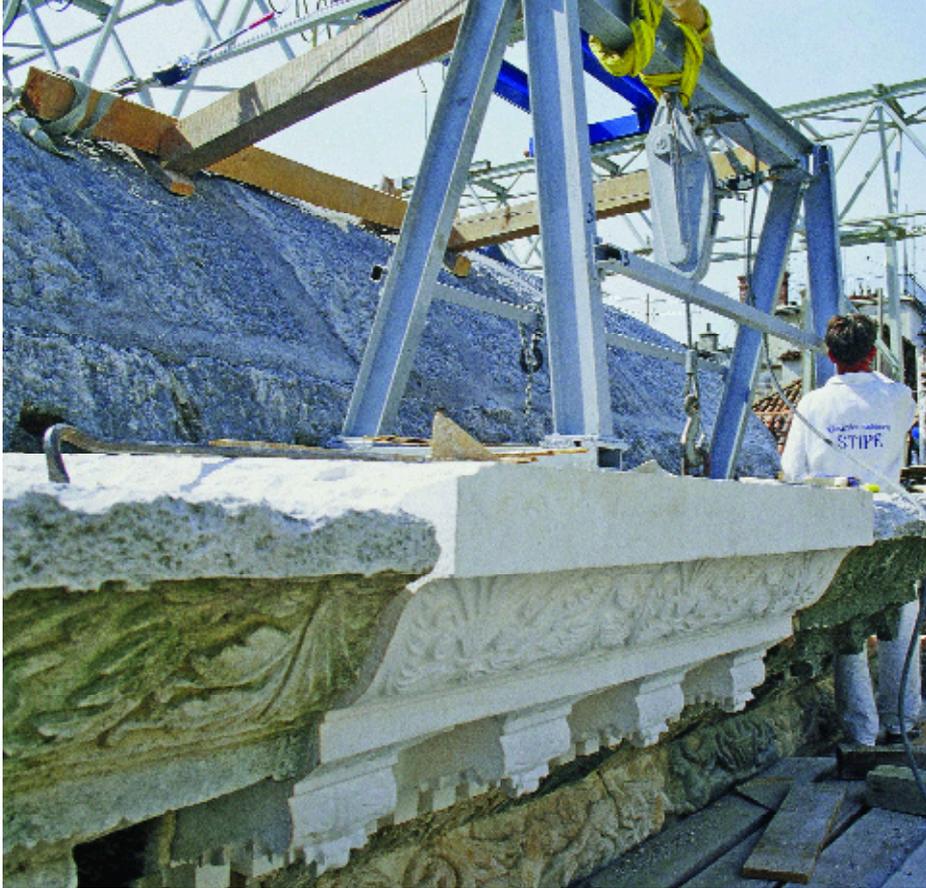
A NEW CARVED STONE SECTION OF THE NORTH CORNICE IS HOISTED INTO PLACE, LEFT. RENDERINGS OF THE TEMPLE OF JUPITER BY THE EIGHTEENTH-CENTURY BRITISH ARCHITECT ROBERT ADAM, BELOW LEFT AND ABOVE, AND A STONE MASON CARVES A NEW CORNER SECTION, BELOW RIGHT. REPLACEMENT STONE WAS QUARRIED FROM THE ISLAND OF BRAC AS WAS THE ORIGINAL USED TO BUILD TO TEMPLE.
