Portal TO THE Past

Restoring Argentina's seventeenth-century Misión de San Ignacio Mini

RESTORATION OF THE PORTAL

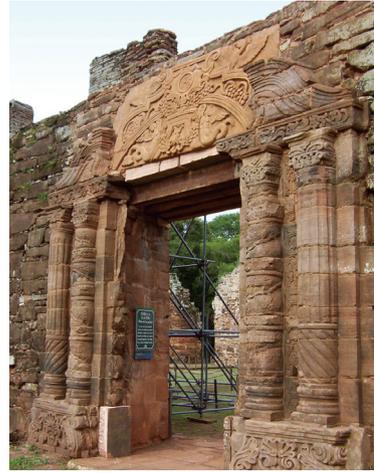
STONE MASONRY

Mortar joints in the masonry had deteriorated as a result of water infiltration.

DECORATIVE LINTEL

Extraordinary carvings on the lintel had been obscured by biological growth.

JAMB

The masonry of the door jamb had deteriorated over the centuries while wooden beams had begun to sag.

LINTEL

The four wooden beams, installed in the 1940s to support the decorative lintel, had deteriorated to the point of collapse.

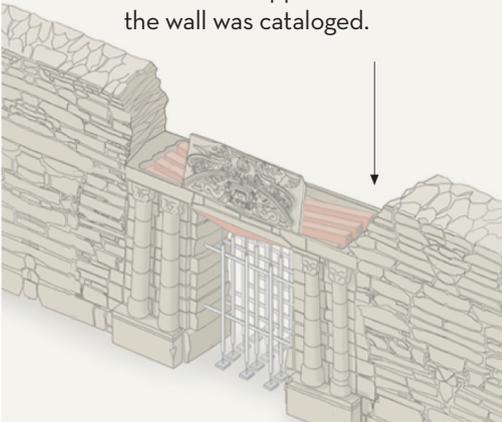
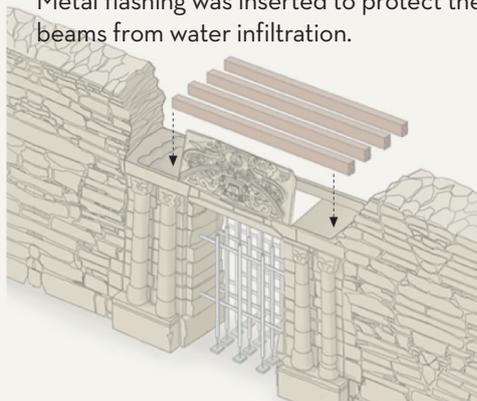
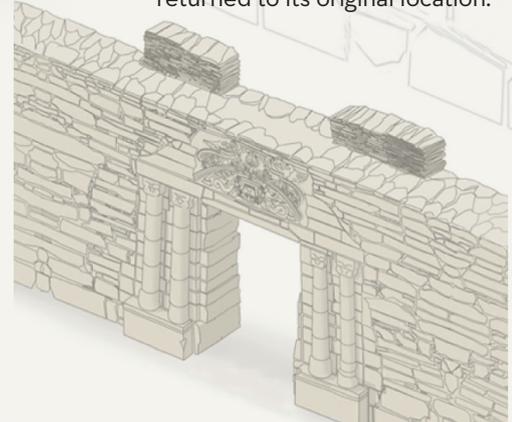
THE RESTORATION

1. During the restoration, the ornamental stone lintel was left in place, temporarily supported, while wooden beams were replaced.

2. Prior to disassembly, each stone in the upper section of the wall was cataloged.

3. Beams were replaced with new ones hewn of the same type of wood as the originals. Metal flashing was inserted to protect the beams from water infiltration.

4. The portal was reconstructed with each stone having been cleaned and conserved, and returned to its original location.
