by SUSANA VARELA FLOR

Glory of Lisbon

RESTORING NOSSA SENHORA DA ENCARNAÇÃO

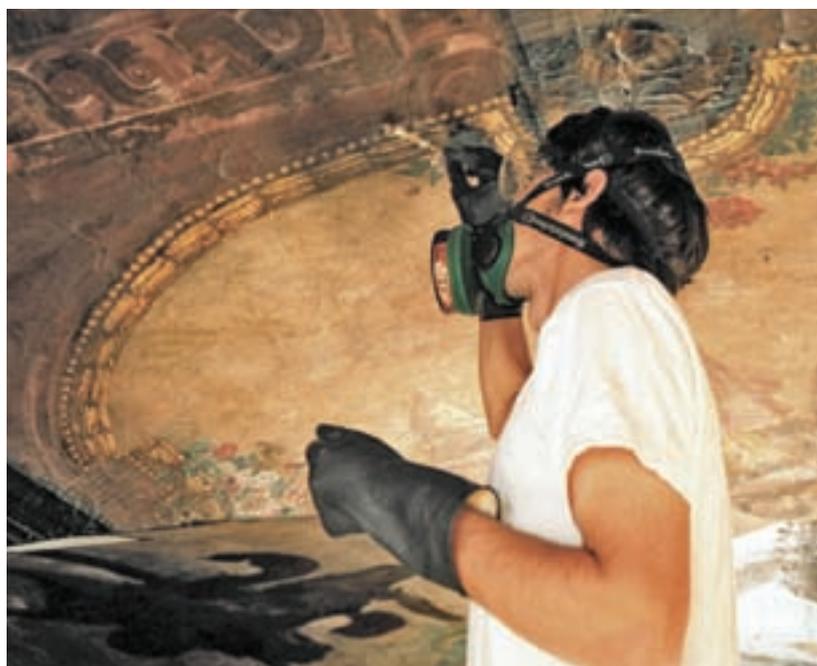
A CONSERVATOR, RIGHT, CAREFULLY REMOVES DIRT AND PIGMENTS FROM AN EARLIER RESTORATION. ORIGINAL PAINT WAS CLEANED, CONSERVED, AND, WHERE NECESSARY, REATTACHED. COMPLETION OF THE RESTORATION IS CELEBRATED AT HIGH MASS ON JULY 3, 2004, BELOW AND FACING PAGE.

Over the course of ten months, some 1,200 square meters of painted canvases were cleaned and consolidated. All of the layers of paint and varnish were removed. The canvas support beneath the paintings was treated, places that had curled were unfurled. And, on July 3, 2004, the restored church was inaugurated in a splendid high mass. Now as one enters the sanctuary, the church seems much larger and lighter, truly fulfilling the Countess of Pontével’s desire to celebrate the glory of God. ■
