# The conservation project of the Temple of Quetzalcoatl

# How was a pyramid such as Quetzalcoatl built?

# What happened to the pyramid?

# How was the pyramid restored?

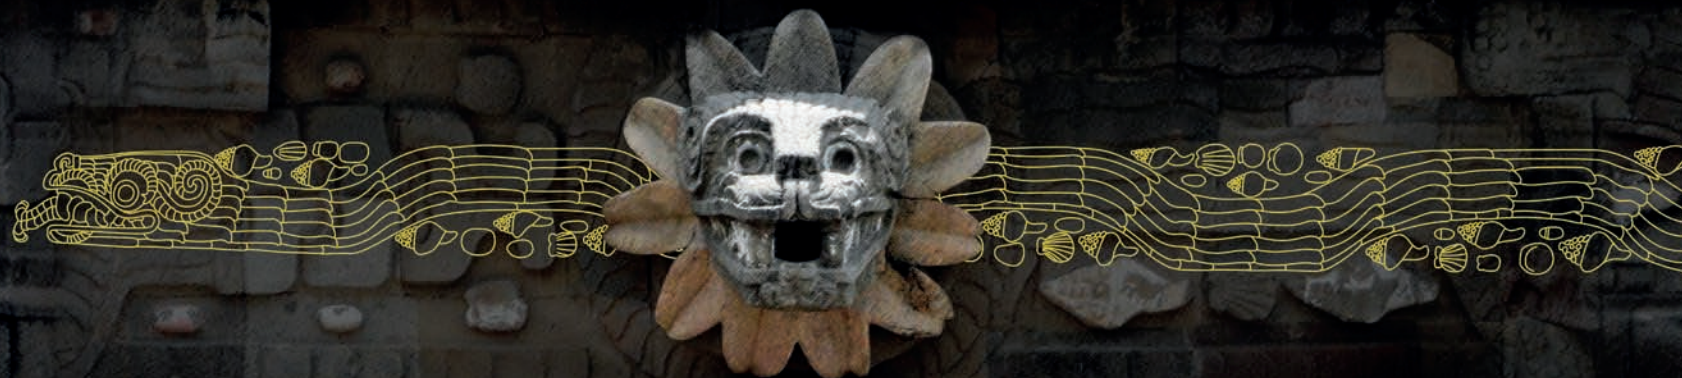
The pyramid of Quetzalcoatl has been exposed to weathering factors from the environment since the moment of the excavation, due to the **loss of its original protection** (coating) throughout time.

**Sun**  
Its heat produces thermal tensions.

**Dew**  
It forms every morning and wets surfaces.

**Humans**  
They may alter the structure on occasion producing damage.

**Animals and plants**  
Animals: they nest inside the structure.  
Plants: they grow on the building.

**Capillarity**  
Groundwater rises from the soil and foundations up to the inner structure.

Remains of the anchors that supported the heads.  
The weight of the heads creates tensions that produce cracks.  
Water causes the dissolution of the material.

Drastic changes in temperature during day and night affect the stones, producing subtle changes of volume that micro-crack the material.  
As time passes, micro-cracks become larger until fractures are produced

Cracks in the stones.  
Salt crystallization affects the surface of the stone by disintegrating the material.  
The water inside the building freeze when the temperature drops below 0°C.  
While freezing, ice increases its volume, creating small cracks in the stones.

**Wind**  
It transports particles that hit the surface and abrade building materials.

**Rain**  
It falls over the building and penetrates the building.

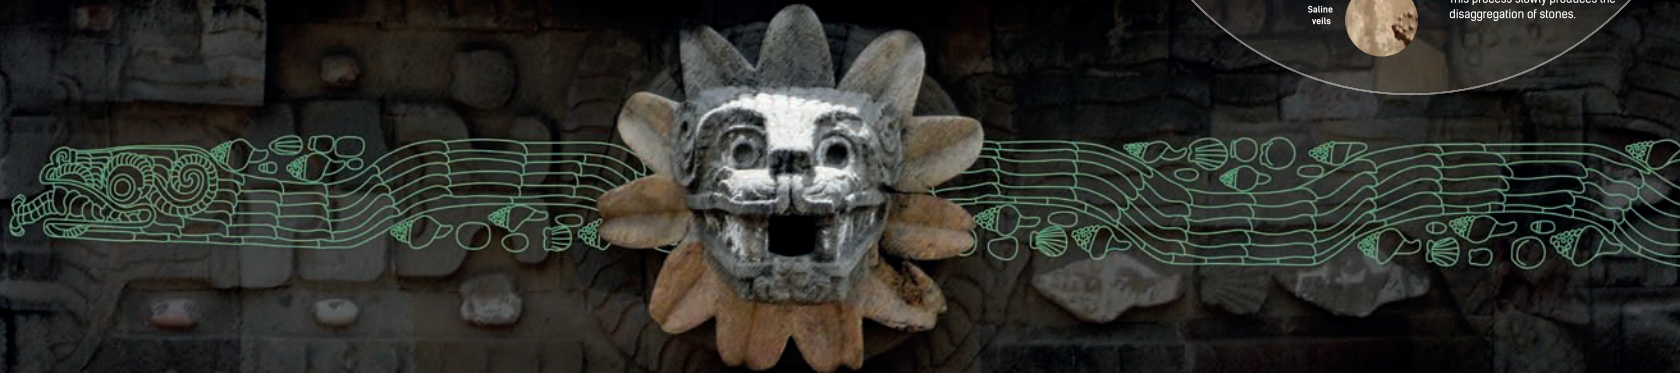
Every problem of the pyramid was treated with a different strategy to stop the decay.
