**PREAH KHAN CONSERVATION PROJECT  
HISTORIC CITY OF ANGKOR**

**REPORT IV**

**FIELD CAMPAIGN I - PROJECT MOBILIZATION**

## Preah Khan, Angkor THE WEST LANTERN APPROACH

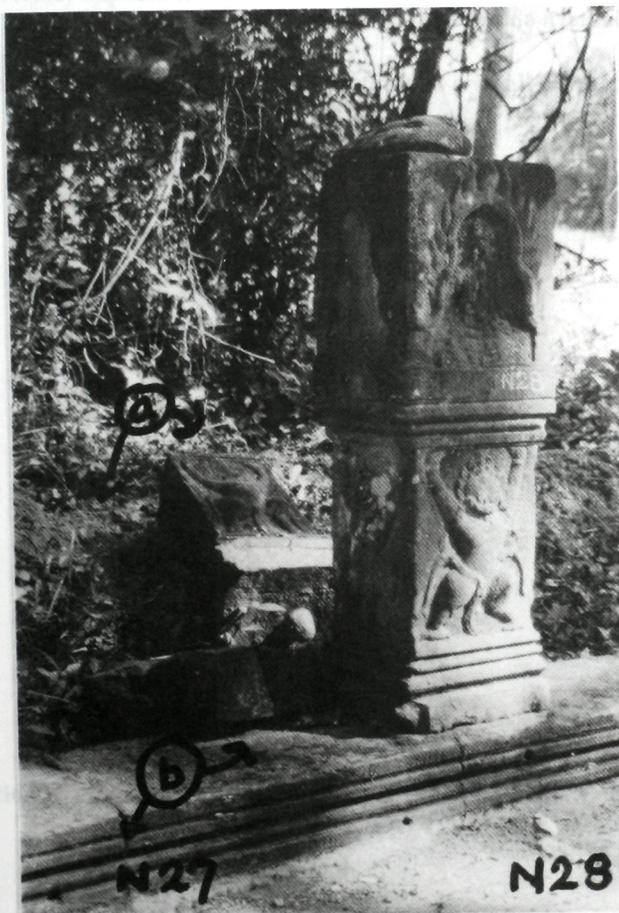
**Lantern No. N28**

Priority No action

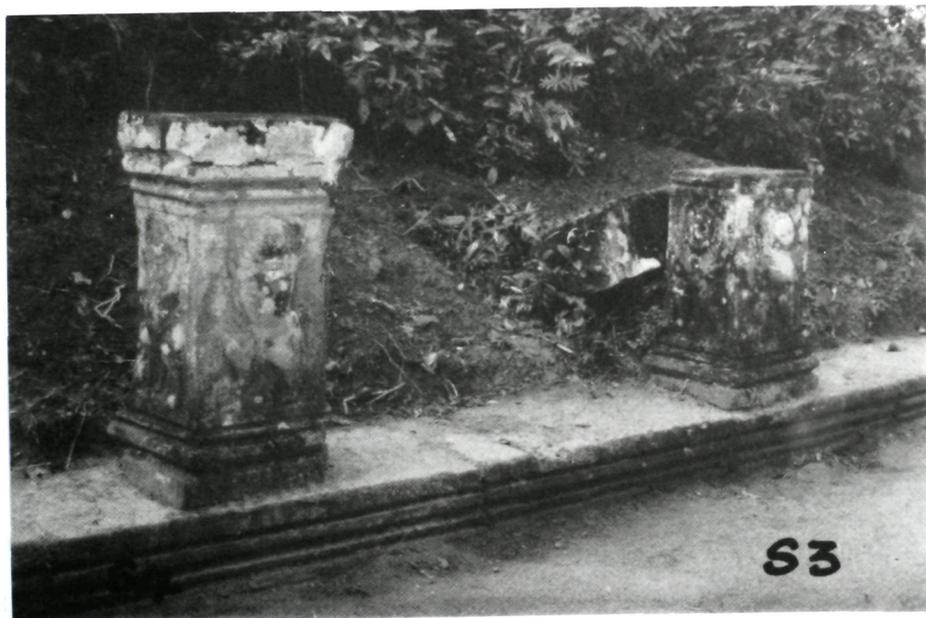
**Lantern Nos. 53 & 54**

Priority Medium

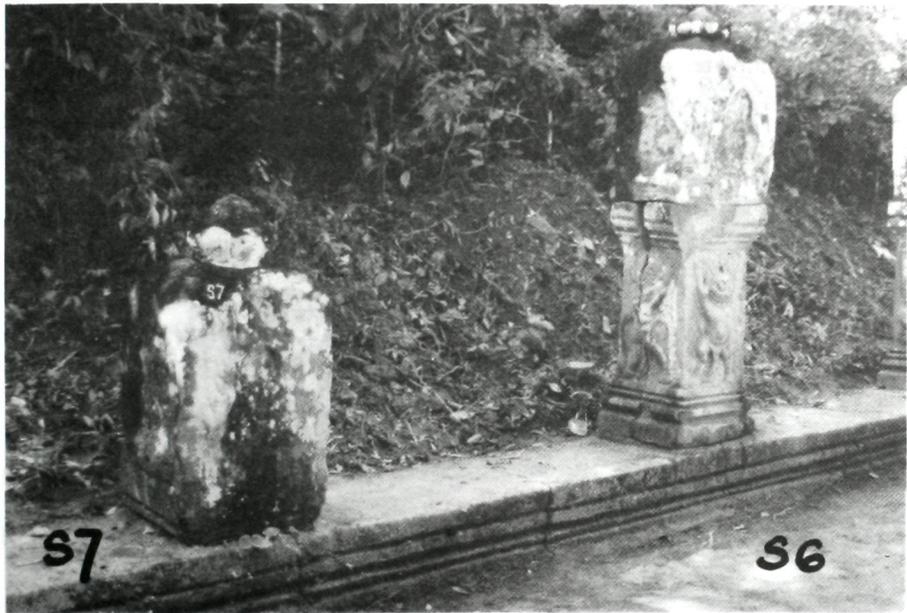
Lantern Nos. **S6 & S7**

Priority M.

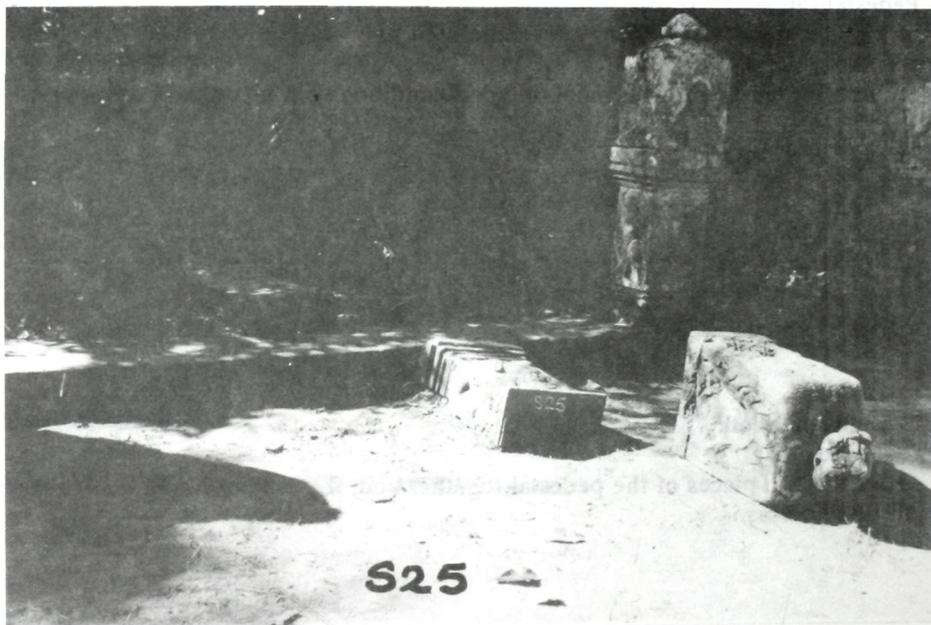
Lantern No. **S25**

Priority High  
Action Taken

S24	Low	Check crack in lantern.
S25	High	Re-assemble & repair & re-erect if possible.
S26	No action	
S27	No action	
S28	High	Repair pedestal, repair lantern & place on plinth.
S29	High	Repair & reposition.

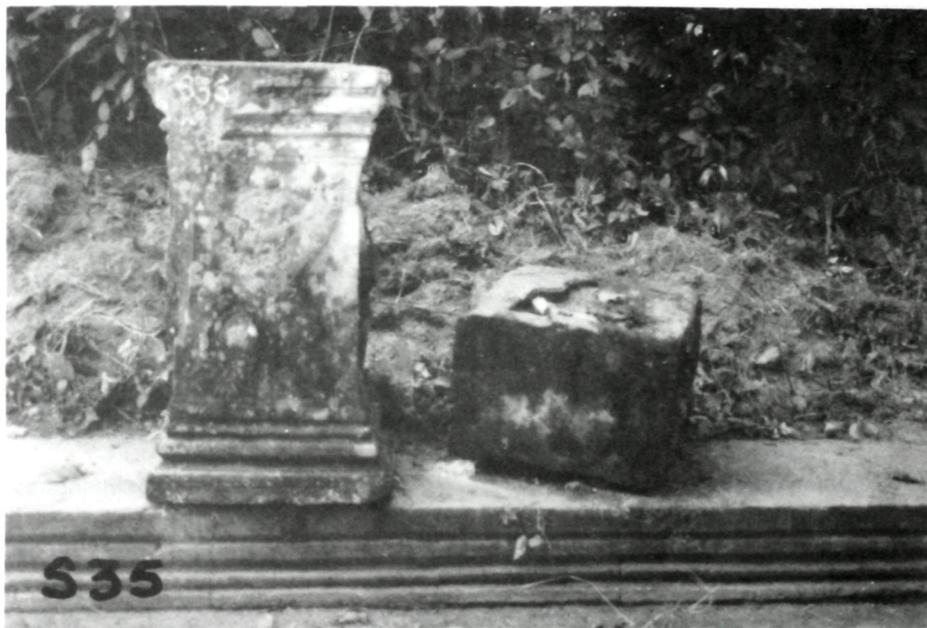
Lantern No. S35

Priority Medium

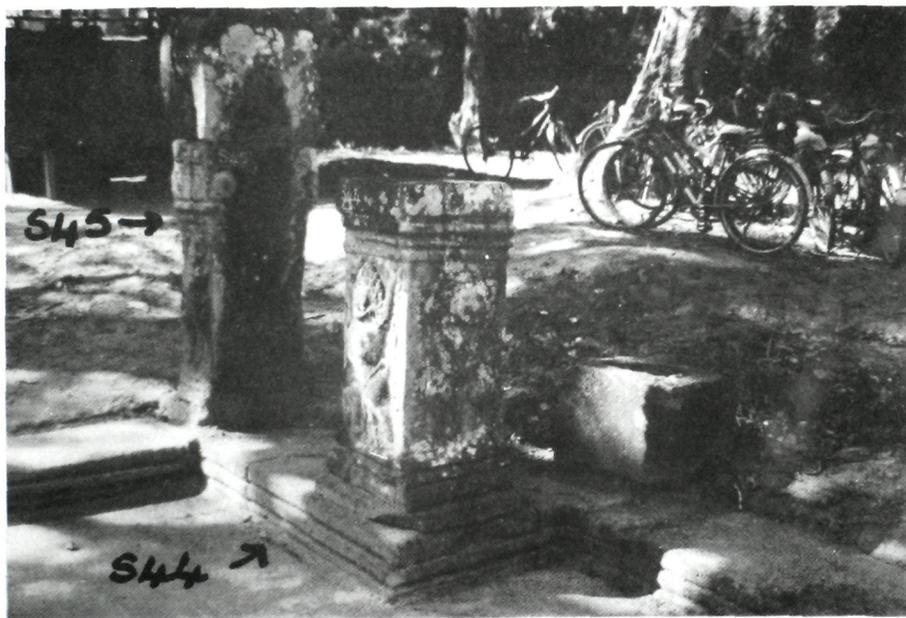
Lantern NoS. **S44 & S45**

7. Not all the pedestals and lanterns sit comfortably on their respective plinth bases or pedestals and there is evidence of incorrect re-positioning in the past. For example S44 & S47 are both on a north-south axis whilst S2 sits on a bed of mortar or cement. Conservation interventions are known to have taken place at Preah Khan between 1954 & 1959 by Jean Laur & Rene Dumont and dates in 1956 appear carved on at least two of the lanterns in the west approach (N1 & S2). It is to this period of work that we can ascribe the repairs noted below, some of which appear to have been successful others not so.

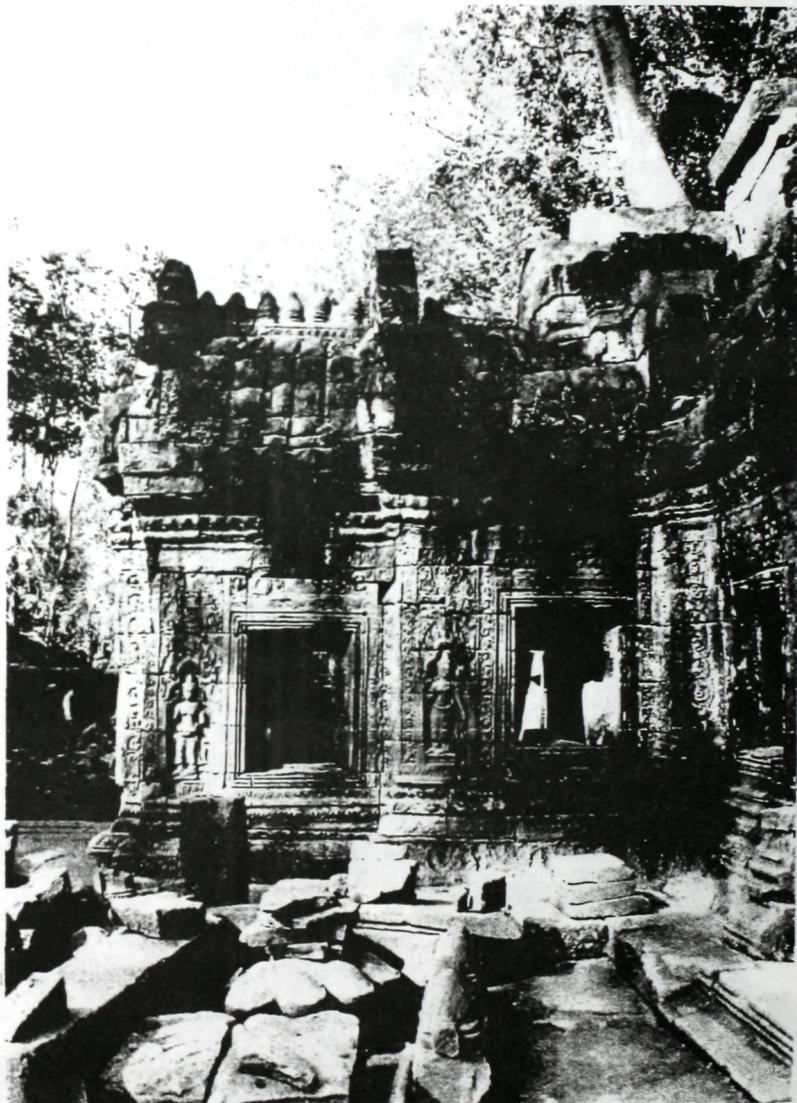
Plate 8 Yard B - the south elevation of the central passage and porch  
(see Fig 7).

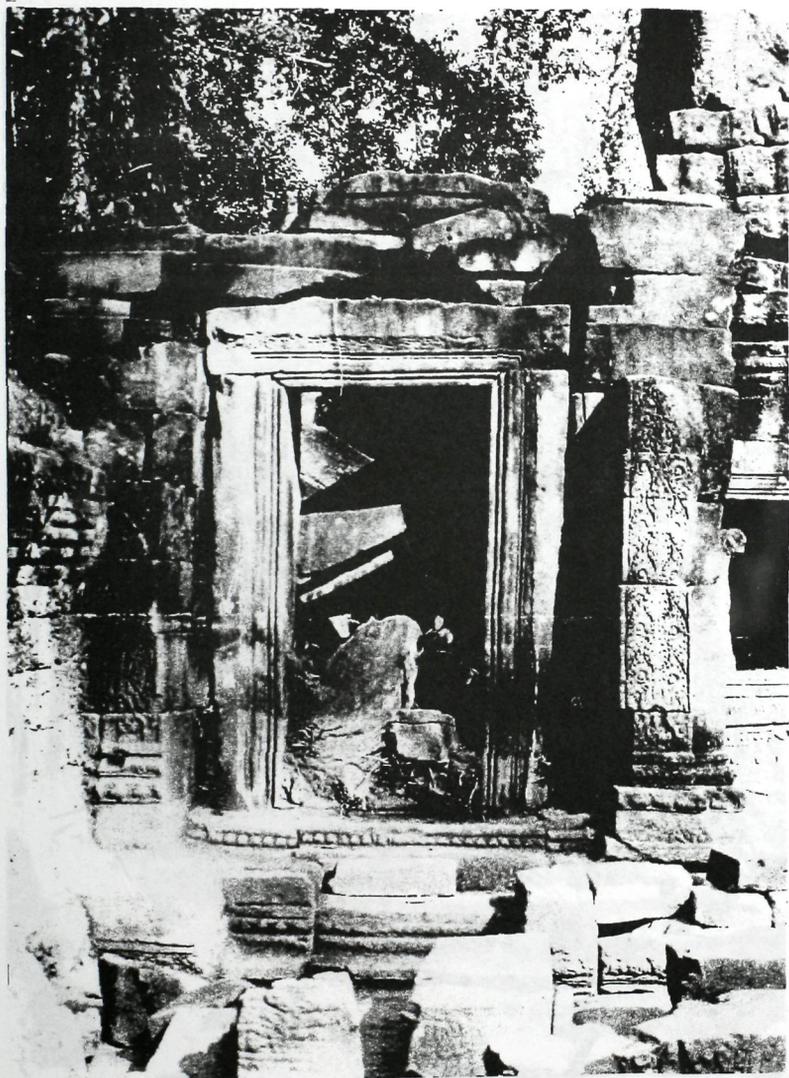
Plate 9. Yard A - west elevation of the north porch  
(for Record drawing see Fig 13).

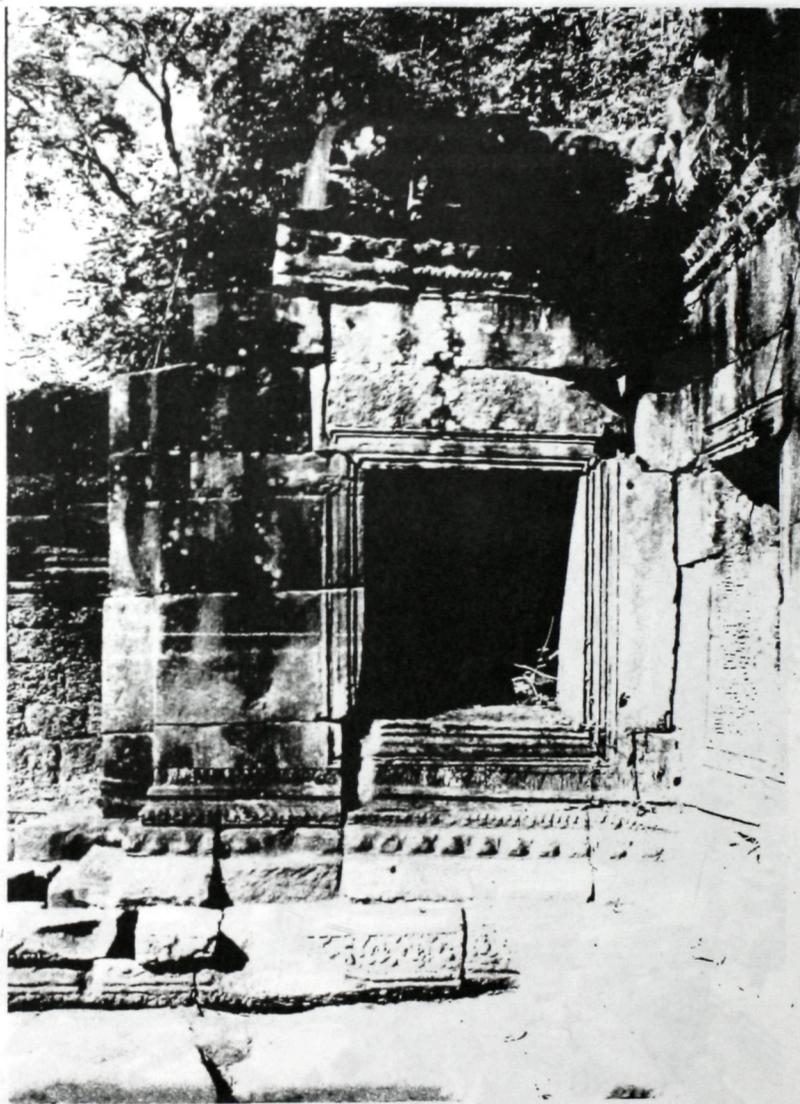
Plate 10 Yard A - south elevation of the north porch.

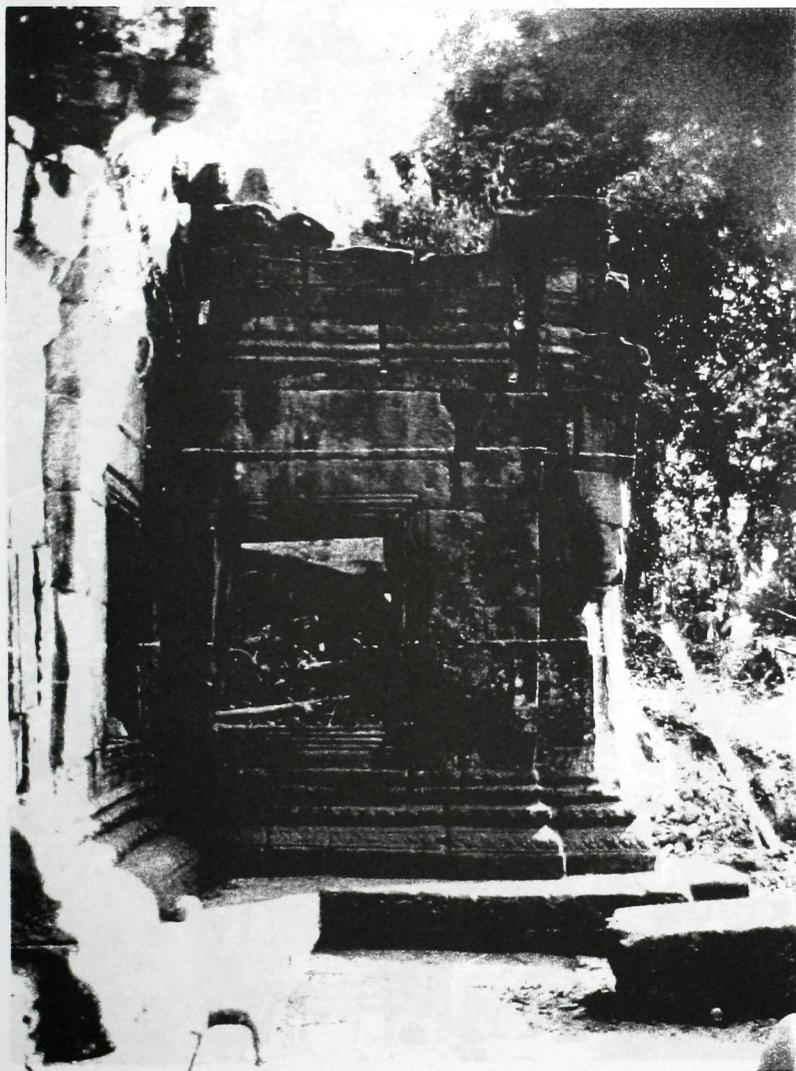
The *south porch* had collapsed but the surviving *in situ* evidence (Plates 11 & 12 and Fig 19a & b) showed that it had contained a doorway (Door 4). A study of the stones found in the adjoining yard (Fig 20) provided evidence that the door had been surmounted by a large fronton, part of which has been re-assembled (Plate 22 & 23 and Fig 19c). The method of construction was similar to that for Door 1 with a lintel (301 - 303) supported on octagonal columns and a shallow rebate. The fronton, supported on the lintel and side pillars, includes a large number of bonding stones, forming an integral part of the main structure of the porch.

Plate 11 Yard B - north elevation of the south porch.

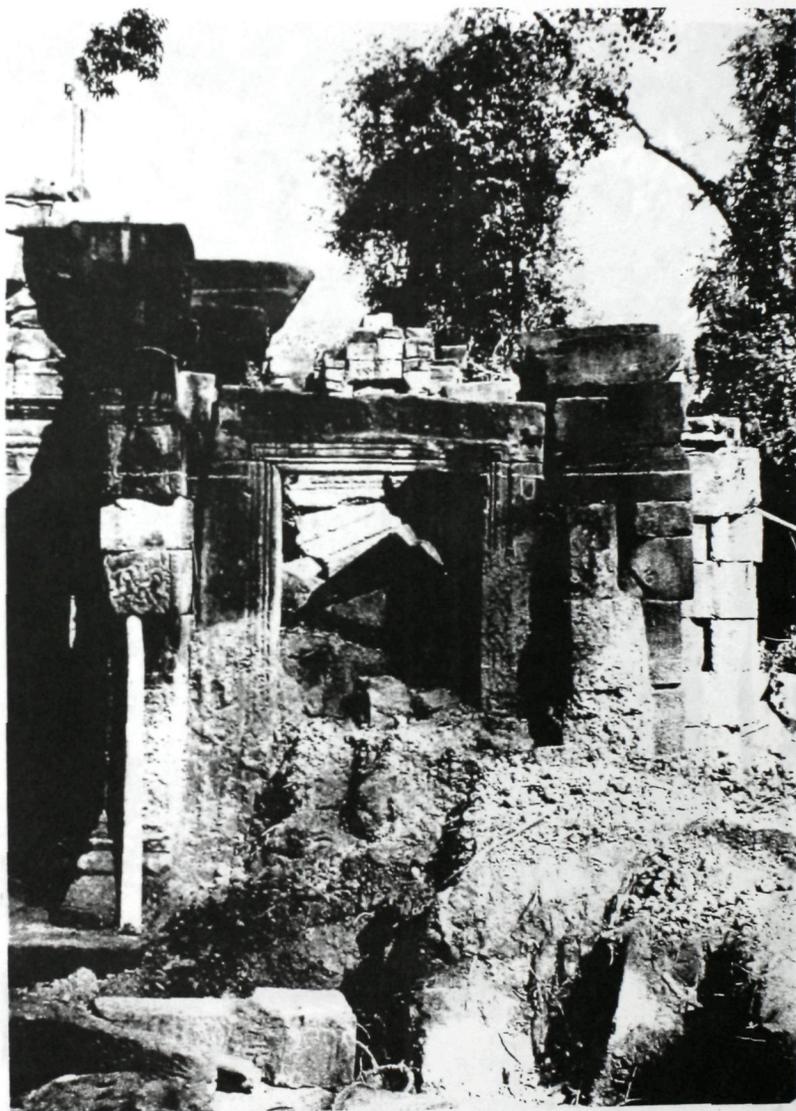
Plate 12 Yard B - west elevation of the south porch, partially cleared.

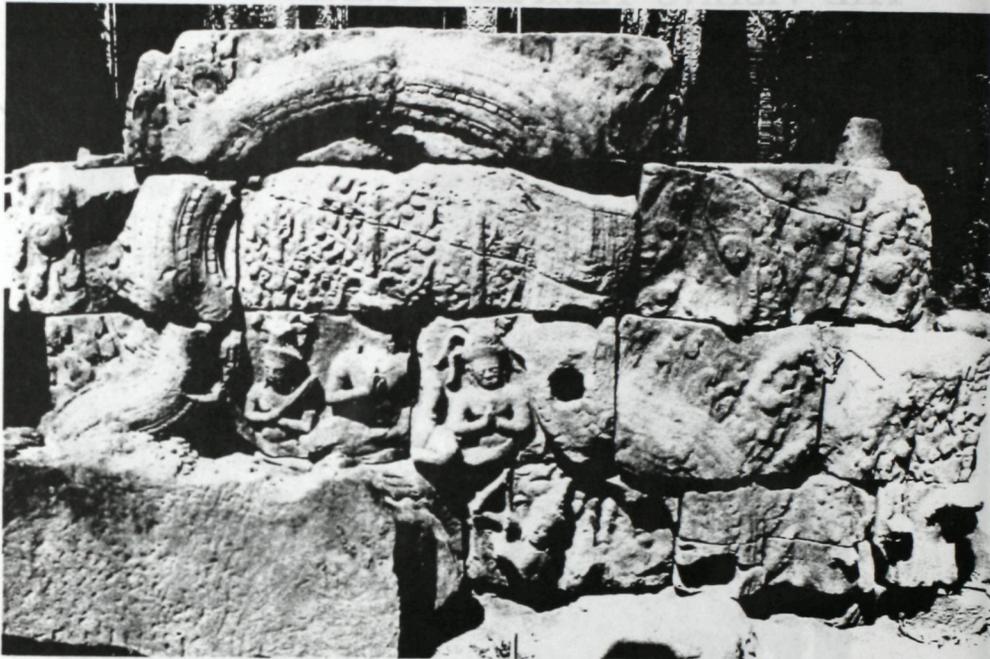
Plate 14 Door 1 - re-assembled components of the decorated fronton (see Fig 13c & d).

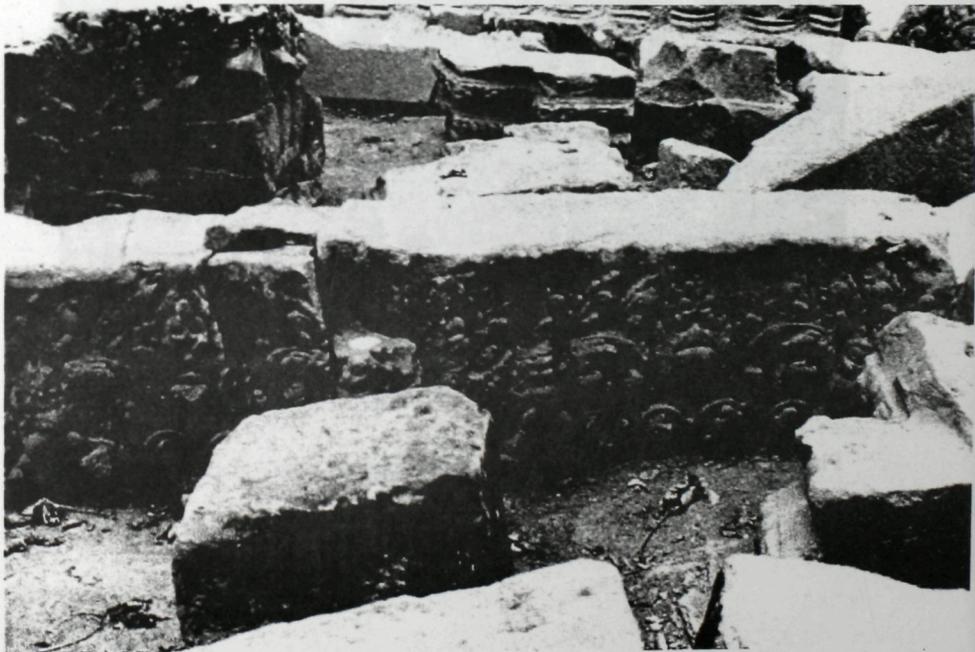
Plate 15 Door 1 - components of the carved stone lintel (see Fig 13 c & d).

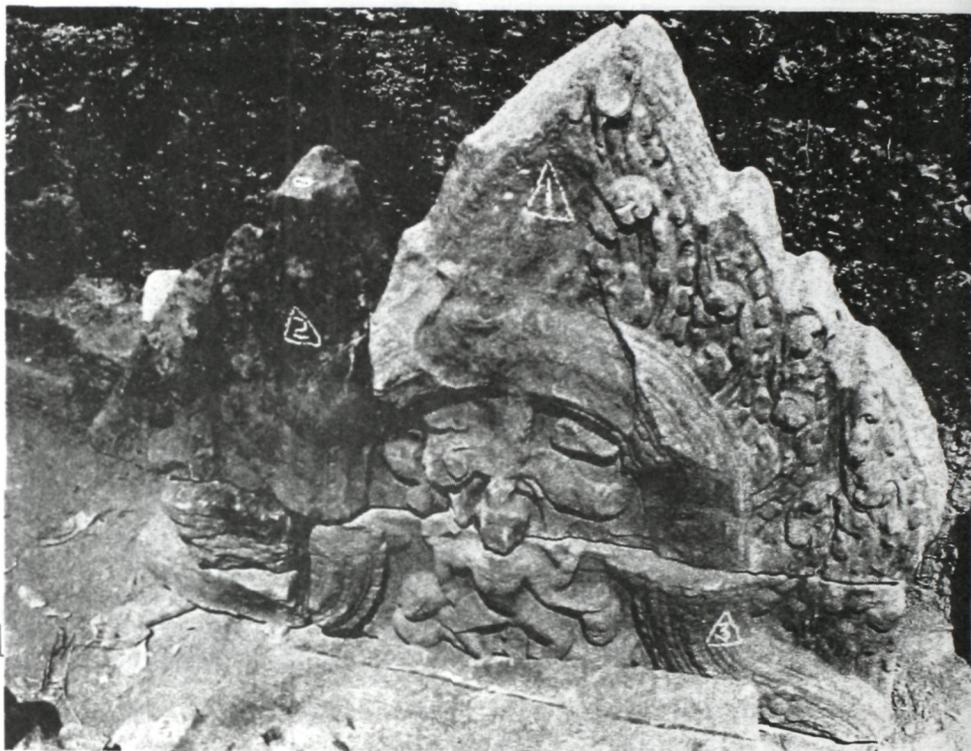
All but one of the decorated stones needed to reconstruct the door surround and fronton have been identified, and the completed scene includes the rows of nine kneeling figures beneath an individual figure, perhaps Vishnu, with two attendants (Plate 18 & 19 and Fig 15c).

Plate 18 Door 2 - re-assembled components of the decorated fronton (see Fig 15b & c).

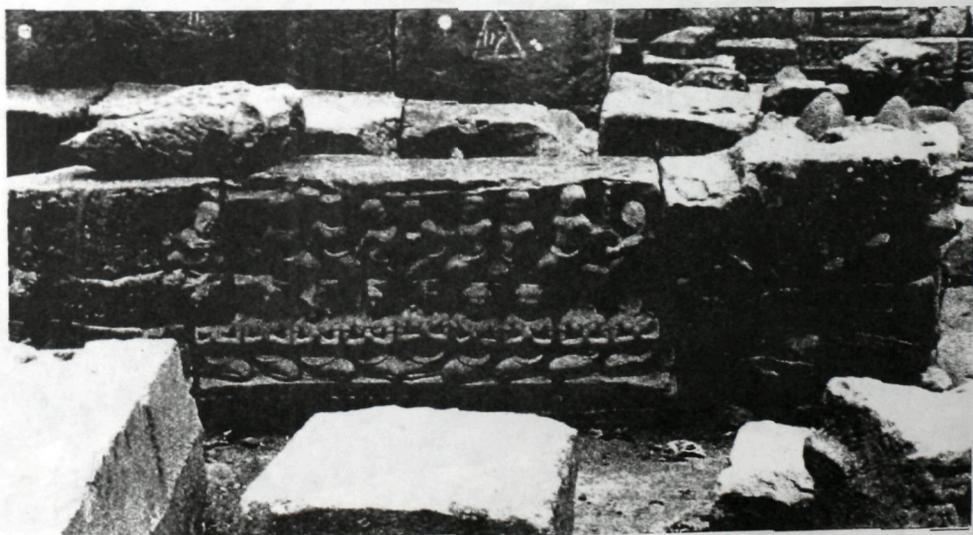
Plate 19 Door 2 - re-assembled components of the decorated fronton (see Fig 15b & c)

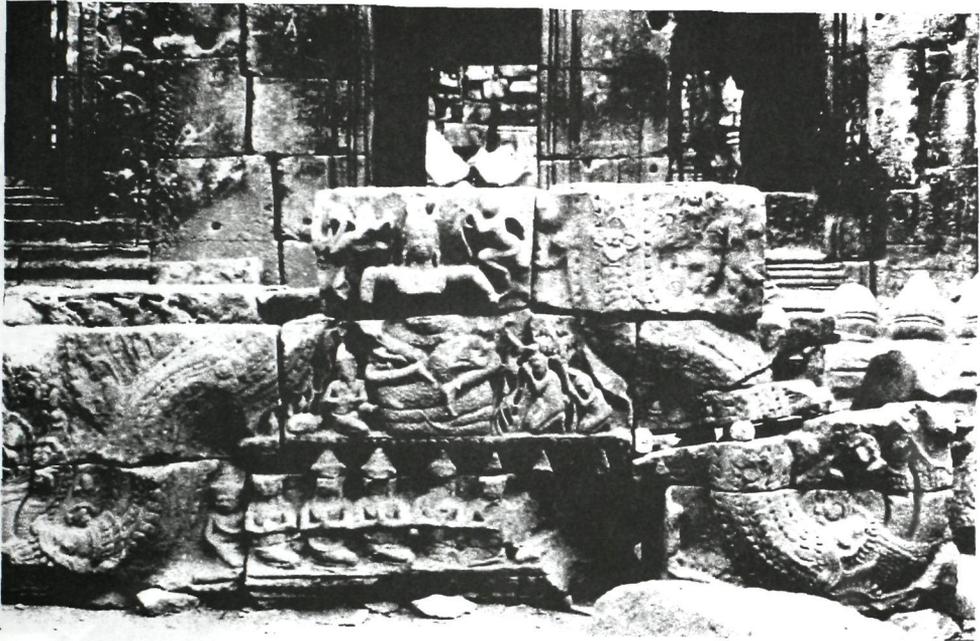
Most of the decorated stones needed to reconstruct the door surround have been identified, and the completed scene includes a row of nine kneeling figures beneath a coiled serpent mounted by a seated figure with five attendants (Plates 20 & 21). The scene is thought to depict the story of Krishna protecting the cow-herders by capturing the King of the Nagas and pulling off all his heads.<sup>2</sup>

Plate 20 Door 3- re-assembled components of the decorated fronton (see Fig 17b).

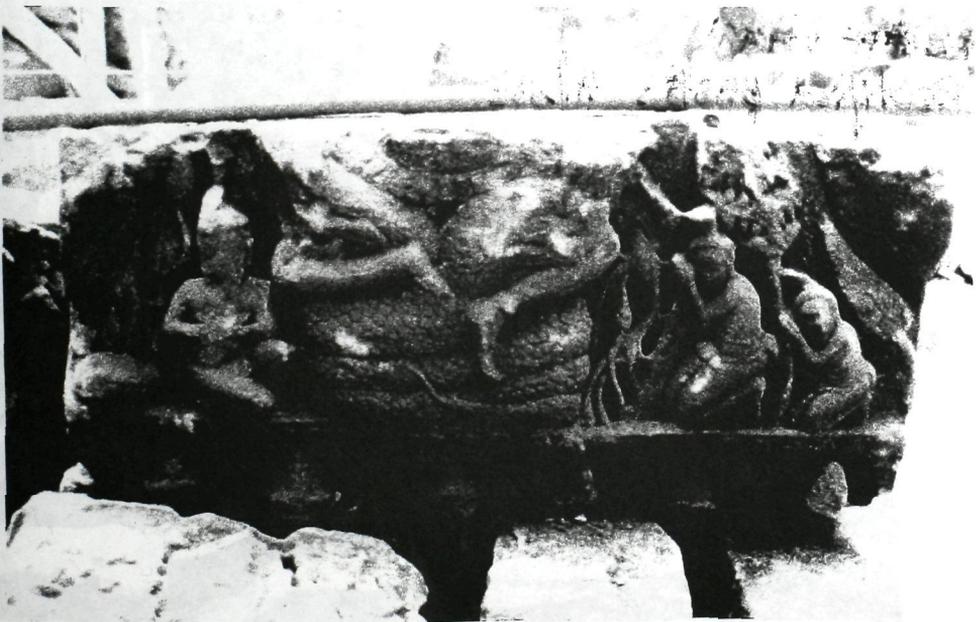
Plate 21 Door 3 - one of the decorated stones from the fronton .

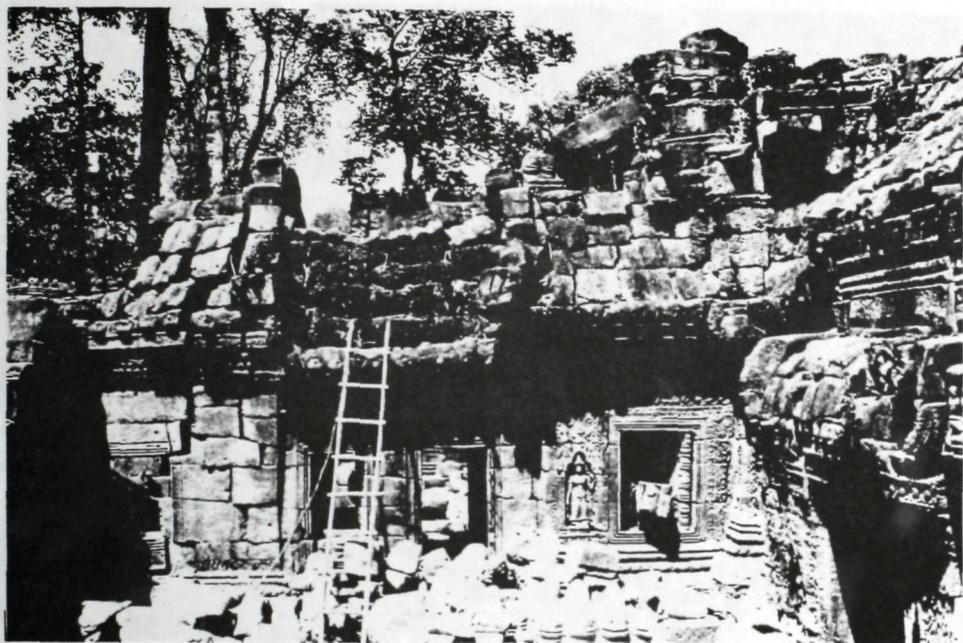
Plate 24 The roof - the east elevation of the west passage, north of the central passage.  
Note the roof section constructed partially in laterite stone.

In the areas where laterite stone had previously been used it is recommended that consideration be given to the use of modern replacements or precast slabs to replace those that are broken or beyond recognition and repair.

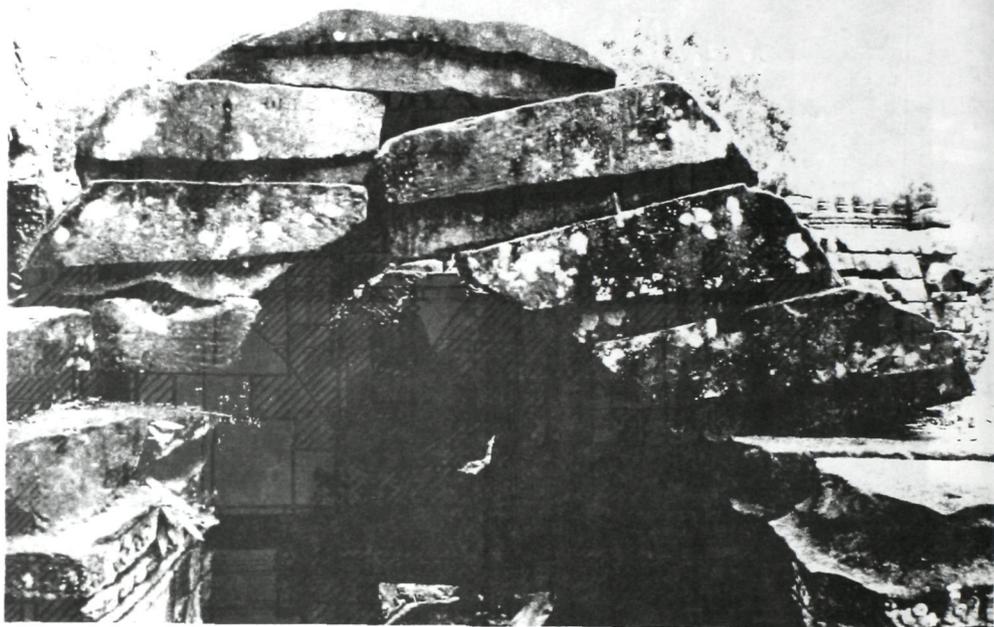
The method of roof construction is typical of the Preah Khan temple complex, with corbelled roof slabs rising from a stone cornice to a capstone surmounted by a ridgepiece (Plate 25 & Fig 6). Rebated joints between roof slabs slope downwards from the centre to provide a rainwater run off between slabs. Where the roof extended over an interior dividing wall bonding stones are included over the wall to carry the roof and a reduced form of fronton between roof sections (Plate 26). The stone corbels forming the vaults have extremely smooth horizontal faces and were probably rubbed using an abrasive to produce a remarkably tight dry bed.

Plate 25 The roof - section at the north end of the west passage, looking south.

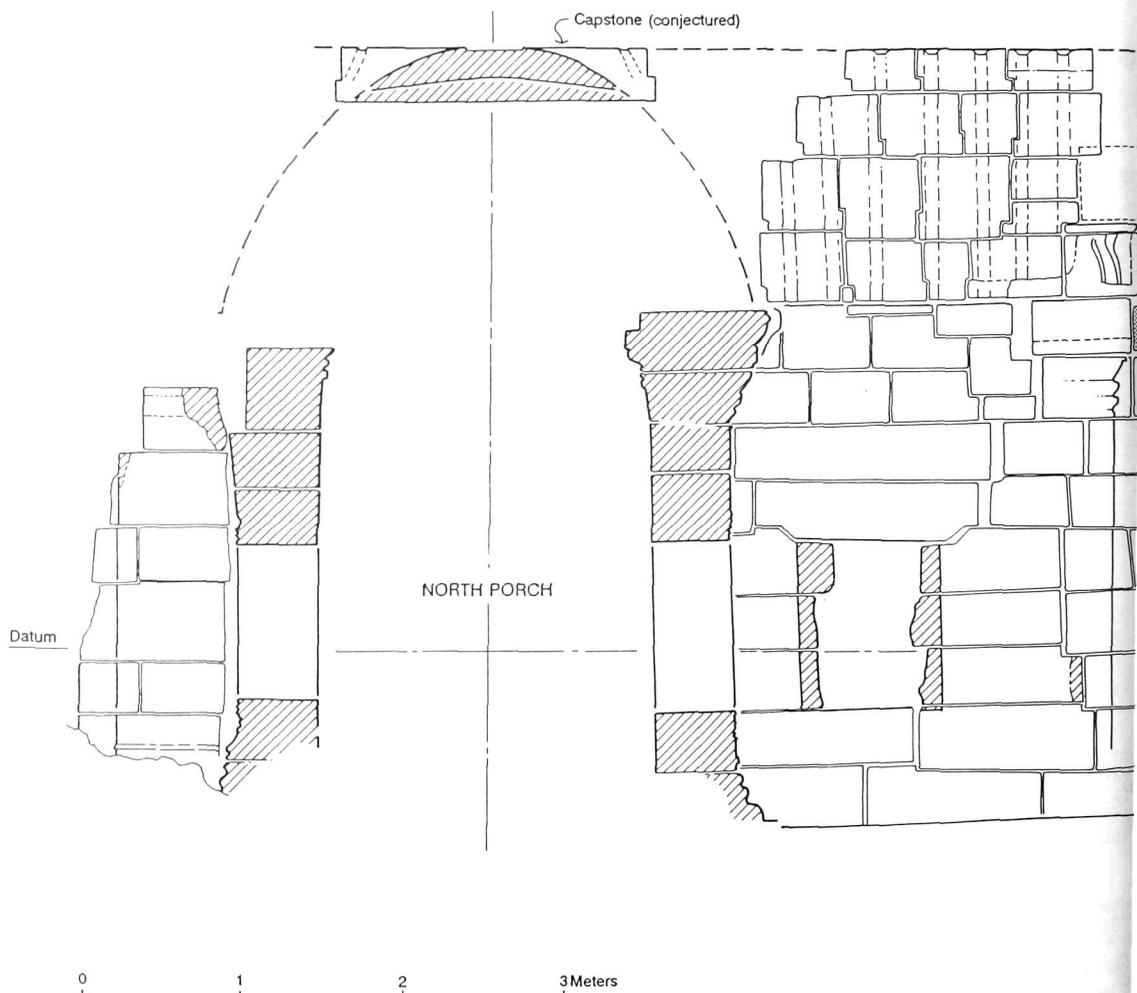
Fig. 4 Record elevation drawing and sections AA (Based on surveys by Cheam Phally & Lek Sereth).  
(For a scaled photograph see Fig.9).

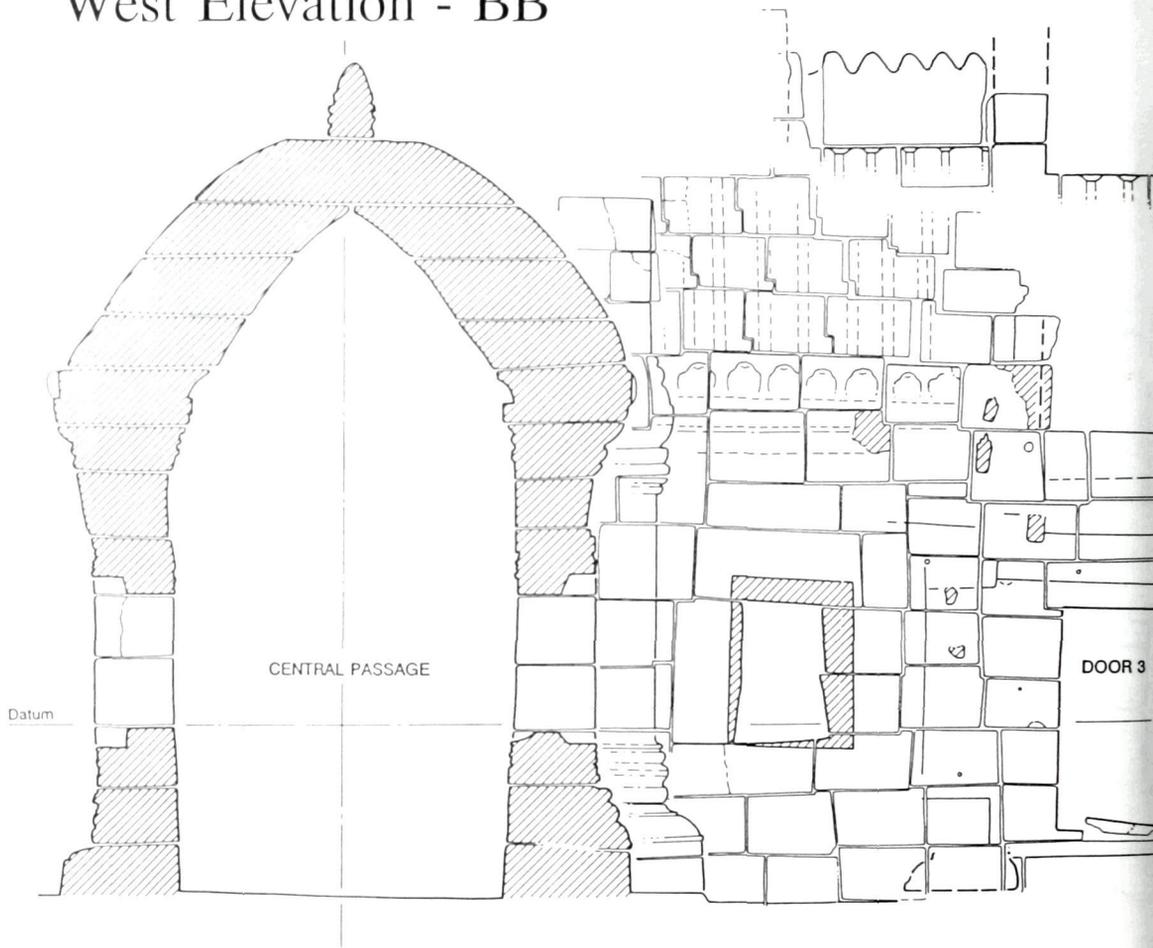
Fig. 5 Record elevation drawing and sections BB. (Based on surveys by Chhun Soma and Lek Sereth).  
(For a scaled photograph see Fig. 11).

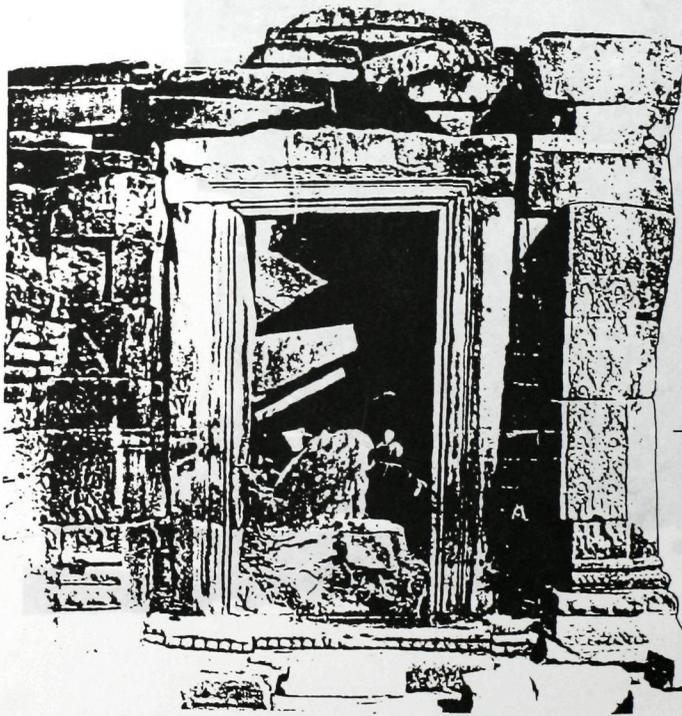
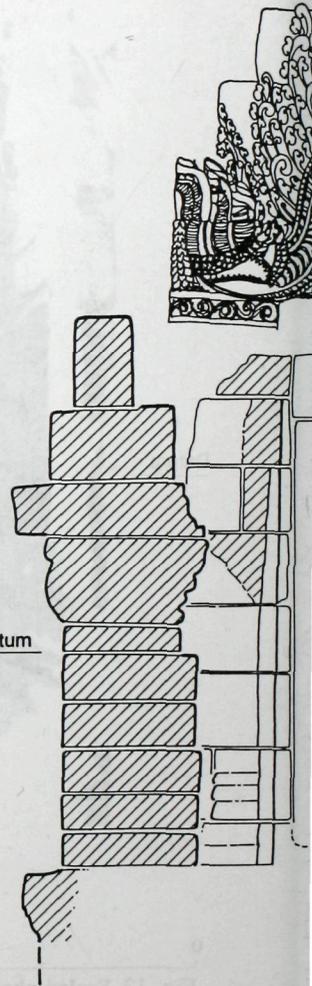
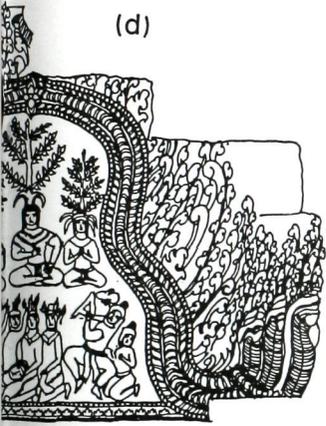
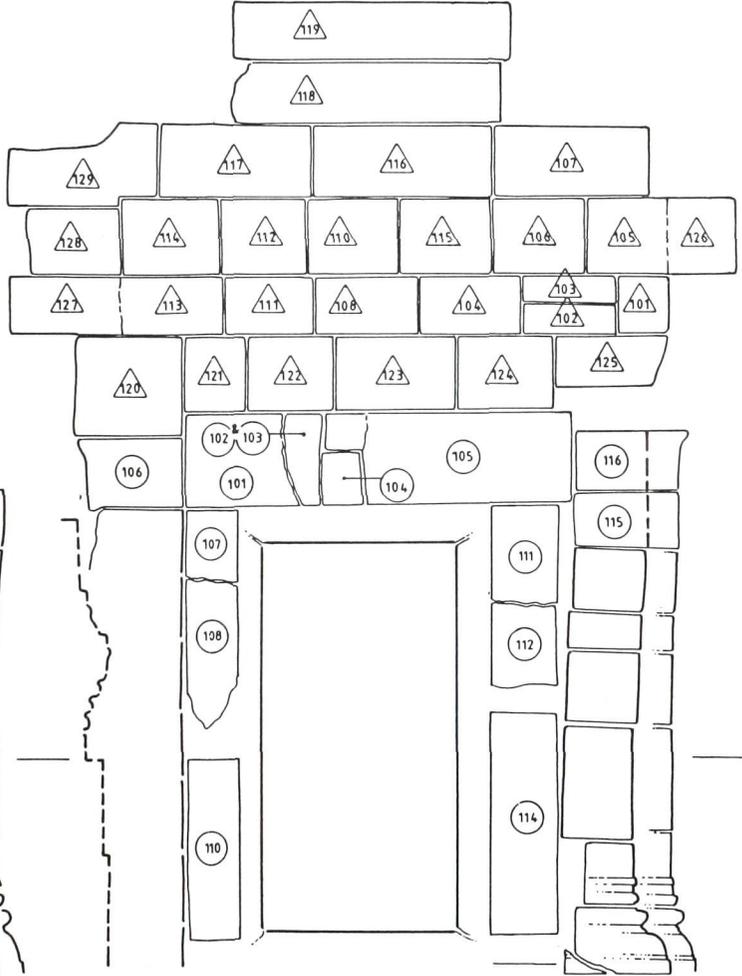
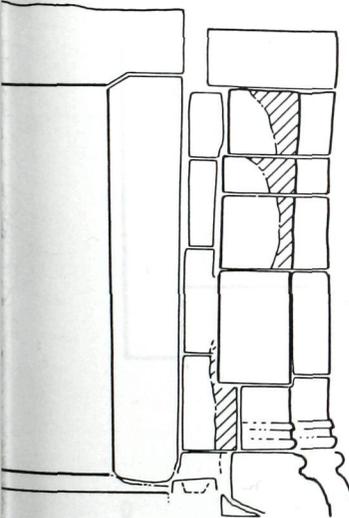
Fig. 13 Door and Fronton 1 ~ Scaled photograph (a); record drawing (b); reconstruction drawing (c); and detail drawing (d).  
(Based on drawings by Chhun Soma, Cheam Phally, and Var Morin).

The *north porch* had collapsed but the surviving *in situ* evidence (Plates 9 & 10 and Fig 13a & b) show that it had originally contained a door. A study of the carved stones found in the adjoining yard (Fig 14) provided evidence that the door had been surmounted by a large fronton, the majority of which could be re-assembled to produce a beautifully sculpted scene depicting Vishnu and his attendants (Plate 14 & Fig 13 c & d).

The decorated lintel (Plate 15 & Fig 13c 101 - 105) is supported on a pair of octagonal columns (107 - 110 & 111 - 114), which are each secured at their base by a small tenon set into a mortice hole in the stone blocks on either side of the threshold. Neither the lintel nor the columns appear to have been attached to the porch in any way. The lintel and side pillars support the fronton over the doorway, at the west end of the north passage. The stones making up the lower part of the panel are end-on to the west elevation. They appear on the internal elevation as part of the cornice arrangement, and as bonders, they form an integral part of the main structure. It is not until this level is reached that there is any bonding between the door surround and fronton and the north porch. A few missing pieces belonging to the fronton have yet to be found amongst the stored stones, but doubtless they can be located.

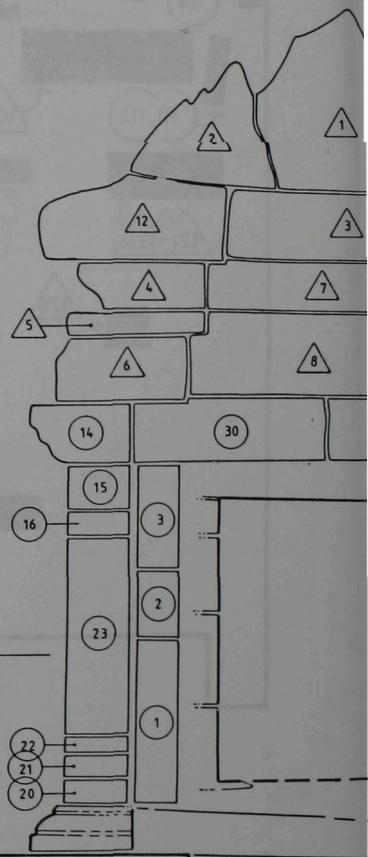
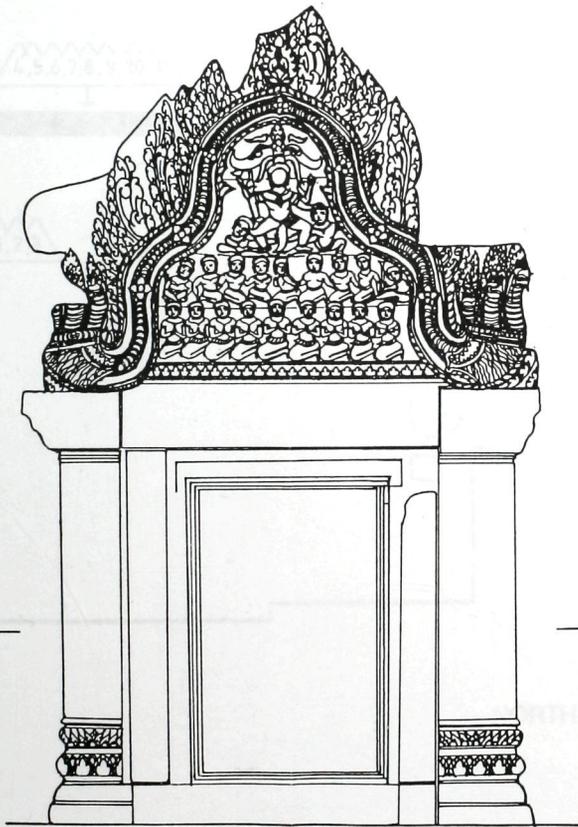
Fig. 15 Door & Fronton 2 ~ scaled photograph (a); reconstruction drawing (b); and detailed drawing (c). (For the record drawing see Fig. 4).  
(Based on drawings by Chhun Soma, Cheam Phally, and Var Morin).

To the south of the north porch are two windows and the opening for a second door leading into the west passage (Door 2 Plate 5, Figs 4, 9, & 15a). A study of the stones found in the adjoining yard (Fig 16) enabled the reconstruction of the door surround and the fronton which it supported (Plates 17 - 19 & Fig 15b). Octagonal columns on either side of the opening, one of which survived *in situ* and the other recovered in pieces from the collapsed debris (Plate 16 and Fig 15b 1 - 3), supported a decorated lintel (Plate 17 and Fig 15b 30 & 31), which at its south end may also have engaged the body of the wall in a shallow rebate.

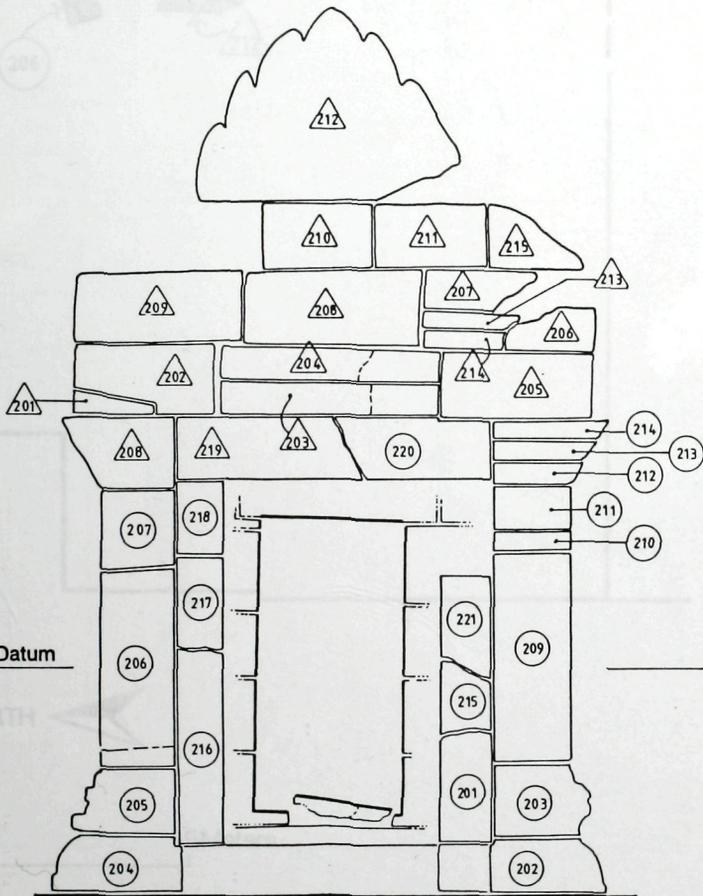
Fig. 17 Door and Fronton 3 ~ scaled photograph (a); and reconstruction drawing (b). (For the record drawing see Fig. 5).  
(Based on drawings by Chhun Soma, Cheam Phally, and Var Morin.)

An examination of the stones found in the adjoining yard (Fig 18) enabled a reconstruction of the door surround and the fronton which it supported (Plates 20 & 21 and Fig 17b). Octagonal columns on either side of the opening supported a decorated lintel (219 & 220) which may also have engaged in a shallow rebate cut in the stone at the head of the door.

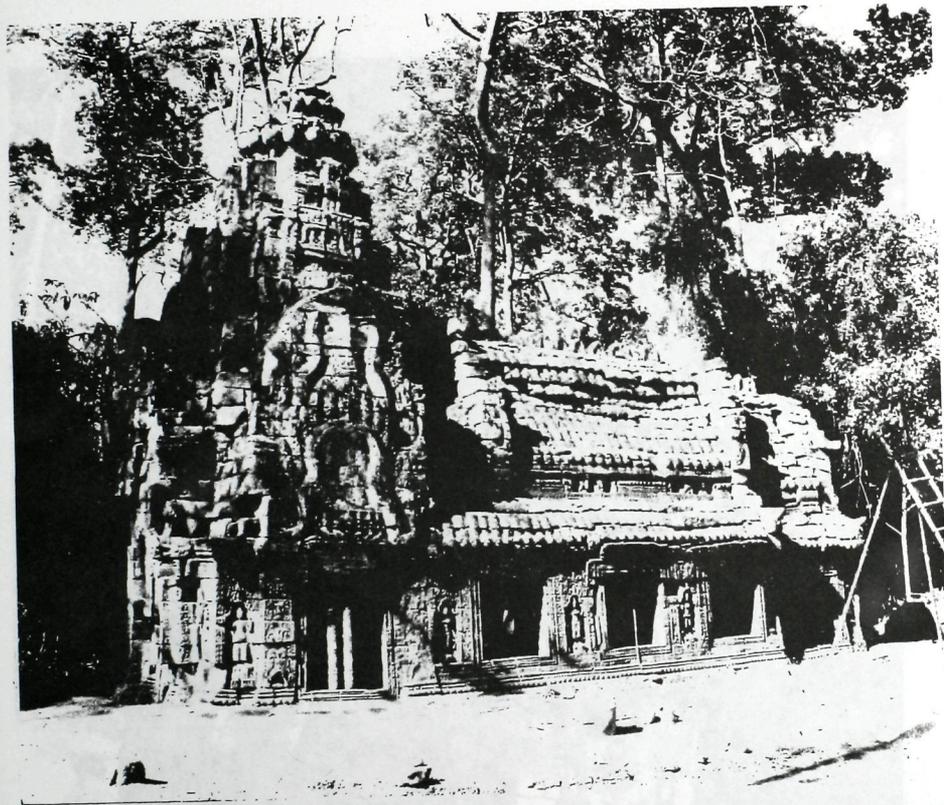
Plate 1 The Dharmasala from the South-West.

The structure, although in a seriously unstable condition, is almost complete, and undamaged apart from a small number of fallen or broken stones (Plates 1 - 5 & record photographs). It is rectangular in plan, measures a little over 14 meters in length and 6 meters in width on an east-west orientation, and comprises three definable sections - a central rectangular space measuring 7.0 meters by 4.5 meters internally, a smaller space at the east end measuring 2.3 meters by 3.5 meters internally, and a space at the west end under the tower measuring 2.7 meters by 5.3 meters internally. The roof rises to a height of 6.2 meters externally at the east end, and 6.6 meters in the center, whilst the tower is about 11.0 meters high.

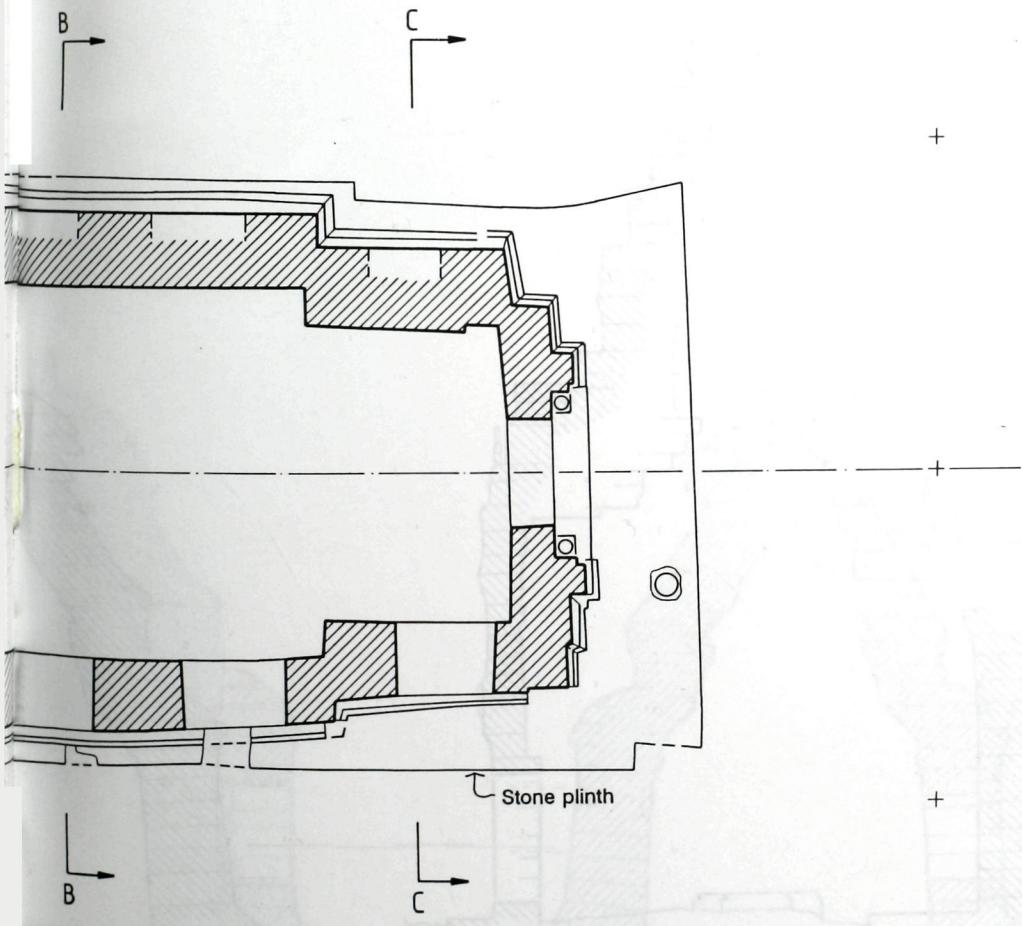
Fig 2

As with most of the Preah Khan roofs the corbelling method of construction provides little or no lateral constraint, but here the problem is exacerbated by the addition of a clerestory in an uninterrupted section of roof which measures 7 meters in length. In the middle of the central space in the building, the ridge piece and upper two courses have remained in their original position but the corbel stones beneath them on the south slope of the roof have slid northwards and dropped. The roof sections have moved a total of 50 cms (Fig 3 Section BB). As a result of the defective foundations along the north wall, it is tilting about 20 cms inwards.
