**PREAH KHAN CONSERVATION PROJECT  
HISTORIC CITY OF ANGKOR**

**REPORT IV**

**FIELD CAMPAIGN I - PROJECT MOBILIZATION**

## Preah Khan, Angkor THE WEST LANTERN APPROACH

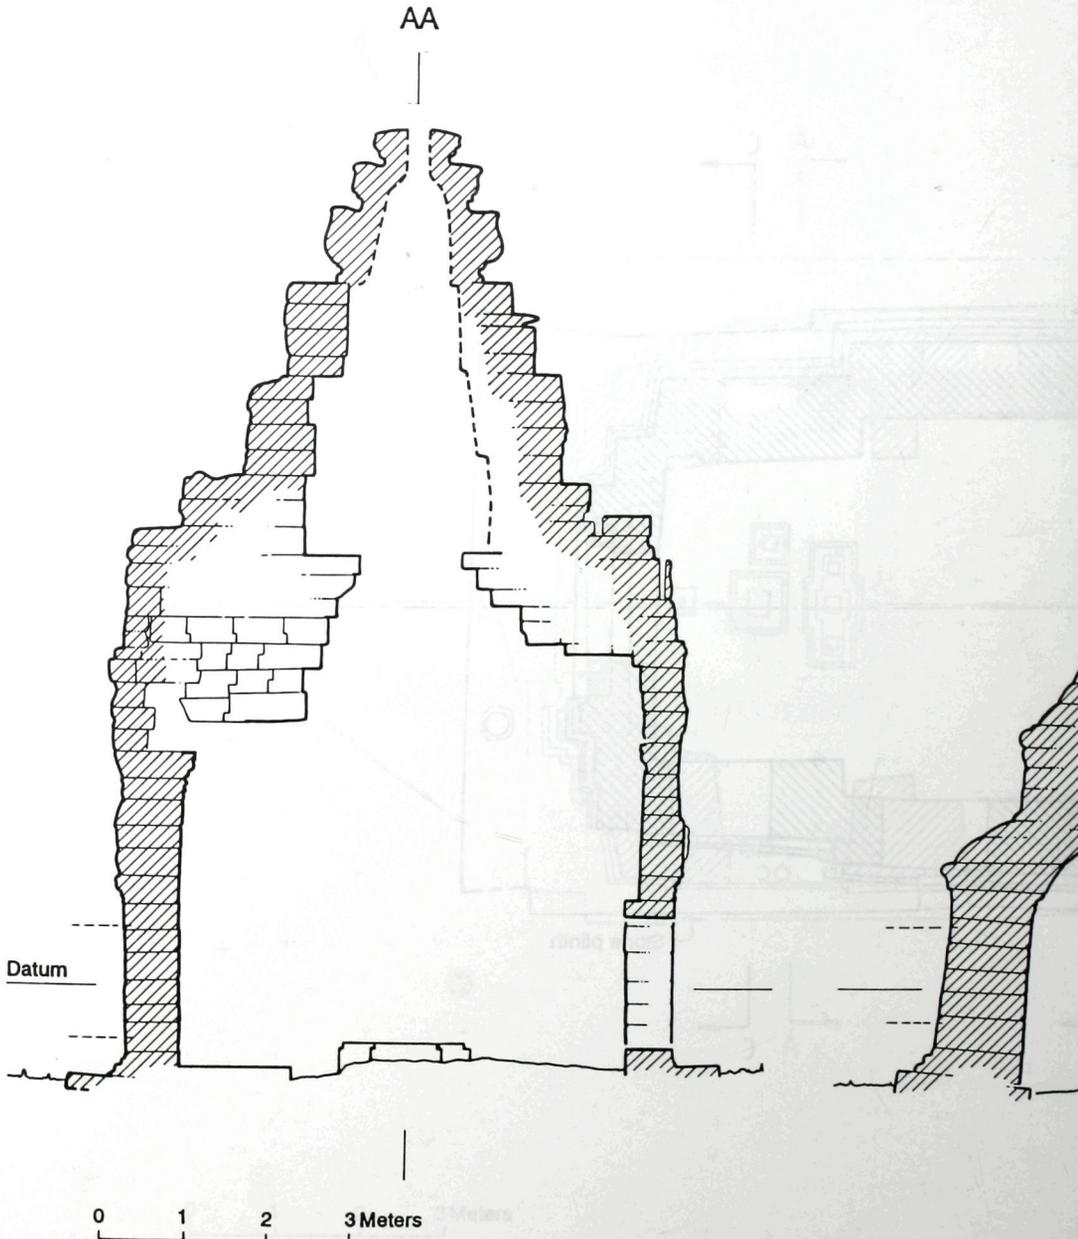
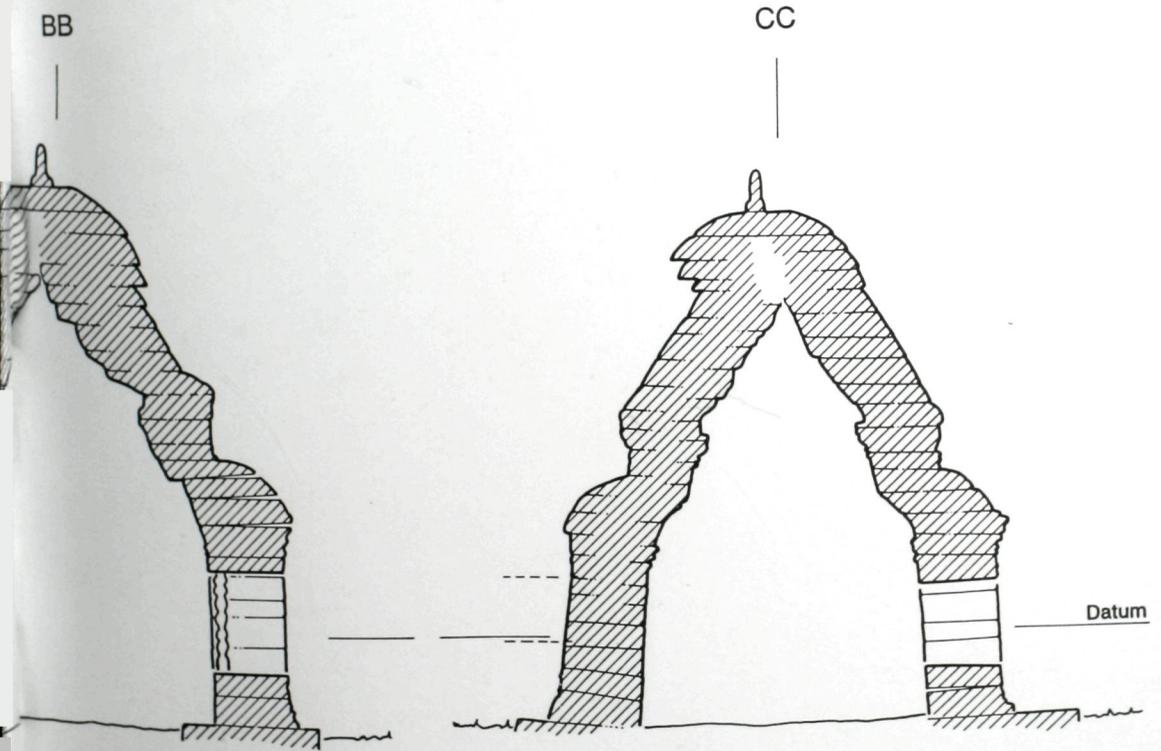
Fig. 3

The same effects can be seen in the roof at the eastern end where the movement is again seen to be greater on the north side than on the south (Fig 3 Section CC). The substantial weight of the walls and roof on what appear to be an inadequate foundations are undoubtedly contributory causes to the problems.
