# **Preserving Haiti's Gingerbread Houses**

## **2010 Earthquake Mission Report**

**A World Monuments Fund / ICOMOS Project funded in part by Prince Claus Fund and FOKAL**

**2010 Earthquake Mission Report  
December 2010**

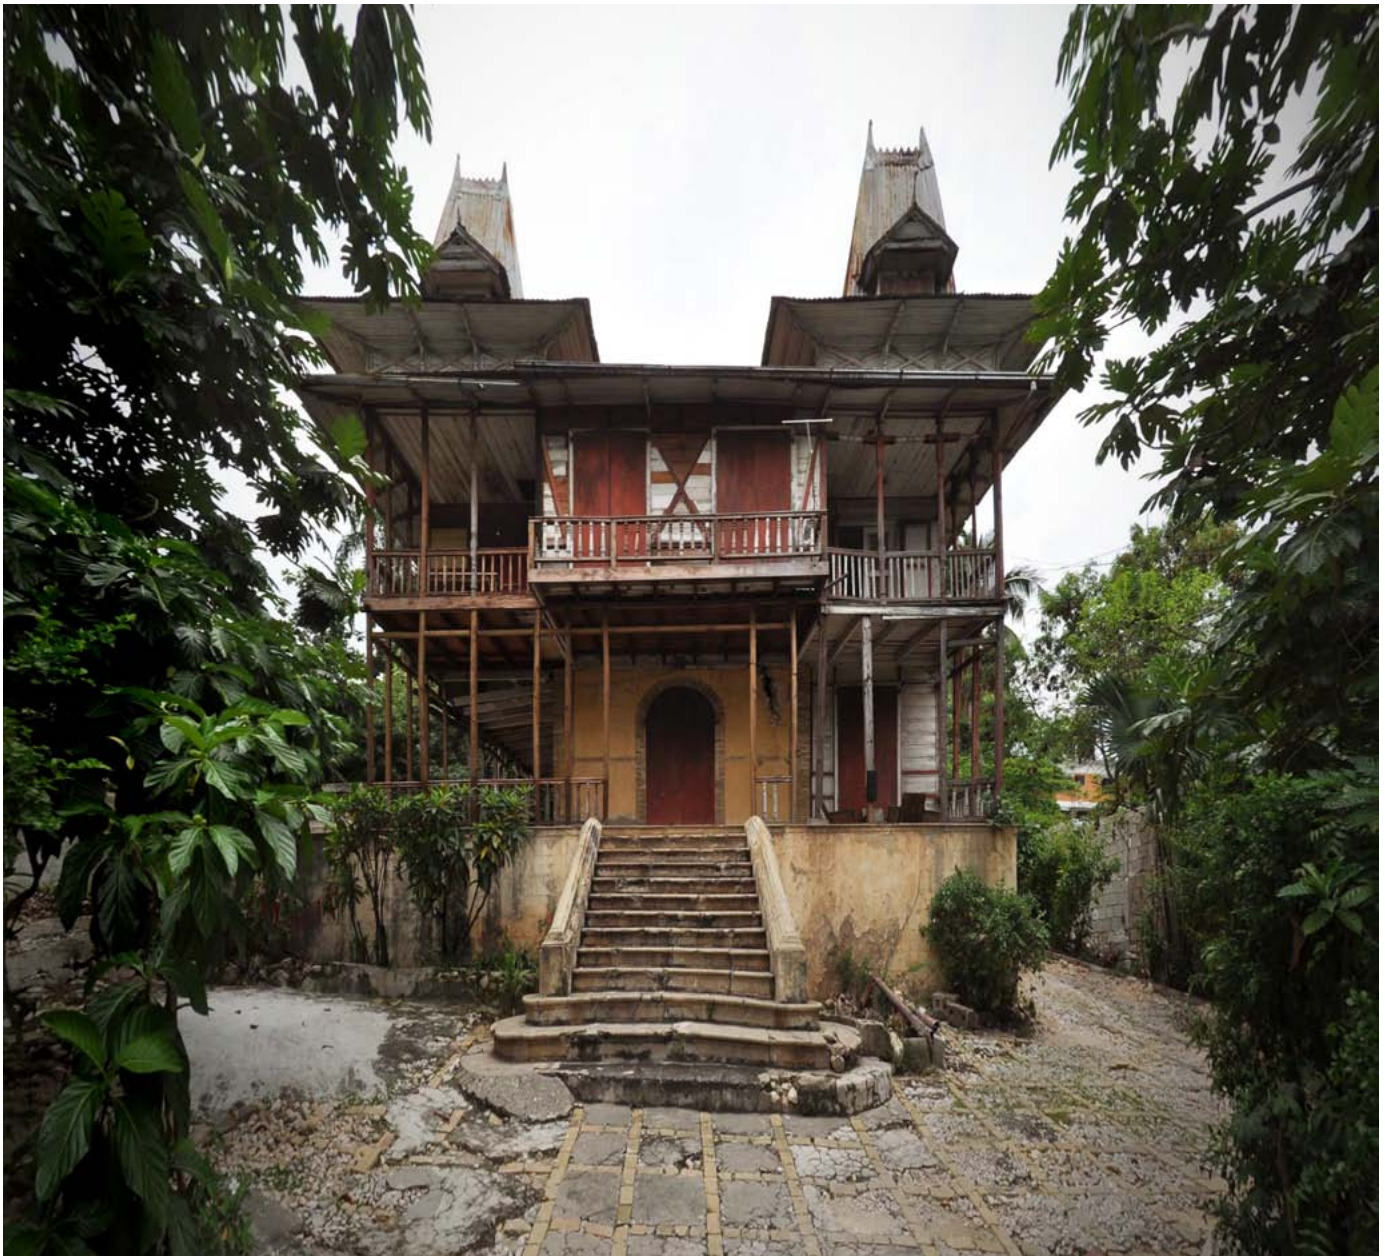
**FIGURE 2 above** The Patrice Pamphile House at 4 Rue Casseus, a particularly unusual yet characteristic house in the Haitian vernacular of the Gingerbread era. It combines stone and brick masonry construction with *colombage* and timber frame and clad sections into one composition. The wide porches, tall doors and high ceilings are all characteristic elements of the Gingerbread typology.

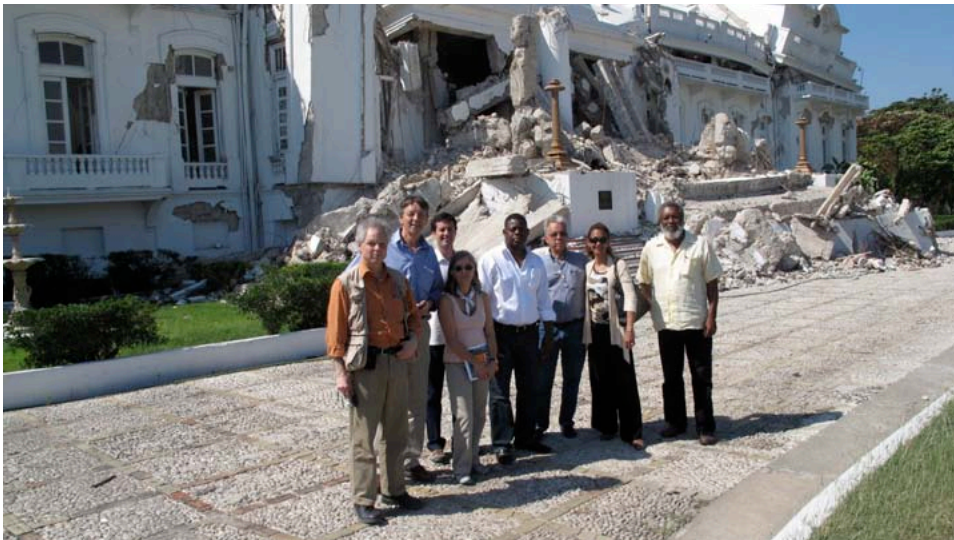
**FIGURE 5** Dinu Bumbaru (ICOMOS), Herman van Hooff (UNESCO), Conor Bohan (HELP), Norma Barbacci (WMF), Olsen Jean Julien and Frederick Mangones (Assessment Team), Monique Rocourt and Daniel Elie (ISPAN) in front of the National Palace in February 2010.

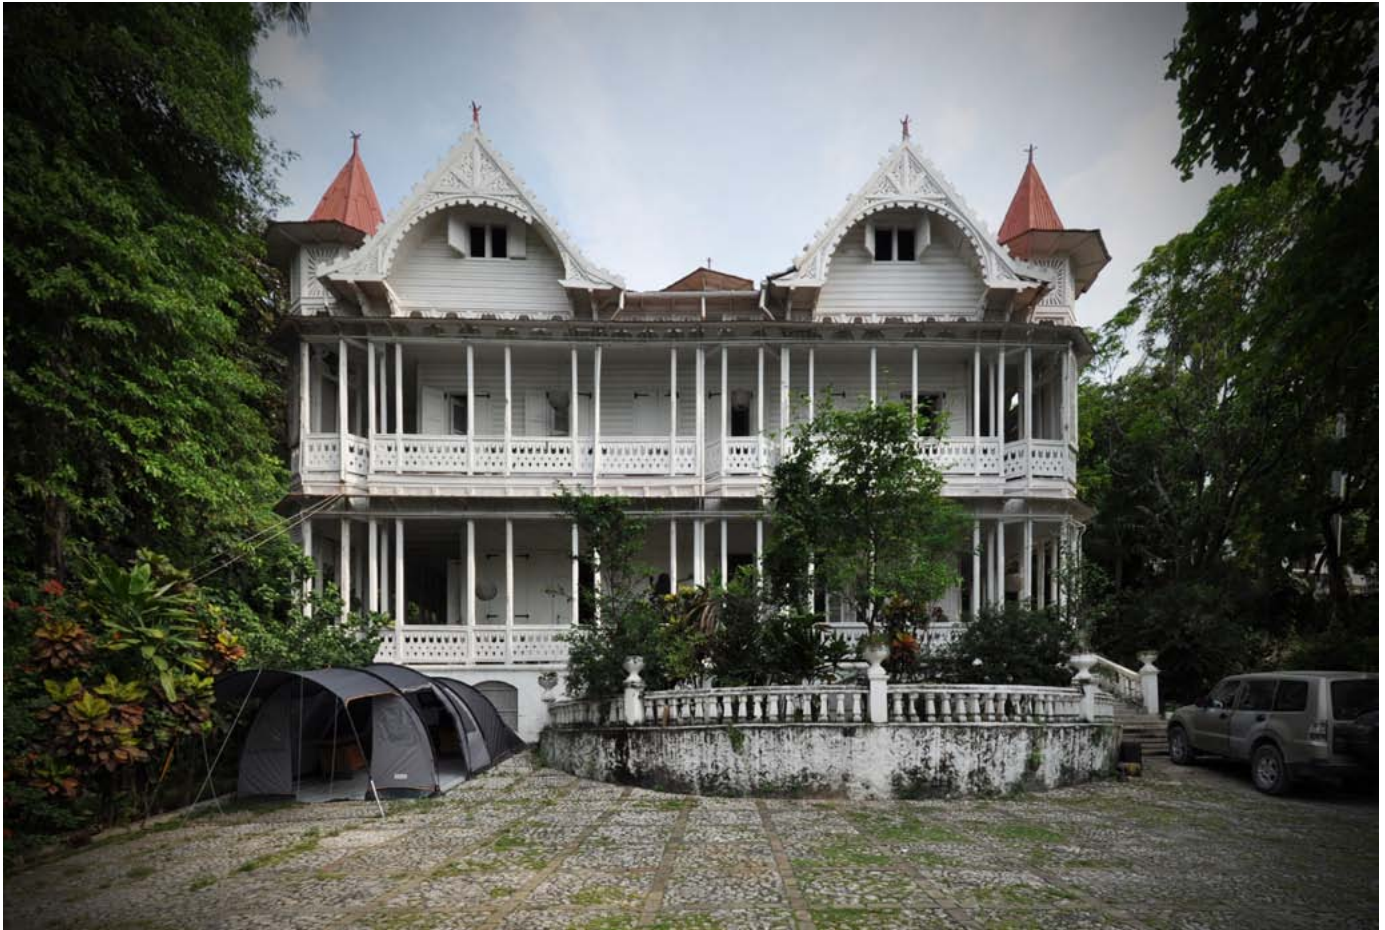
FIGURE 15 The 1912 Peabody House in Pacot. This *colombage* and timber frame house survived the earthquake almost undamaged.

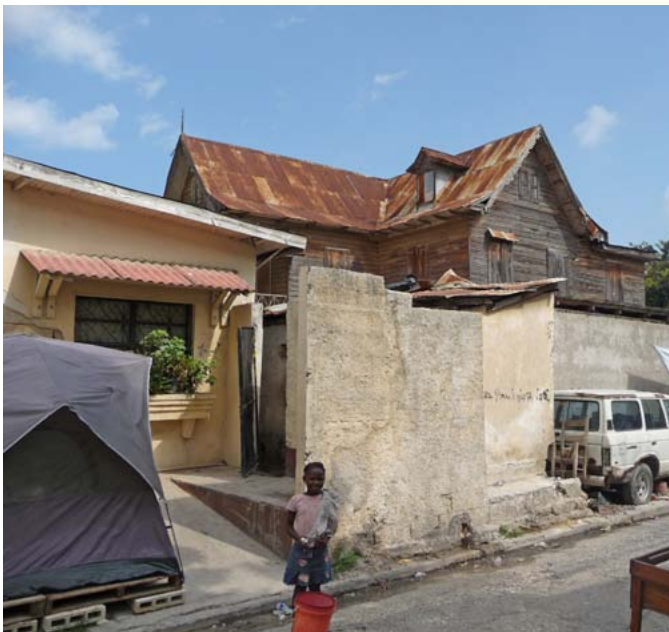
**FIGURE 21** A security wall and a modern streetside residence obscure most of a weathered Gingerbread house from public view.

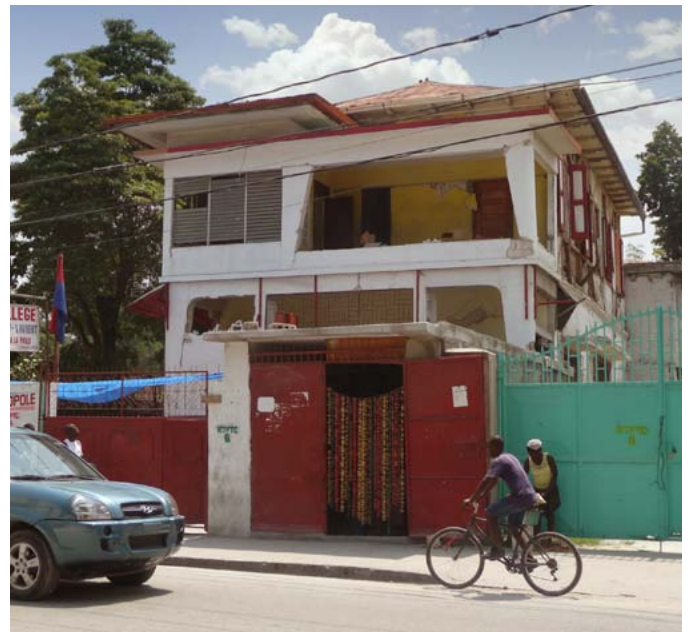
**FIGURE 22** A concrete addition at 4 Ave. Christophe all but conceals the original building's identity as a Gingerbread.

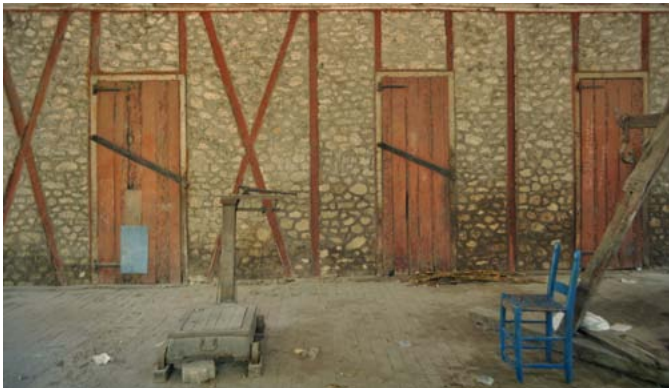
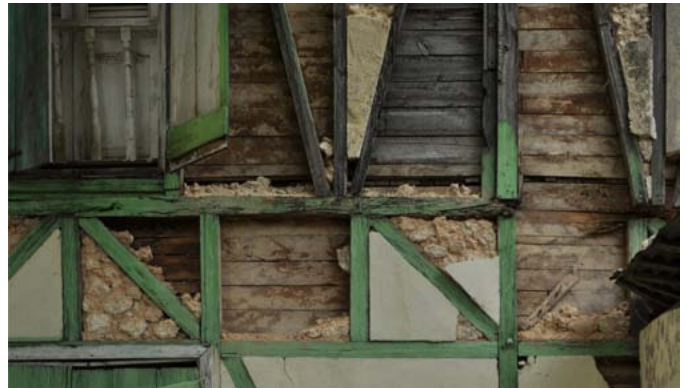
**FIGURE 25** *left* A barn in Léogâne is an example of rubble stone *colombage* made with stronger igneous rocks than those used in Port-au-Prince, and not stuccoed. *right* A heavily damaged *colombage* wall showing the rubble stone infill characteristic of Port-au-Prince. See also figure 86.

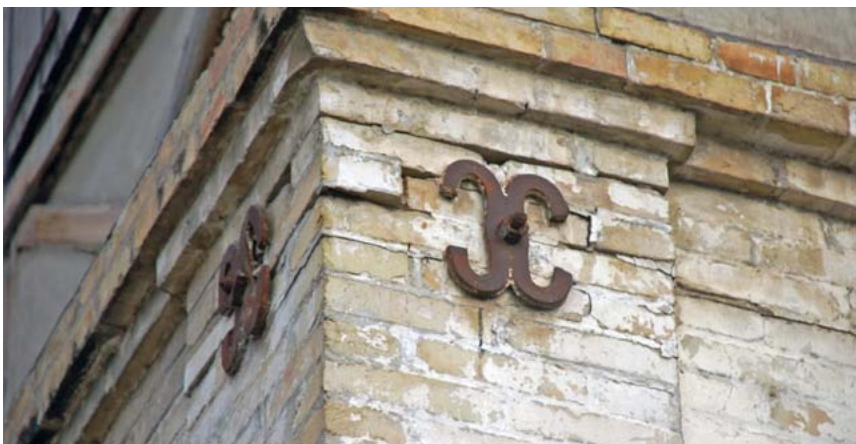
**FIGURE 26** View of decorative end plates at the corner of this brick structure indicate horizontal ties along each wall of the intersect.

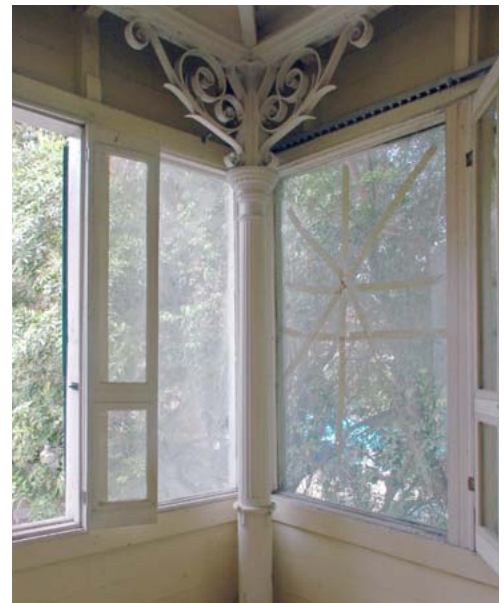
**FIGURE 27** An example of the ornate metalwork in the second-floor balconies of Le Manoir. This metalwork is obscured by wooden exterior walls.

the Gingerbread Houses (Figure 26). Le Manoir was the single Gingerbread house in Port-au-Prince observed that had extensive metal detailing on its balconies (Figure 27), though this ornament had been obscured by added enclosures.

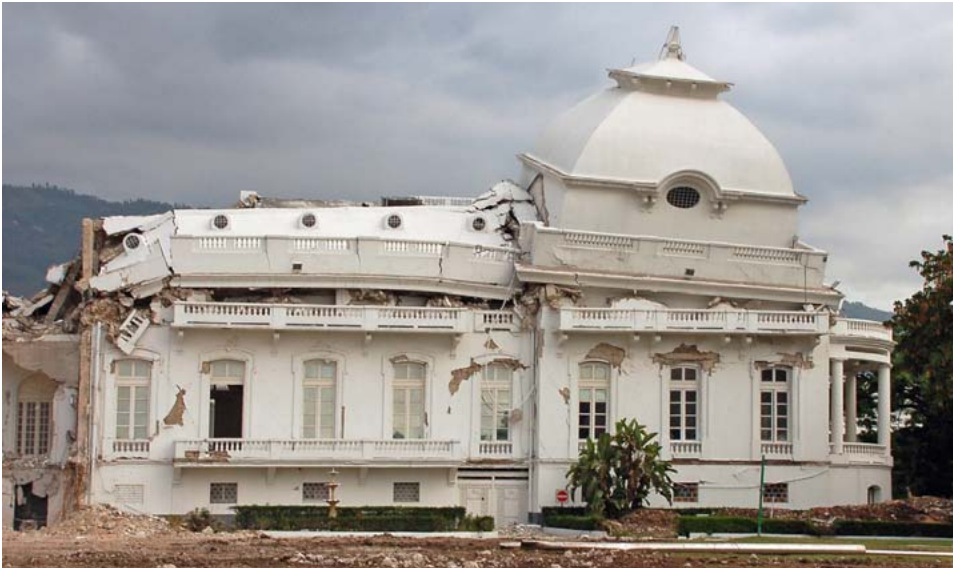
**FIGURE 28** The *Palais Nationale*, constructed in 1918, is an example of early reinforced concrete use in Haiti. These buildings typically suffered full or partial collapse.

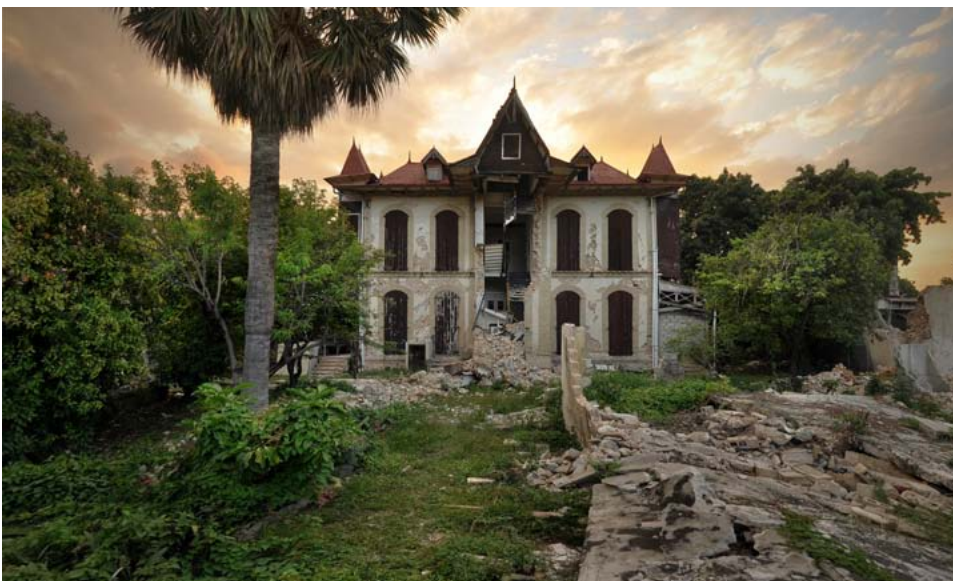
**FIGURE 29** The east (back) elevation of the Villa Castel Fleuri on Avenue Christophe, a grand brick and rubble stone masonry house. This house was occupied by the President of Haiti for a short period in its history. It has suffered extensive damage in the earthquake mainly to the projecting stair tower on the east side, and porches on the west. The plates that hold the iron ties that penetrate the building are visible on the façade. See also Figure 47 on page 29.

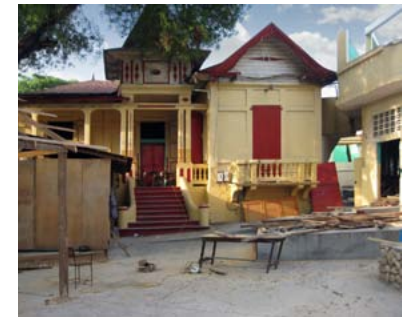
**FIGURE 30** Concrete frame/confined masonry Gingerbread. This is the only variant of this type seen. It was undamaged.

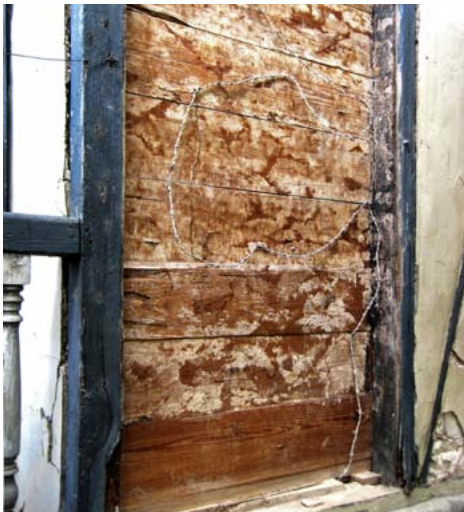
Where rubble stone infill was used, it was often reinforced with barbed wire laid haphazardly within the space to be filled, and nail fastened to the wood members on both sides of that space (Figures 40 and 41). In almost all cases, horizontal board sheathing was nailed to the inside of the frames, then the earthen mortar and stones were placed between the wall framing members. Nails were used at roughly six-inch intervals in most buildings to help hold the infill (Figure 43).

**FIGURE 40** In this *colombage* construction the stone infill has collapsed due to the earthquake revealing the barbed wire reinforcement. This is an example of a non-construction material being adapted for construction due to its apparent availability. The barbed wire was galvanized and is still in good condition.

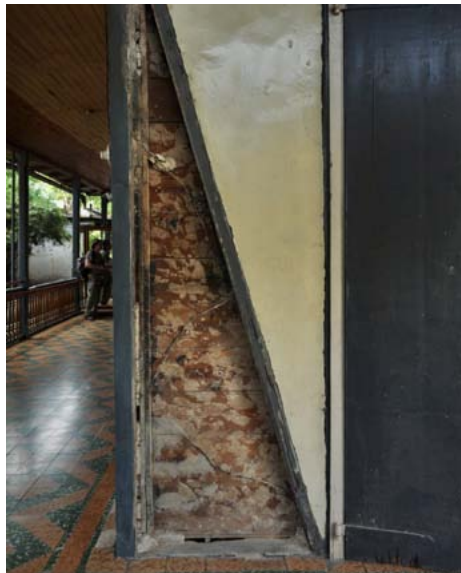
**FIGURE 41** House at 15 Rue M showing plastered rubble stone infill. On the left, one panel fell out in the earthquake, revealing that it was reinforced with barbed wire inserted into the bay in a zigzag layout.

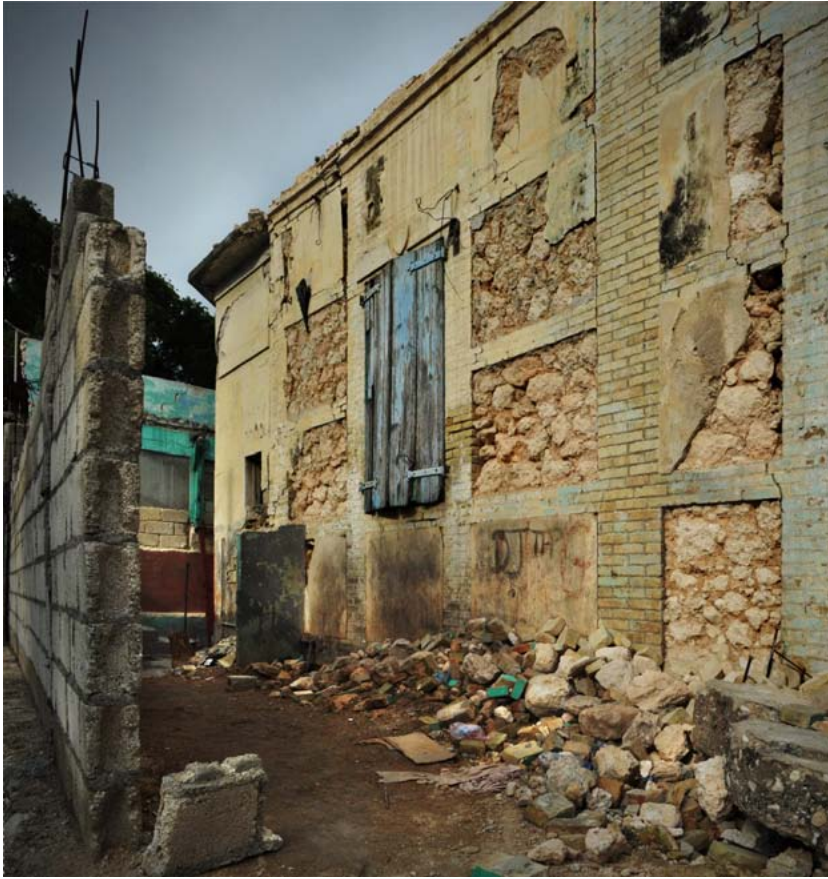
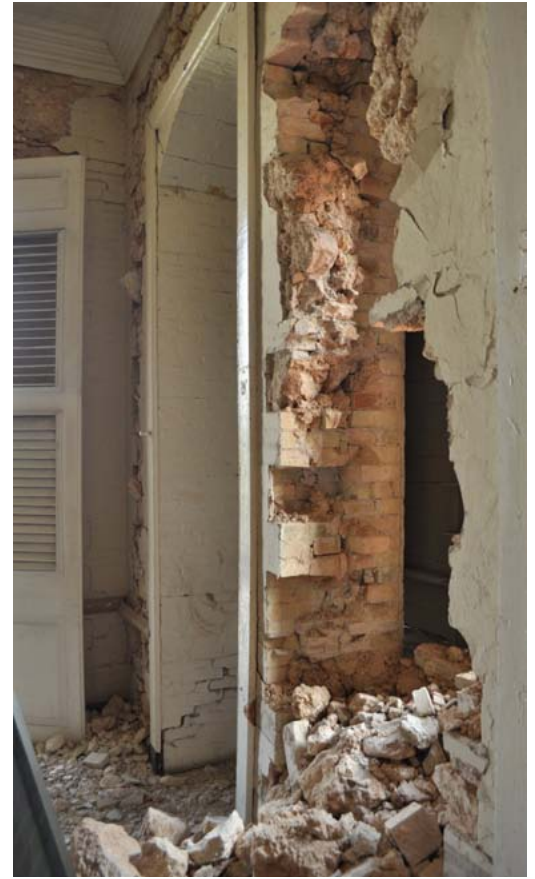
**FIGURE 45** *left* Wall of a commercial building on Avenue Lamartiniere showing the characteristic layout of the mixed brick with rubble stone masonry found in many Gingerbread houses in Port-au-Prince. The brick piers and horizontal brick courses are crucial in restraining the walls from complete collapse. *right* Interior view of wall of the Villa Castel Fleuri (see Figure 1) showing a rubble stone panel which has completely collapsed out from between the brick masonry piers. Notice the brick keys that had extended into the rubble stone panel.

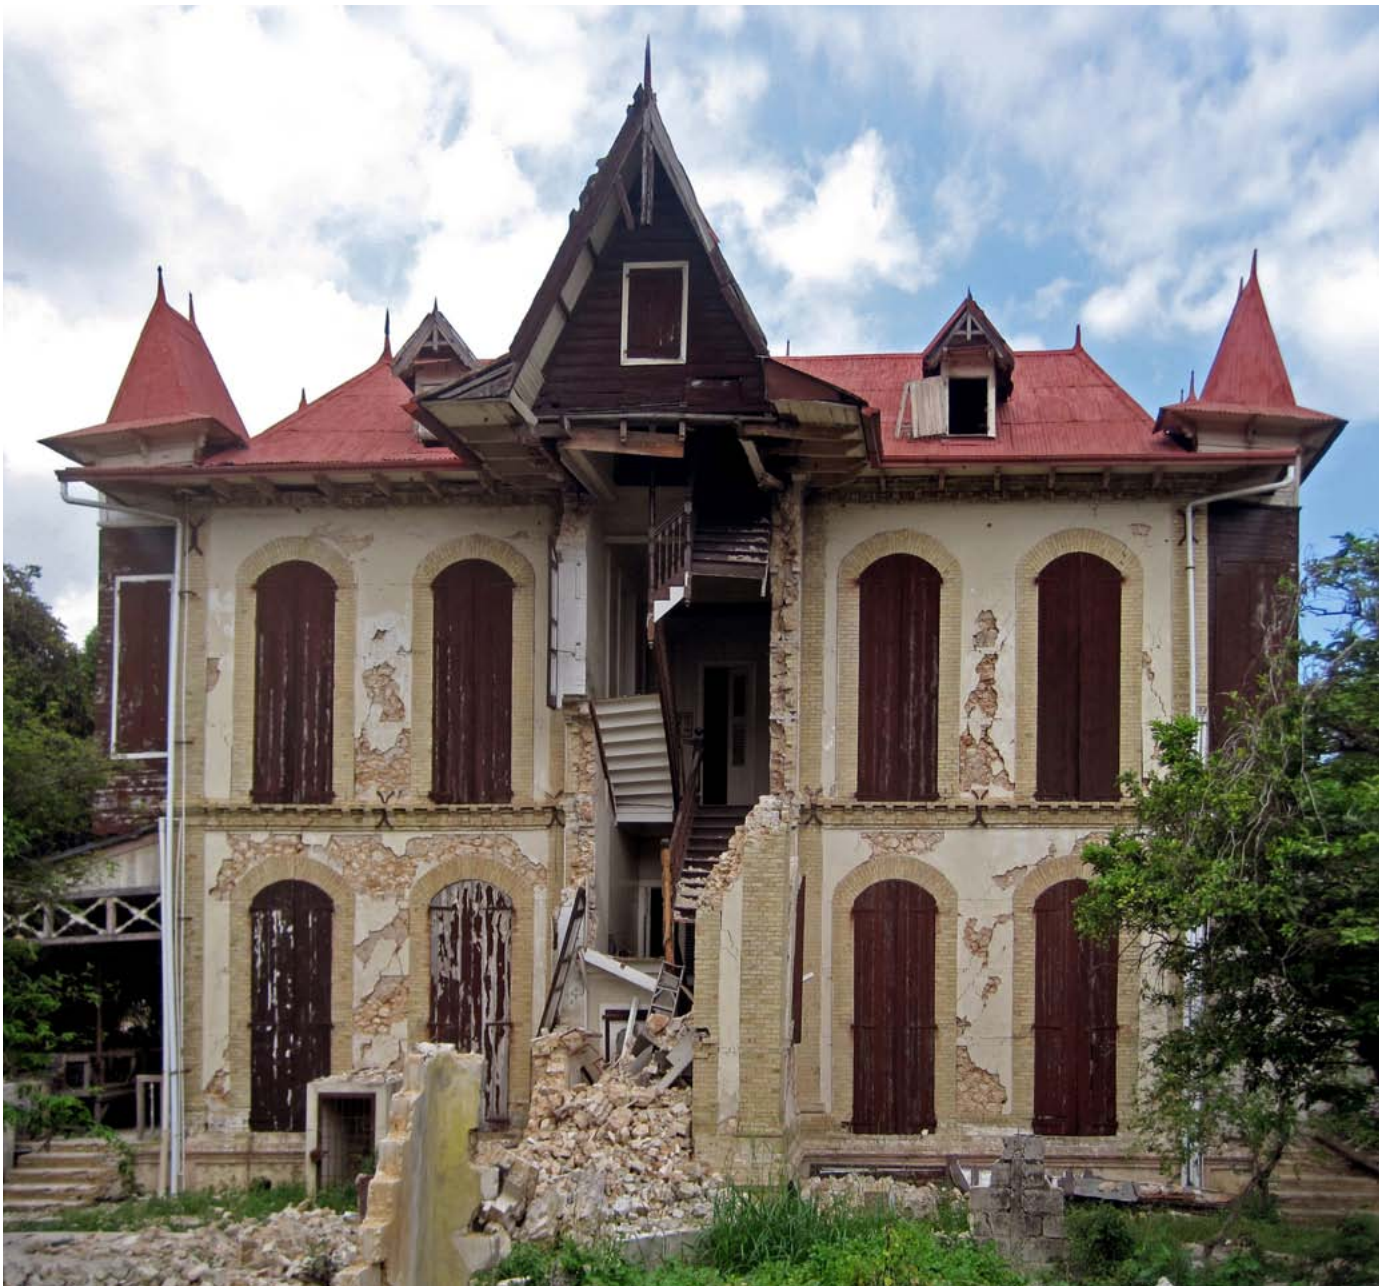
**FIGURE 47** View of the back elevation of Castel Fleuri. The use of brick masonry surrounding the windows, at the corners, and at floor lines in tandem with the stucco over the stone masonry elsewhere forms a pleasing composition. Note the X-shaped end plates of the iron rods visible on the façade, which were not installed at the building corners in this case. See also Figure 108.

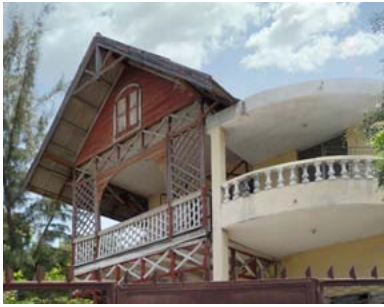
**FIGURE 48** Concrete additions are often awkward or compromise the Gingerbread buildings architecturally, like this one at 51 Avenue Christophe.

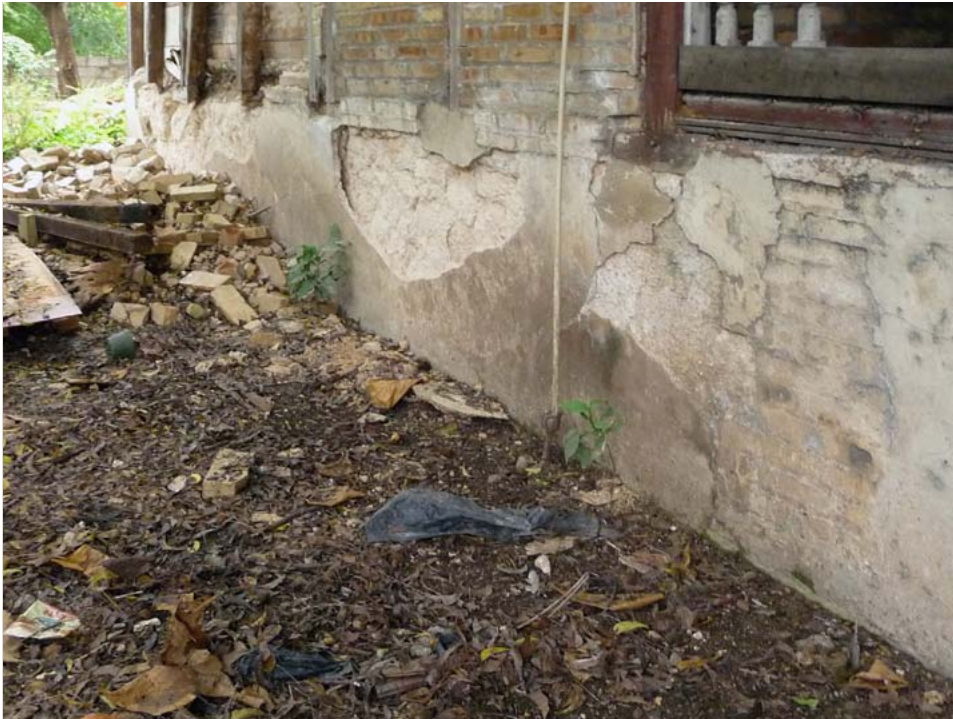
**FIGURE 50** Spalling of the exterior finish plaster of the house at 84 Lamartiniere reveals two contiguous sections of foundation stem wall. One of irregular limestone *left*, and one of brick *right*.

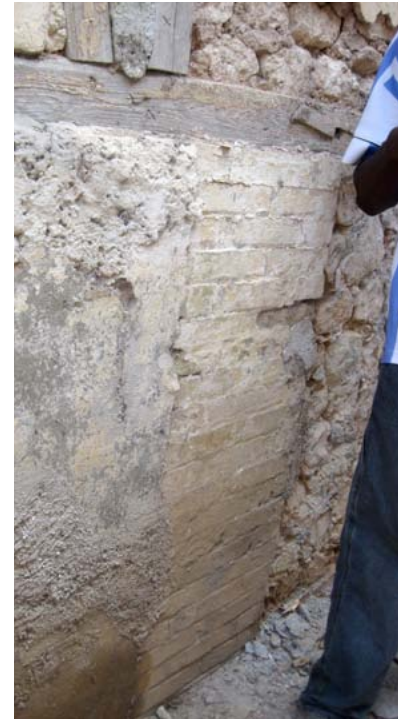
**FIGURE 51** The original brick masonry foundation pier can be seen and is infilled on either side with stuccoed stonework. Rising damp from the ground has caused extensive deterioration to the exposed stone masonry. This results from the migration of soluble salts to the surface where they expand on drying, causing the surface of the masonry to spall.

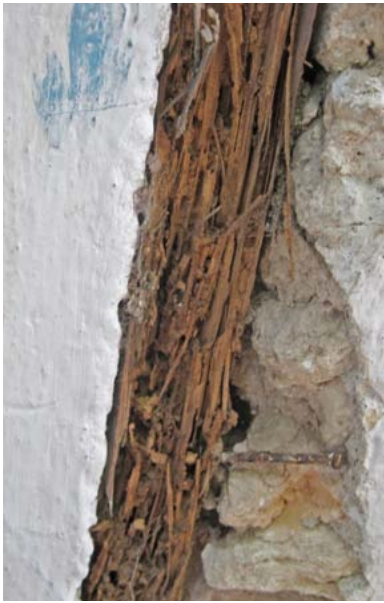
**FIGURE 62** Termites thrive in Port-au-Prince, and many of the wooden structures are severely damaged due to termite attack.

**Insect and fungal decay:** The principal condition that was seen in the structures composed of wood was the evidence of termites (Figure 62). Termite damage and, to a much lesser extent, wood rot were commonly observed in *colombage* and timber frame buildings and appeared to play a role in the extent of earthquake damage suffered, especially where decay affects the tie between floor and wall, or wall-to-wall at a corner (Figure 63). For example, severely rotted or termite-damaged bottom plates sometimes failed and allowed entire masonry panels to fall out under their own weight (Figure 64). Wood elements directly exposed to weather or to leaks in the building envelope were subject to rot (Figure 65). This is especially true at locations that invite rainwater collection (bottom plates, 'V'-shaped diagonal-to-vertical joints, bottoms of porch posts) and at locations in poor drying environments (areas of constant shade and/or limited air movement).

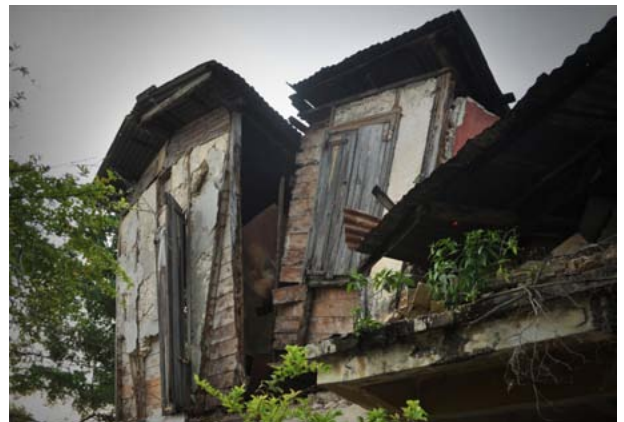
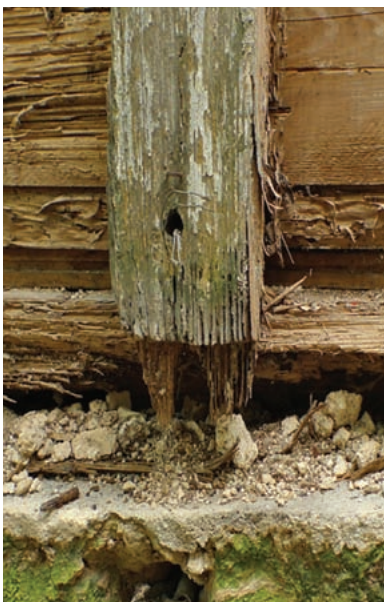
**FIGURE 63** Heavily rotted and termite-eaten house on Avenue Lamartiniere, which partially collapsed during the earthquake.

**FIGURE 64** The post tenon is still present; the sill has rotted away.

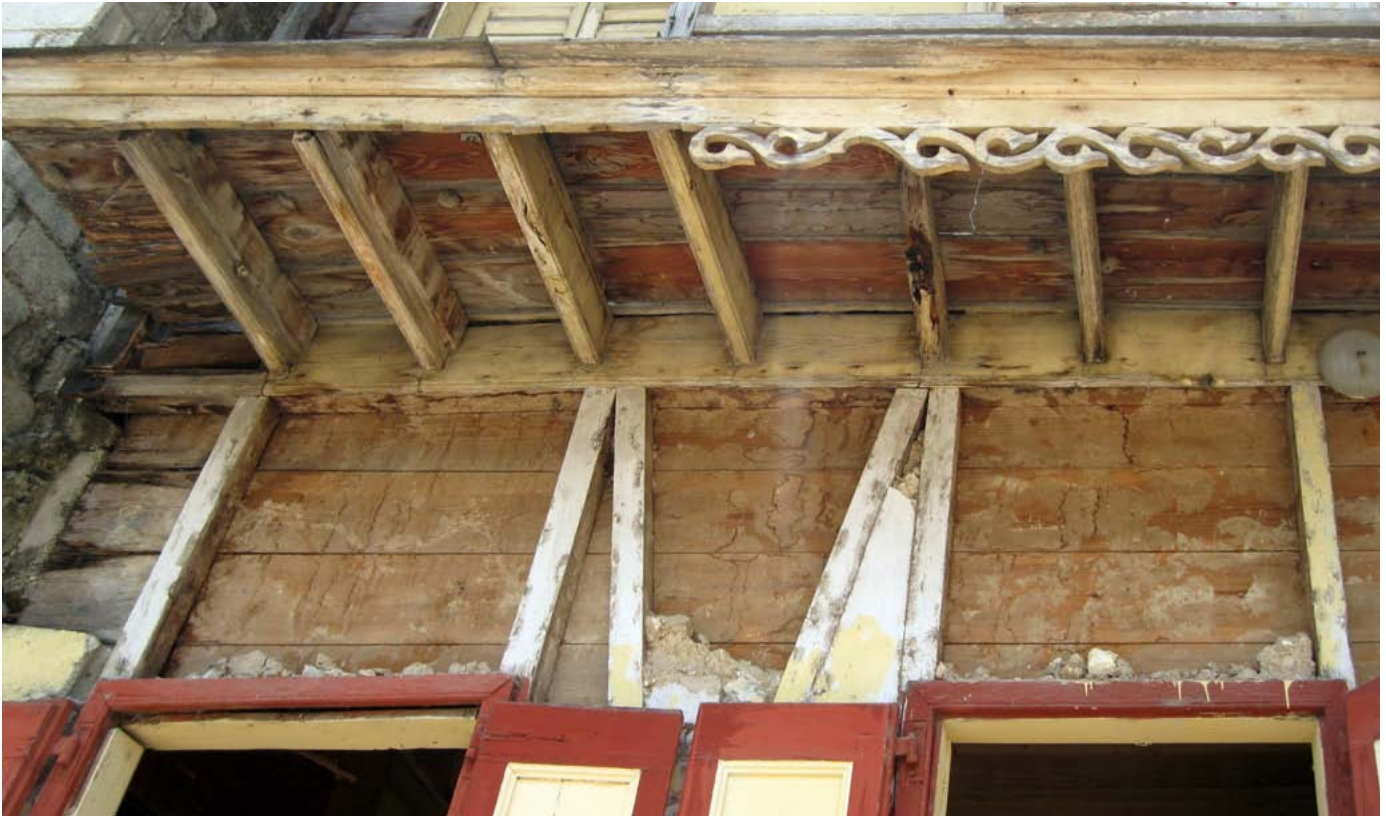
**FIGURE 66** Poor construction and detailing have made many balconies vulnerable to decay and structurally unsafe. For those balconies supported on the cantilever extension of the floor joists, decay can extend into the house, putting both the balcony and interior floor at risk.

Termites are extremely aggressive in Haiti and have left numerous balconies and floor boards in an unsafe state (Figure 66). Termite damage was most often seen in the following structural elements: timber framing in *colombage* walls and in wood frame walls, floor planking (first and second floor), floor joists, and porch posts (Figures 67 and 68). Wood members within *colombage* construction, and within frame construction with pocket walls, allow termites to propagate undetected to the upper floors through timbers that are set in masonry or which are clad on both the inside and outside.

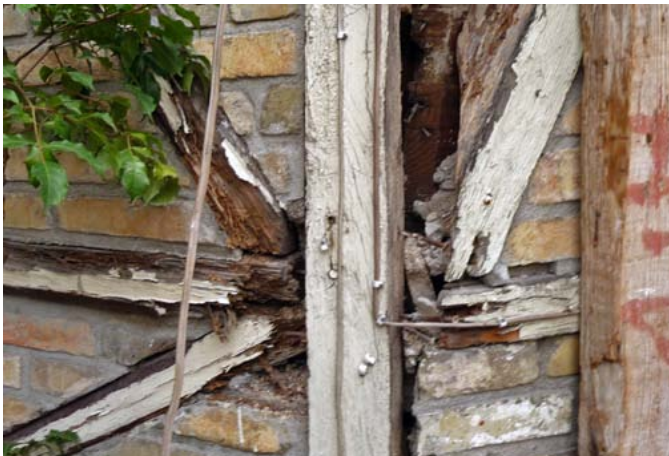
**FIGURE 67** Rot of timber frame members at corner of *colombage* house at 32 Lamartiniere.

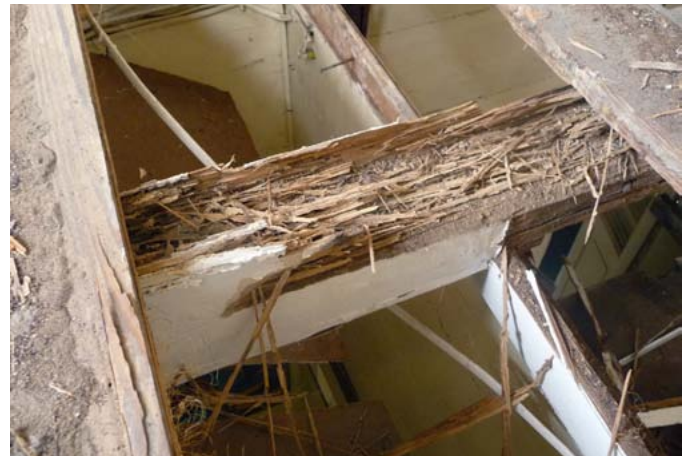
**FIGURE 68** Termite damage in second story floor joists.

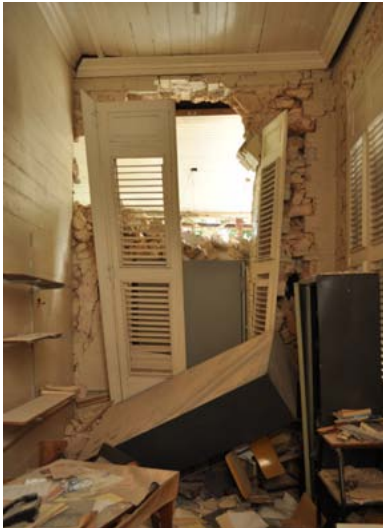
**FIGURE 69** Hole in the masonry wall of Castel Fleuri caused by a concrete vault constructed in the exterior side and adjacent to this wall.

***Concrete Additions:*** The first was the widespread use of reinforced concrete and/or concrete block to build additions to the Gingerbread Houses. These additions become a structural concern during seismic loading (Figure 69). Houses constructed of braced timber frame or *colombage* have a relative deformability compared to concrete, so during an earthquake the original structure and concrete addition act as separate structures and strike each other. This typically led to damage of the Gingerbread house where it interfaced the addition, and also led in some cases to collapse of the addition (Figure 70).

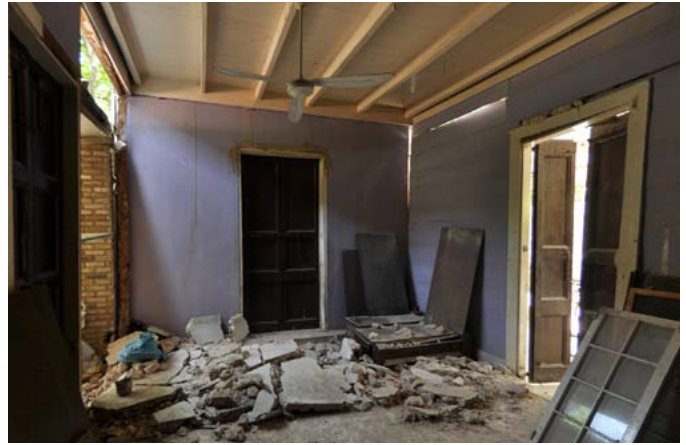
**FIGURE 74** Improper repair of stone infill of *colomage* using concrete. These repairs constitute a fill that is much stiffer and more cohesive than the fill it replaced.

*Use of cement and concrete to repair/replace rubble stone infill:* In many places where rubble stone infill panels on *colomage* walls were previously damaged or required repair, it was either consolidated with Portland cement mortar or the fill was removed altogether and reconstructed with concrete infill or concrete block with cement mortar (Figure 73). These repairs constitute a fill that is much stiffer and more cohesive than fills using traditional materials, which results in detrimental performance of the system in an earthquake (Figure 74). In some instances houses that had been repointed with cement showed wear in the cement pointing possibly related to its incompatibility with the underlying lime/sand mortar.

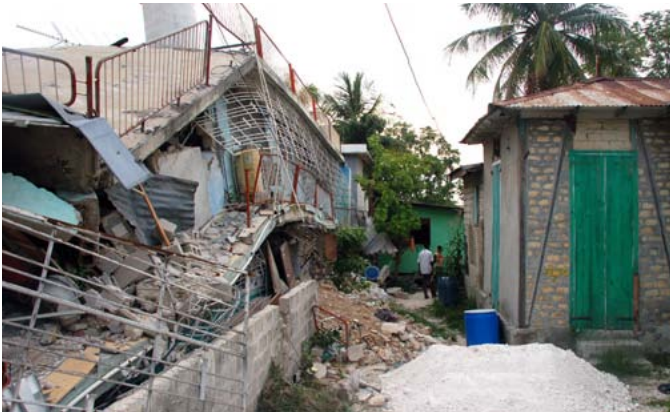
The earthquake performance of the buildings of Port-au-Prince in general can be ranked from best to worst in the following manner: wood structures, masonry structures, and concrete structures. The observations of the mission revealed that this was true of the Gingerbread Houses as well (Figures 75 and 76). Both the braced timber frame and the *colombage*, with their more flexible, energy dissipating systems, tended to perform best.

FIGURE 75 A pancaked concrete-frame building on the left and a *colombage* house on the right showing the comparative performance of these building types in a seismic event.

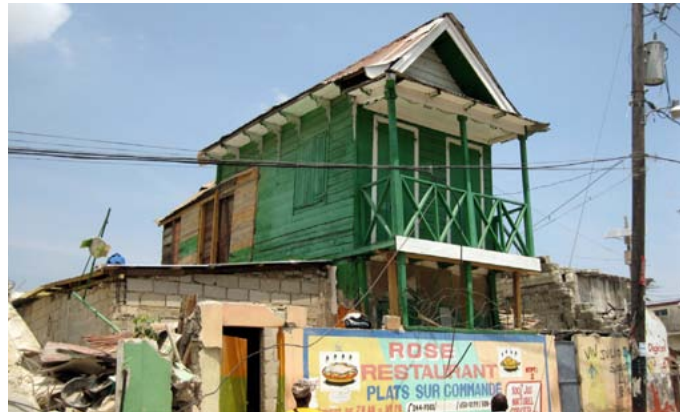
FIGURE 76 This two-story Gingerbread house survived amid the collapse of numerous concrete buildings. The owners do not want to tear it down. However, it needs temporary stabilization and long-term repairs.

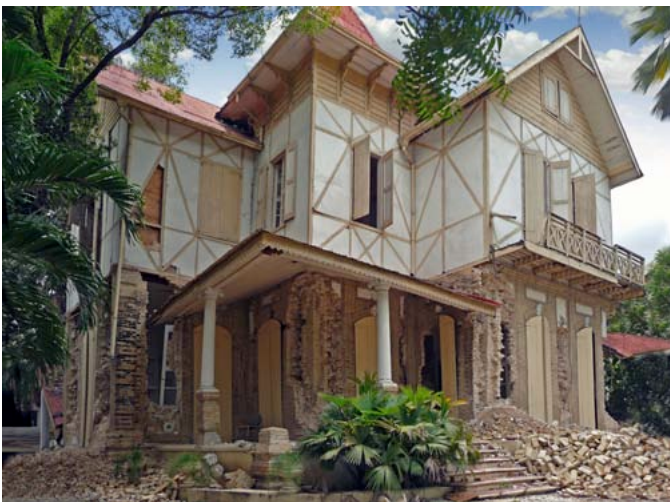
FIGURE 77 The Dufort House, a hybrid structure, exhibited substantial damage to the masonry first-story walls, including its limestone panels and brick piers, but significantly less damage to its *colombage* and wood frame second-story walls. Notwithstanding the increased seismic loads on the first-floor walls, the difference in performance of the systems is indicative of a tendency seen throughout the surveyed buildings.

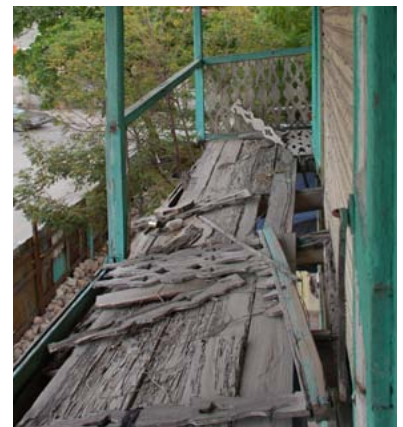
- Collapsed porch structures that had previously been severely compromised by unchecked termite damage (Figure 78).
- crushed sill plates causing the entire structure above to settle lower on its foundations making operation of doors difficult or impossible (Figure 79).
- Collapsed exterior walls especially when they are not load-bearing and therefore not engaged by compression into the structure as a whole.

FIGURE 78 Second-floor porch structure made unsafe by termite damage.

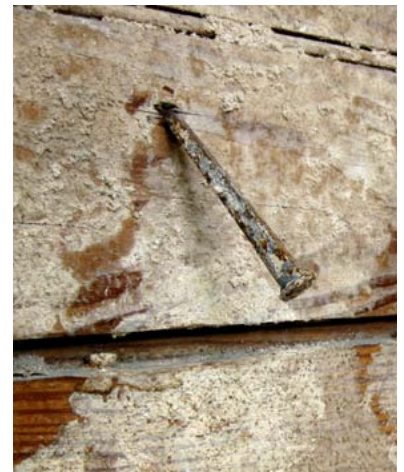
- The cut nails often have not rusted excessively (Figure 81). This could be attributed to the elevated terrain of the Gingerbreads (away from the direct effects of salt), to the prevailing winds being from the east/southeast, and also to the relatively dry climate of the west end of Hispaniola. However, the oxides still tend to cause the nail holes in the wood to widen, weakening the nailed connection. Iron oxide (rust) from bare steel nails can also react with the cellulose in wood, causing the hole to grow in size over time, reducing the friction holding strength of the nail.

**FIGURE 81** Cut nails of iron or steel are common in the Gingerbread houses. Many of the original cut nails show surprisingly little corrosion.

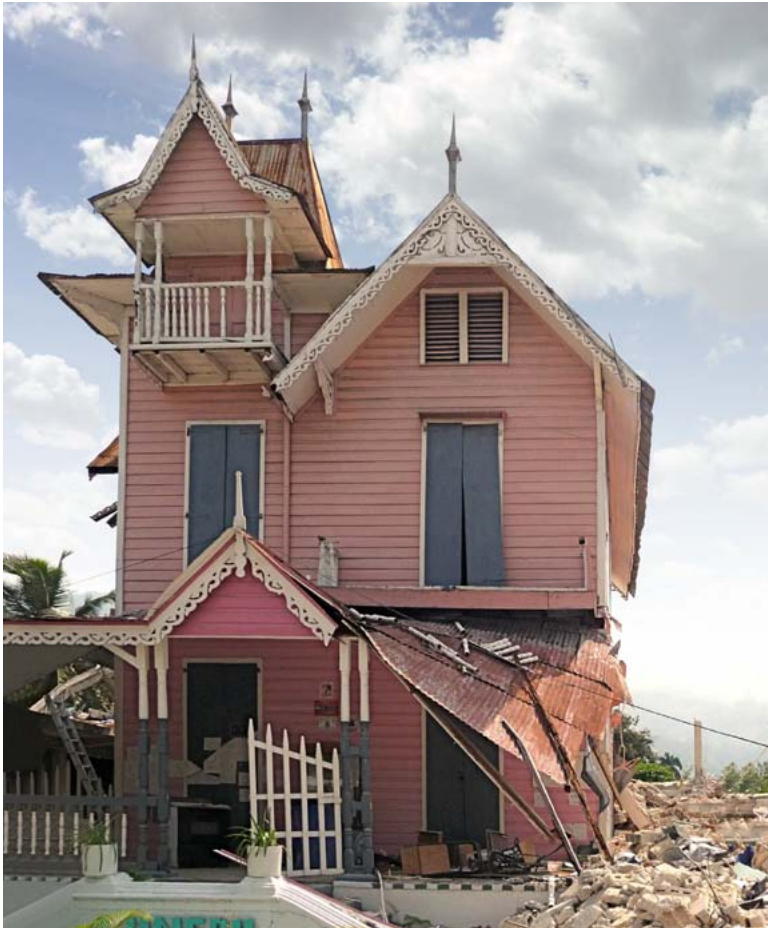
**FIGURE 82** Wood frame Gingerbread at the Episcopal University at 14 Rue Légitime next to the site of a collapsed concrete building.

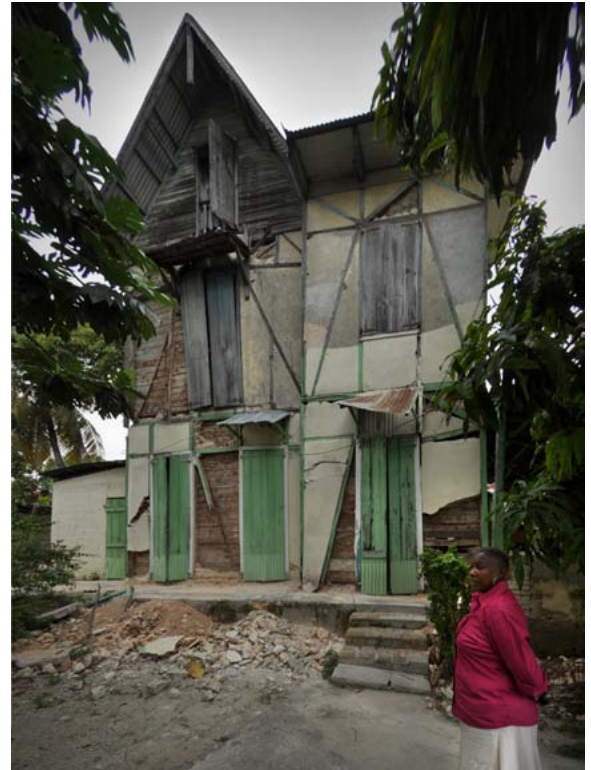
**FIGURE 83** Marie Céleste Florence Jacob, seen here, continues to live in this century-old wood frame house at 14 Rue Marcelin. This house was extensively consumed by termites prior to the earthquake which damaged it further. Even in this badly compromised state, this structure remained standing after the earthquake only a few short blocks away from the National Palace and many other concrete frame structures which collapsed.

Some of the buildings inspected were found to have such extensive termite damage that they could reasonably be considered to be beyond repair. Even where this was the case (Figure 83), collapse of these timber frame structures in the earthquake was extremely rare. However, localized damage caused by the earthquake in many of the houses has served to reveal how extensively they had been consumed by termites (Figure 84).

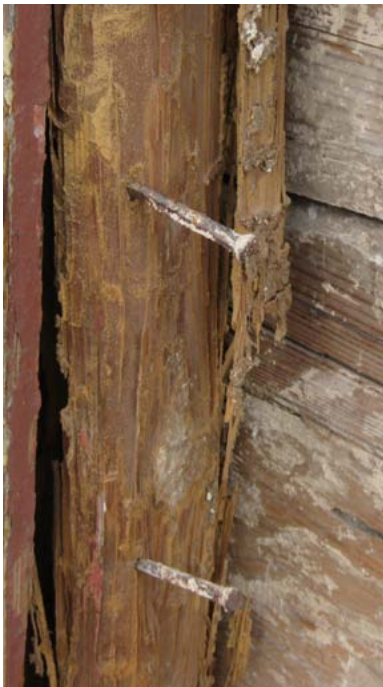
**FIGURE 84** Despite extensive termite damage, the remainder of this post is hard and dense, still holding the nail firmly.

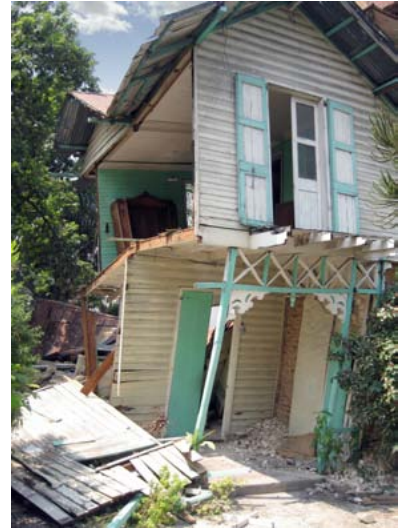
**Colombage:** *Colombage* construction, which incorporates the braced frame, behaved in a similar fashion to braced frame construction and exhibited similar conditions and pathologies as noted above (Figure 85). With *colombage*, however, the masonry infill panels (of either fired brick or rubble stone) in many cases became loosened or completely fell outward (Figures 86 and 87). This should not be considered a failure of the *colombage* technique as the masonry behaved as an energy absorber and protected the building frame as a whole by absorbing the lateral movements in a sacrificial manner.

**FIGURE 85** Despite severe damage, this timber frame building did not fully collapse. Note that the wall that fell away is the one on the side parallel to the joists, thus not having substantial tie to the floor.

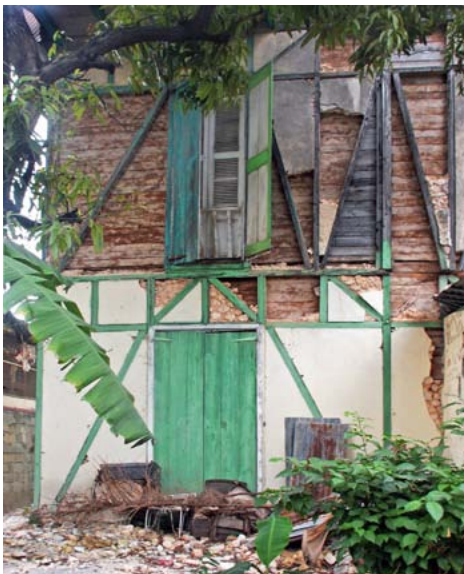
**FIGURE 86** Much of the *colombage* stonework fell out of the walls of the second story during the earthquake.

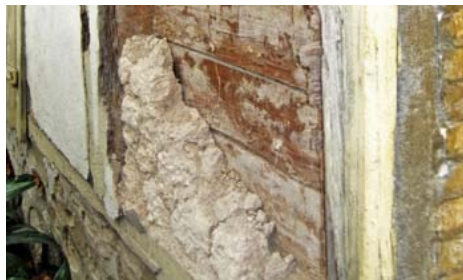
**FIGURE 87** Close-up view of the failed *colombage* stonework. This infill, if laid up in clay, crumbles away and does not compromise the integrity of the wood braced frame.

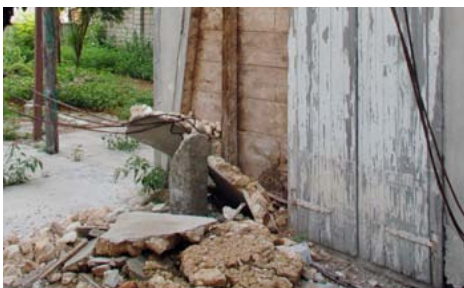
In places where masonry infill had been replaced with cement mortars or concrete block the infill would fall out as cohesive units which caused damage to roof structures below as they fell (Figure 88). They also posed a falling hazard to persons below. Generally, soft fill like rubble stone in mud mortar performed better than hard fill (bricks in cement mortar) by absorbing energy. Hard fill usually failed en masse, rather than crumbling (Figure 89).

**FIGURE 88** Stone infill that had been relaid with cement mortars would fall out of the wood frame in huge pieces during the earthquake causing damage also causing a safety hazard.

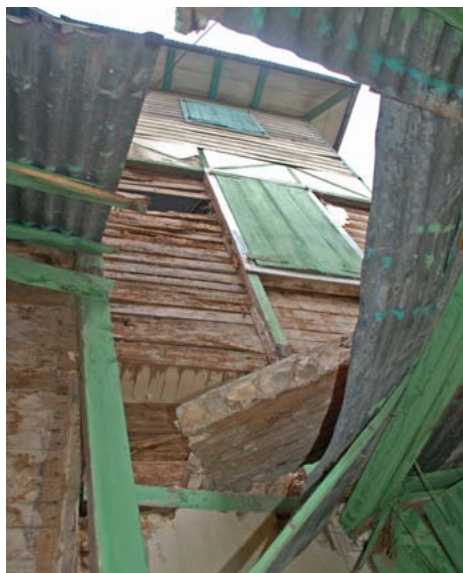
**FIGURE 89** Brick infill that had been relaid with cement mortar fell out in huge pieces during the earthquake, causing damage to construction below.

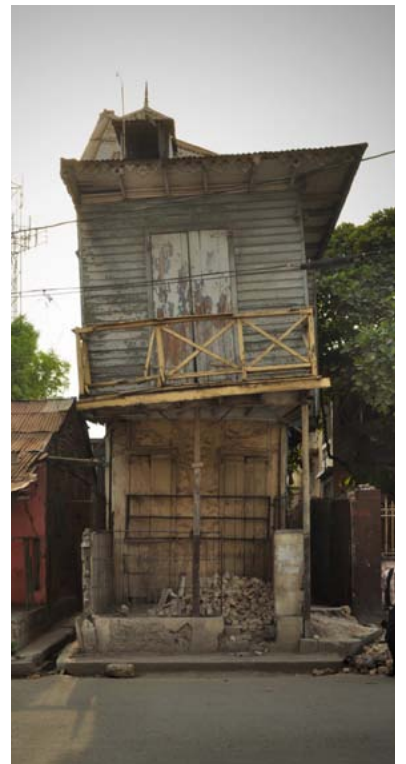
**FIGURE 90** A wood clad and *colombage* structure of the most basic type on Rue Geffard near the National Palace. This structure appears to have been designed to be expanded to double its width, but never was. As a result, it was subject to the earthquake with a width at the base of less than 12 feet (3.6 meters). Also, at the time of the earthquake, it was in extremely poor repair. In spite of all of this, the earthquake did not cause it to collapse.
