# **Preserving Haiti's Gingerbread Houses**

## **2010 Earthquake Mission Report**

**A World Monuments Fund / ICOMOS Project funded in part by Prince Claus Fund and FOKAL**

**2010 Earthquake Mission Report  
December 2010**

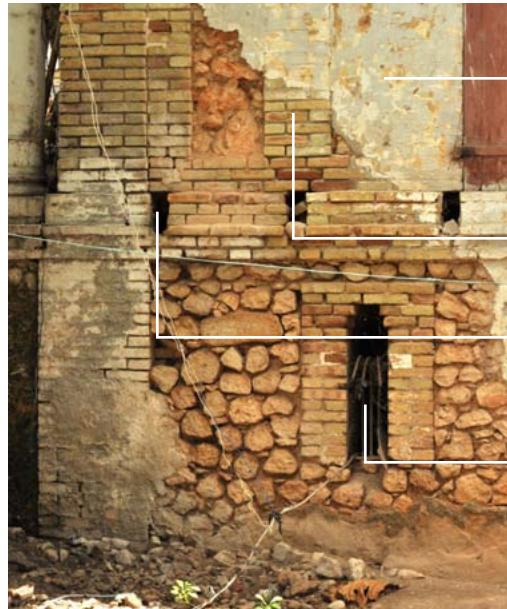
**FIGURE 91** Examining masonry structures

The finished plastered wall surface hides the substrate material from view. Years of rain and lack of maintenance have caused erosion on the building revealing the structure

Pockets for the floor beams; in many instances the ends of the beams showed extreme rot.

**FIGURE 92** Basal erosion of the wall surface and foundation.

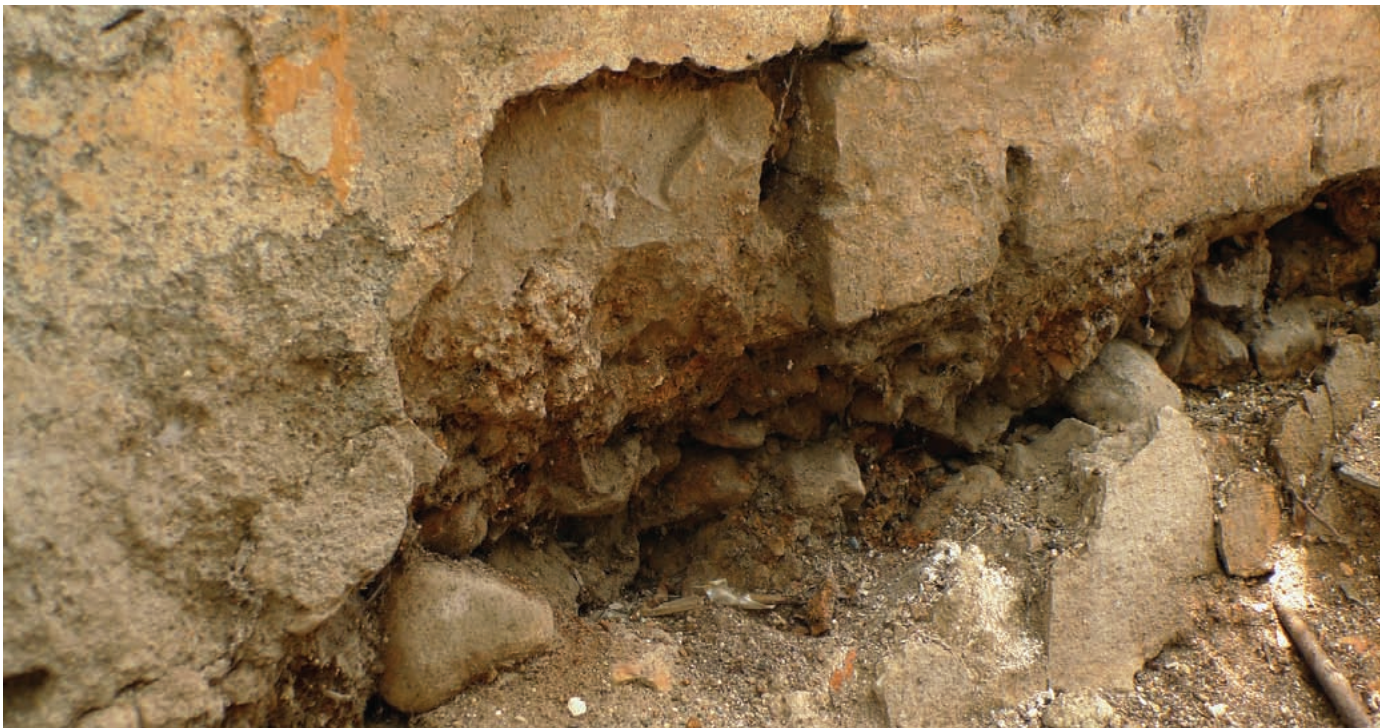
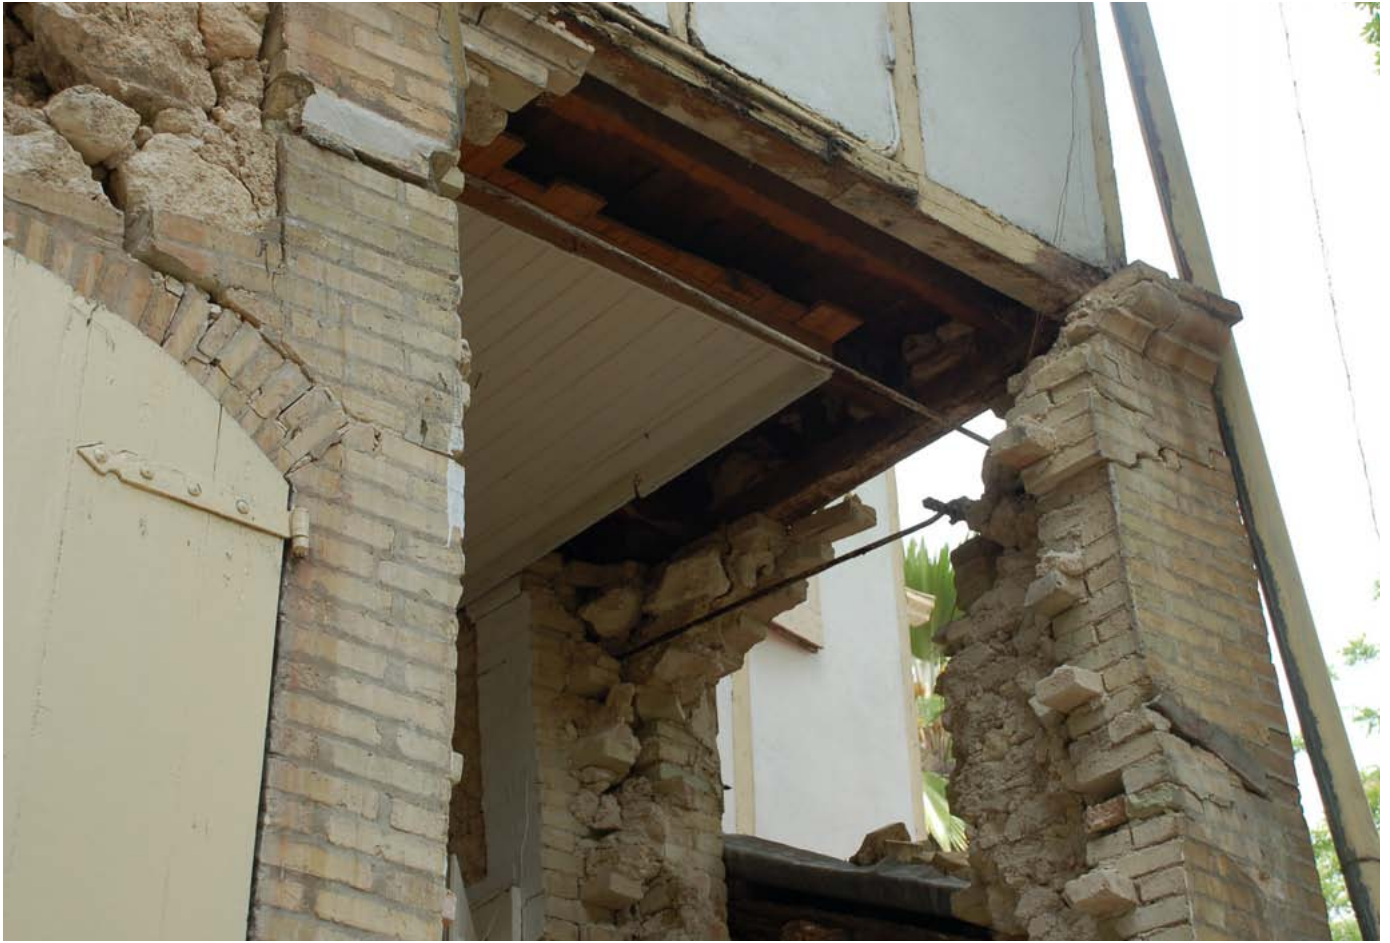
**Masonry Bearing Walls:** The masonry bearing-wall buildings as a class performed better than the concrete and block buildings in the same areas, but not as well as the *colombage* and timber frame construction systems (with the notable exception of the Oloffson Hotel described on page 48). Substantial seismic damage to the masonry walls was common, while many showed signs of pre-earthquake deterioration as well (Figures 91 and 92). Masonry walls—being inflexible—immediately cracked, sometimes buckled, and occasionally collapsed altogether. In numerous houses with a first story of masonry and upper levels of wood framing, the first floor was damaged almost to the point of collapse while the upper levels remained intact with only minor damage (Figure 93).

**FIGURE 93** The masonry bearing walls of the ground floor of the Dufort House on Rue du Travail Deuxième are significantly damaged and partially collapsed, while the wood framed second floor remained almost undamaged. The horizontal iron ties, visible here and in Figure 95, were effective in preventing the collapse of this corner pier despite extensive masonry damage. Without these ties, it is likely that the entire building would have collapsed.

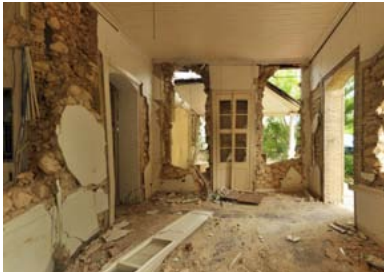
**FIGURE 94** Ground floor interior of the Albert Dufort House on Rue du Travail Deuxième showing complete disruption of the rubble panels in its construction. The interior wall on the left, which did not have brick piers walls because of the lack of window and door openings, collapsed completely.

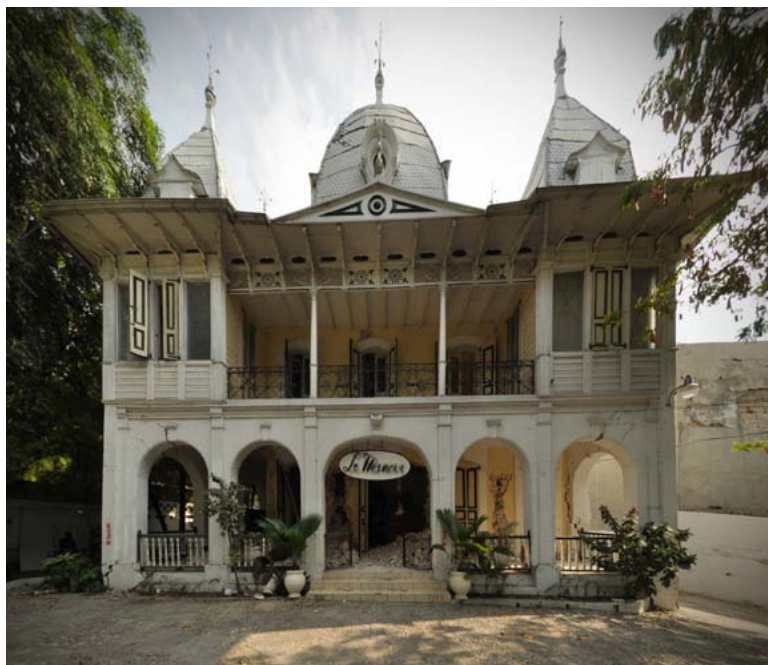
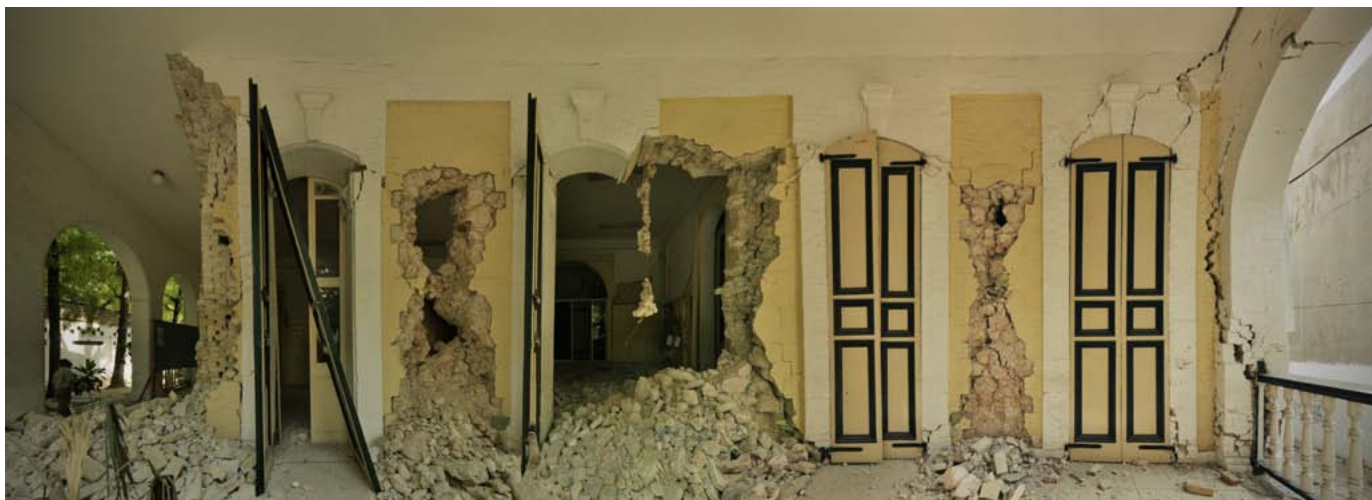
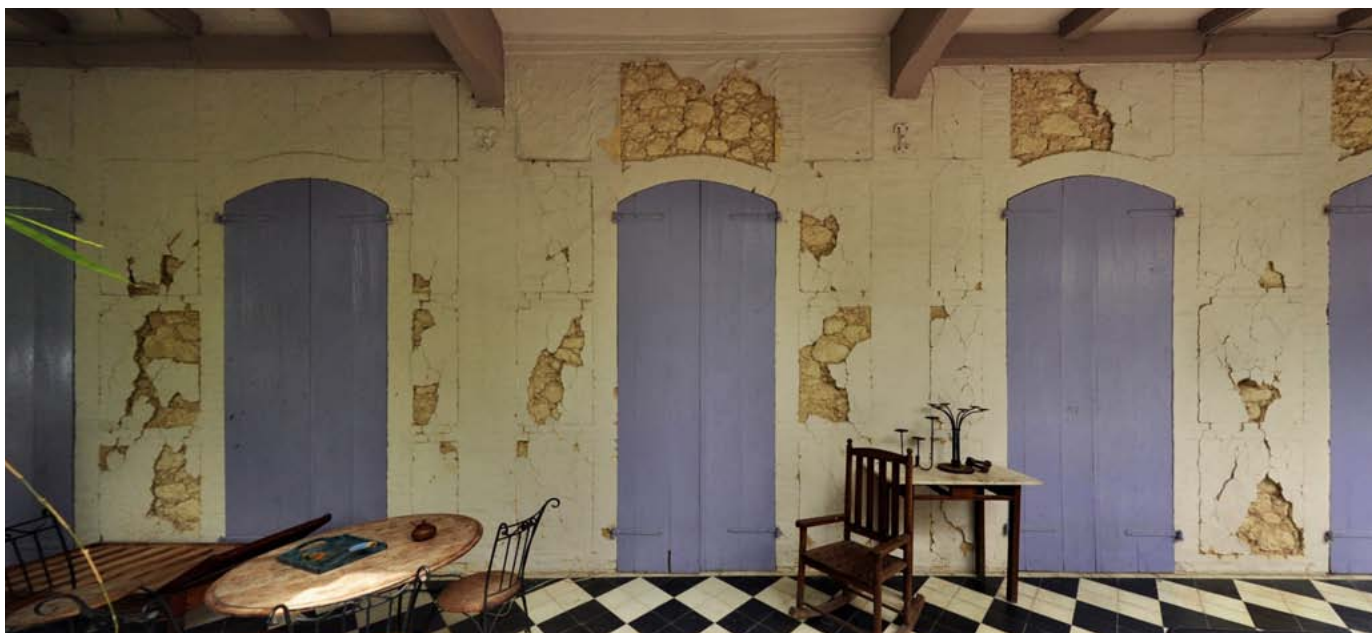
In a number of instances where the rubble stone panels were fully degraded or collapsed, the buildings (such as the Dufort House and Le Manoir) were saved from total collapse by the brick piers that surrounded and confined the rubble stone (see Figures 95 and 96). Unfortunately, this brickwork was not bonded one wythe to the

**FIGURE 96** *top* Exterior view of Le Manoir on Avenue John Brown. *middle* interior view of Le Manoir showing a fully disrupted ground-floor wall where the rubble panels have collapsed, but the buildings remained standing on the brick piers. (view is a mosaic of several photos connected together). *bottom* House at 65 Avenue N showing infill panels manifesting the onset of damage, but little displacement during the earthquake.

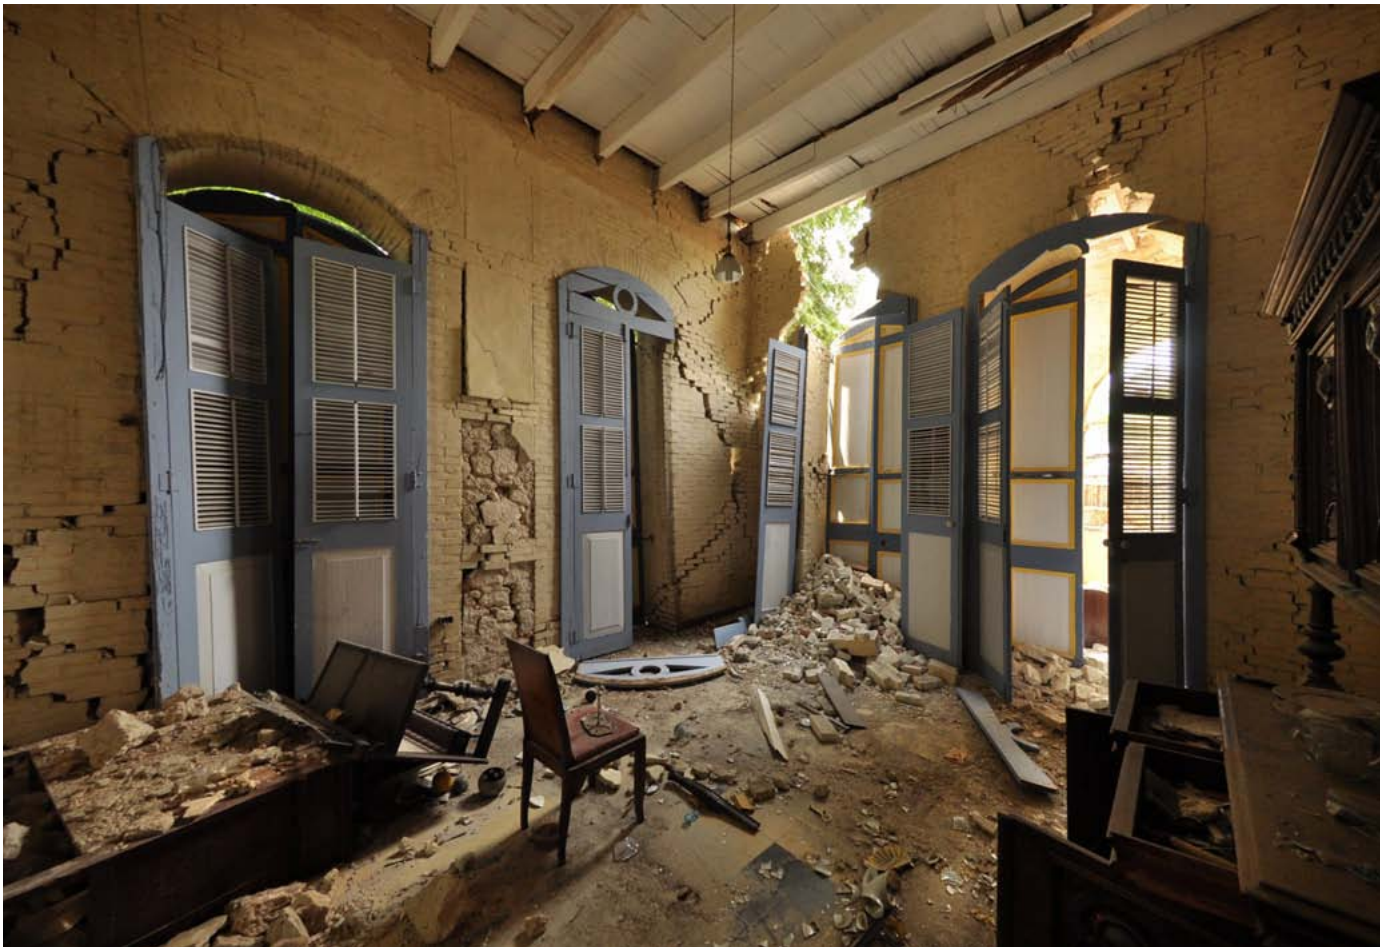
**FIGURE 97** Two-story masonry house at 46 Avenue Christophe. During the earthquake, part of the second floor collapsed, followed by the subsequent collapse of the rest of the second floor. These photos show the ground floor, which remained standing, but with major rupture to the masonry walls, particularly at the corners. *right* The iron rod that had held the building together at the floor level is visible where it had failed because of corrosion. This image also reveals how the inner wythe of brickwork was not bonded to the outer layers of rubble stone. To form the inner corner of the room there is a layer of brick, whereas in the middle of the room, the rubble stone panel goes through the entire thickness of the wall.

next, so the piers have been shifted in those locations where rubble has been heavily disrupted or collapsed (see Figure 97). However, because of the horizontal bedding of the masonry, they remained stable. Walls that were disrupted to this extent will need to be rebuilt, and when rebuilt, a more stable masonry can be substituted for the rubble masonry. Since the rubble was always in recessed panels covered with plaster, substitution with better material should not result in a visual change.

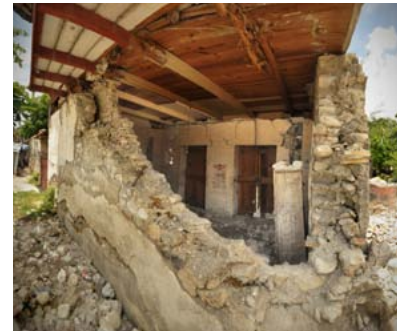
**FIGURE 98** House in Léogâne where the solid rubble stone wall on one side partially collapsed, while the side with the two door openings with brick piers and rubble panels seen through the collapse remained standing with much less damage.

A comparative observation in Léogâne was of the performance of the walls with brick piers compared with solid walls of rubble masonry. One house there had a solid rubble stone wall on its south side without any penetrations by windows or doors, and on the north side, the wall had two tall door openings, which accounted for approximately 40 percent of the width of the wall, leaving three rather narrow piers that made up the remainder of the wall (Figure 98). The standard expectation of earthquake resistance would be that the south wall would be a more competent shear wall, and thus protect the structure from collapse better than the north wall. However, during the earthquake it was the south wall that failed, almost causing the collapse of the wood-framed second story, while the north wall showed the onset of damage to the rubble stone panels between the brick piers on the corners and surrounding the doors. This serves to reinforce the observations in the Port-au-Prince Gingerbreads, which have window and door penetrations on all sides: that the brick piers were crucial to protection against collapse, while the rubble stone was particularly vulnerable to collapse from earthquake vibrations. Moreover, this vulnerability was worse where the panel size was larger both in length and thickness.<sup>10</sup> This is also

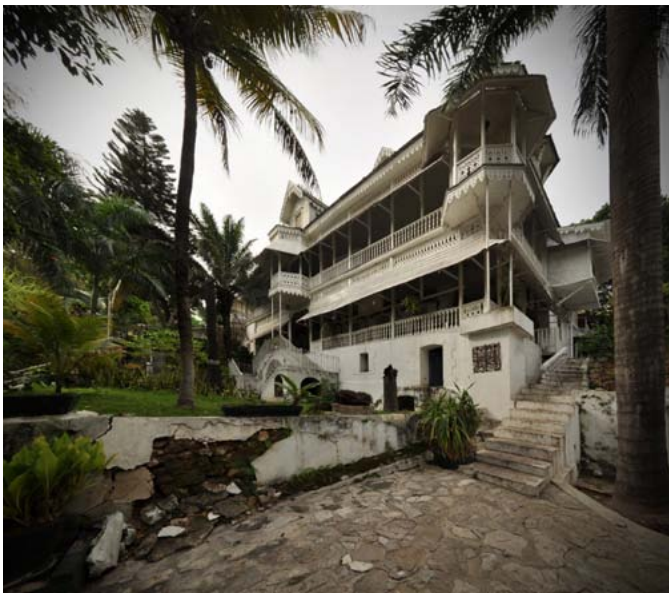
**FIGURE 99** The Hotel Oloffson.

This building is constructed of brick masonry without the rubble stone panels. The masonry walls are hidden in the front by the wide wooden Gingerbread-clad porches, but are visible below.

cause it was constructed of load bearing masonry but without rubble stone panels. The walls appear to have been laid up in brick all the way through. The walls were of similar thickness (about 20 inches or 50 centimeters) as in other buildings, and the building is two stories on a high undercroft, so the loads were by comparison significantly higher than in most other houses, but the damage to this building was almost non-existent. Behind the Oloffson was a multi-story concrete hotel building that pancake collapsed completely, so there is evidence of considerable shaking at the site. The survival of the Oloffson Hotel in an almost undamaged state provides a good data point; it corroborates the observation that the greater damage to many of the other masonry buildings was largely a result of the unique weakness and vulnerability to blow-out of the rubble masonry panels.

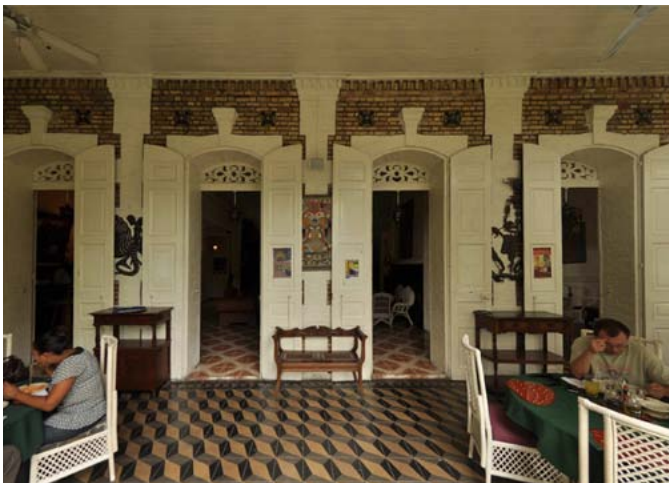
**FIGURE 100 left** First-floor porch of the Hotel Oloffson showing brick façade with the many door openings that surround the building on all sides. **right** Typical brickwork where it can be seen without the porches.

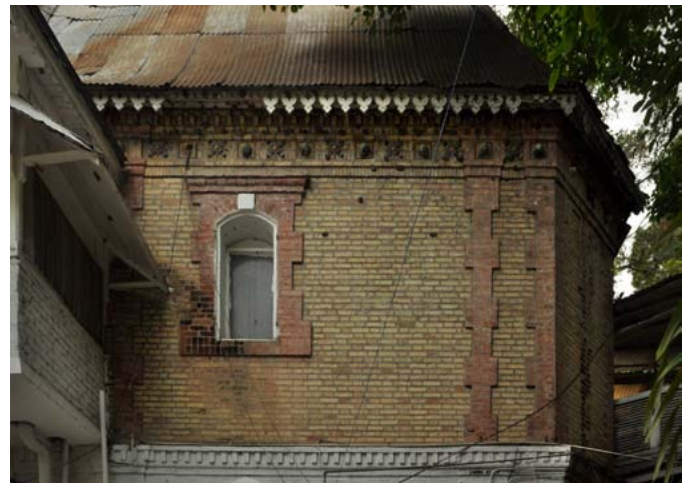
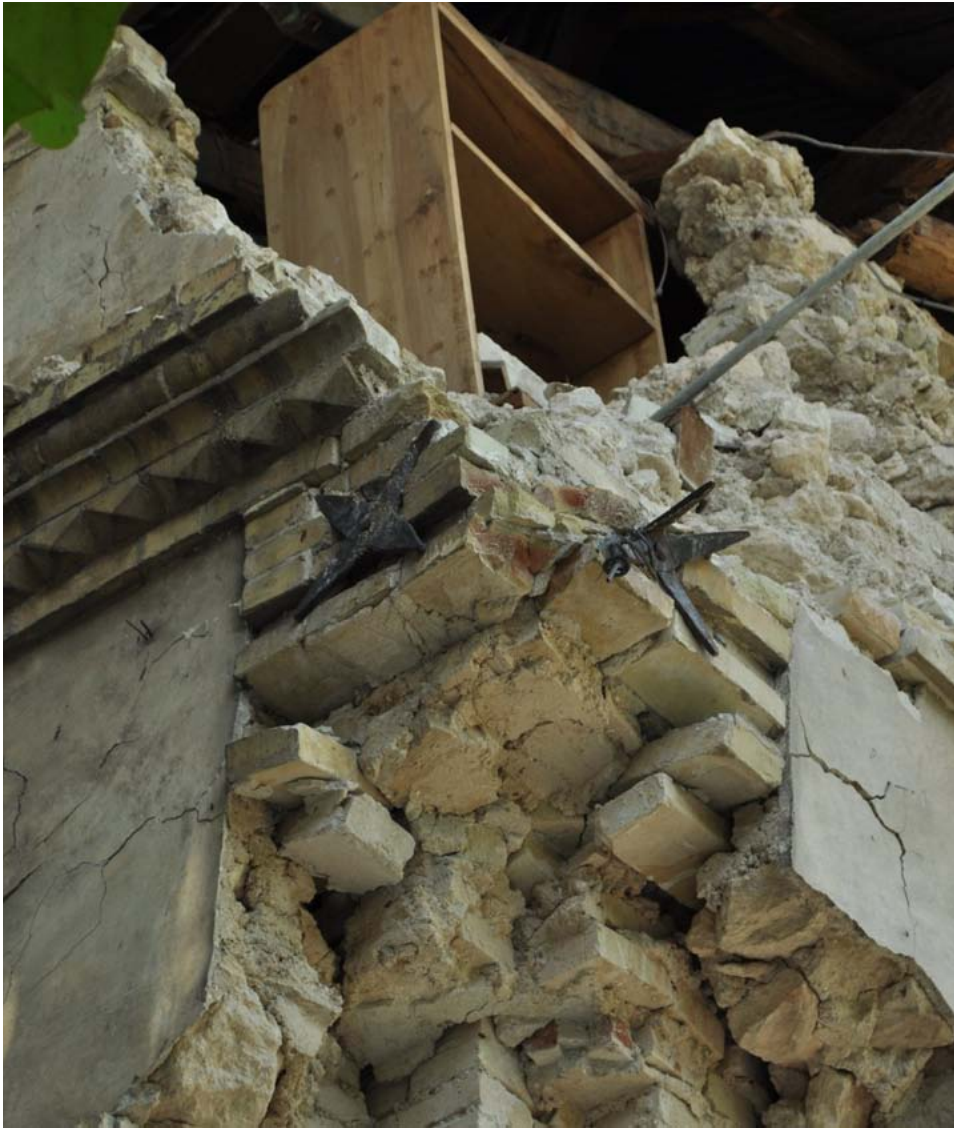
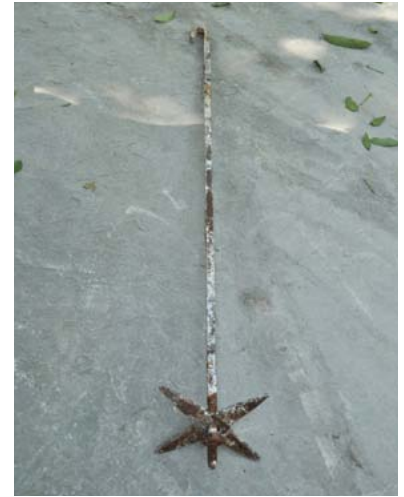
**FIGURE 101** Iron chains are common in many of the masonry walls of the Port-au-Prince Gingerbread houses. Above is the first section of the chain with the star-shaped metal plate, and the view at left shows the metal plates where they remain holding the wall at the floor level in place, thus stopping the further separation of the walls at the corner. Had these floor level reinforcement rings not been installed, the lower floor walls would probably have collapsed as well.

A critically important protective feature of many bearing-wall masonry Gingerbreads is the “iron chains”—the iron or steel rods at the floor and roof levels that tied the walls together (Figure 101). Most of the rods that were observed in the survey ap-

peared intact. Where exposed by the earthquake damage, they were often not heavily corroded, but in a few instances they were observed to have been rusted through. In many of these examples, the tie rod originally surrounded by masonry had been covered by cement; some of these showed a more rapid deterioration from rust, possibly due to the low desorption rate of cements with low porosity.

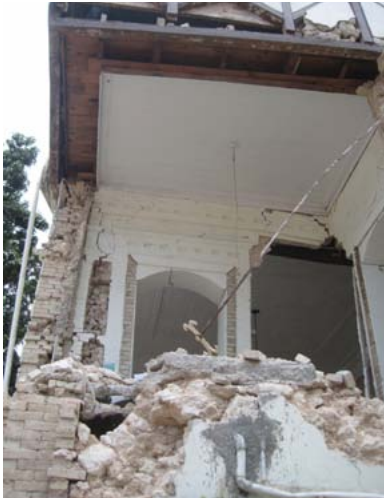
**FIGURE 102** In this case the horizontal metal ties failed to prevent the collapse of these masonry walls, but may have helped prevent the collapse of the rest of the building

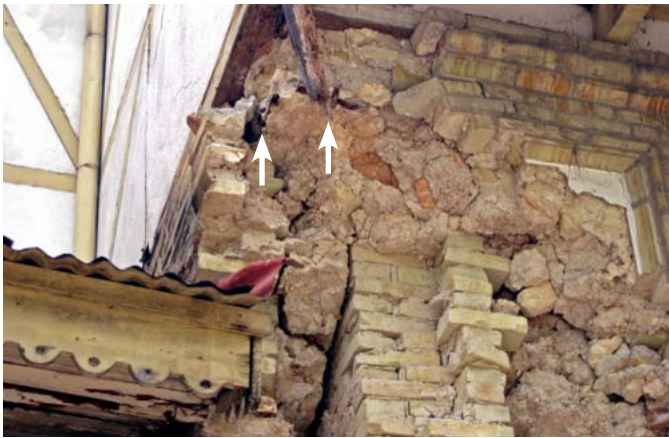
**FIGURE 103** Embedded tie rods cross at the corner, anchored by iron bars. Also note rubble fill between inner and outer leaves of brick masonry.

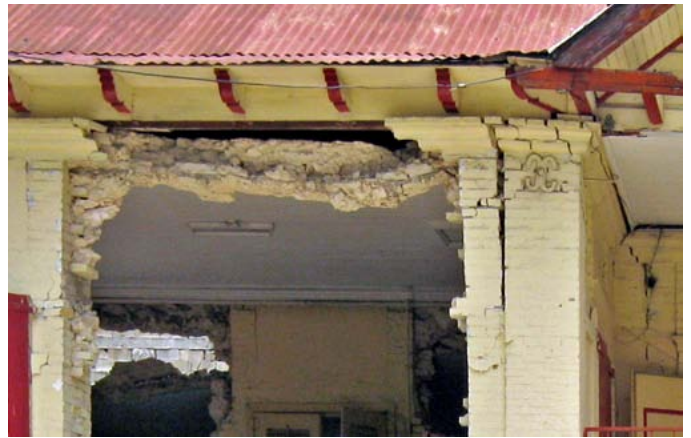
**FIGURE 104** Total collapse was avoided in this heavily damaged masonry building due to embedded iron rods at the top of the walls, with exposed end plates.

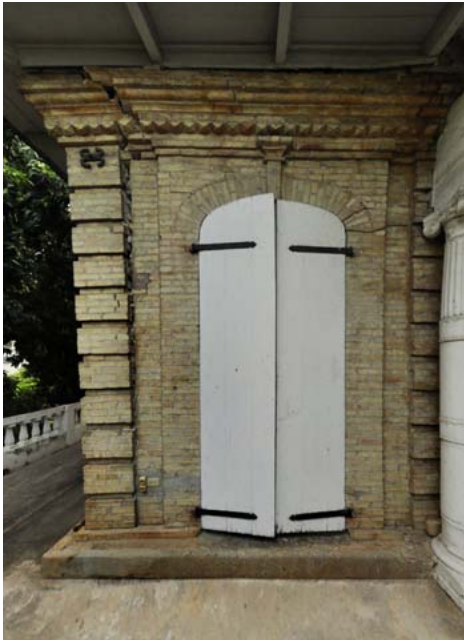
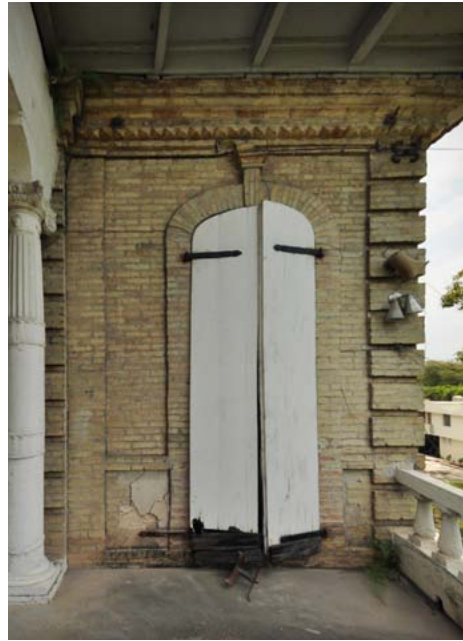
**FIGURE 107** 112 Rue La Fleur Ducheine, showing the metal plates at the end of the iron chains that are laid into the walls at the floor level. The end of the second floor wall on the left suffered damage because the plate around the corner to the left had fallen off probably because of rusting of the rod, whereas the plate on the right hand corner of the same wall shown on the right was intact, and thus the earthquake did not damage the wall at that end.

failed from rust or were not installed at the time of the building's construction, their failure/absence was associated with a greater amount of damage and disruption of the masonry (Figure 107). One good example is the Villa Castel Fleuri, where for an unknown reason rods were not installed at the corners of the second floor, but were installed at the first bay location and at the roof level. In this instance, the second floor corners were more dislocated by the earthquake than were other parts of the building where rods were present (Figure 108 and 47).

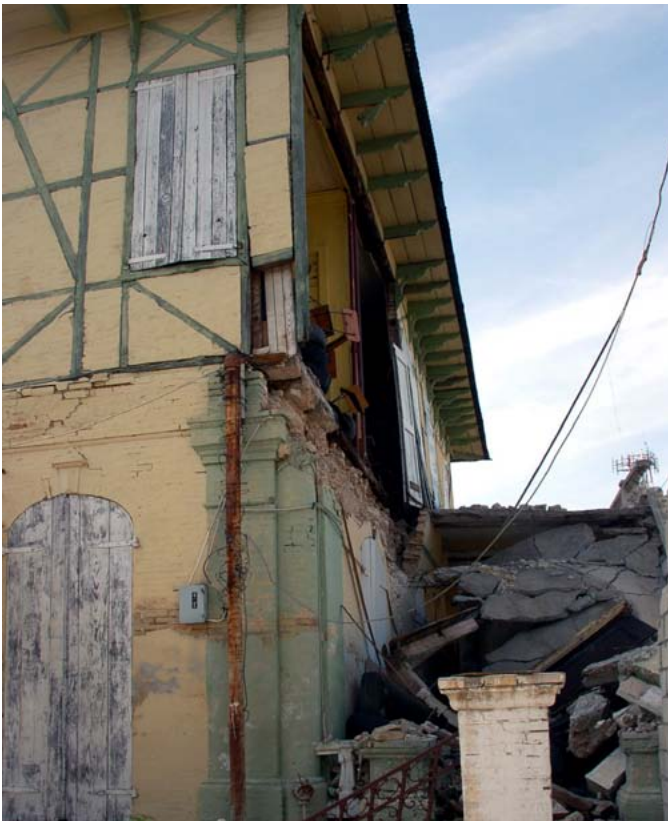
FIGURE 111 The wooden portion of this building remained standing, while the two-story concrete addition pancaked completely. This house is also shown in Figure 136 right

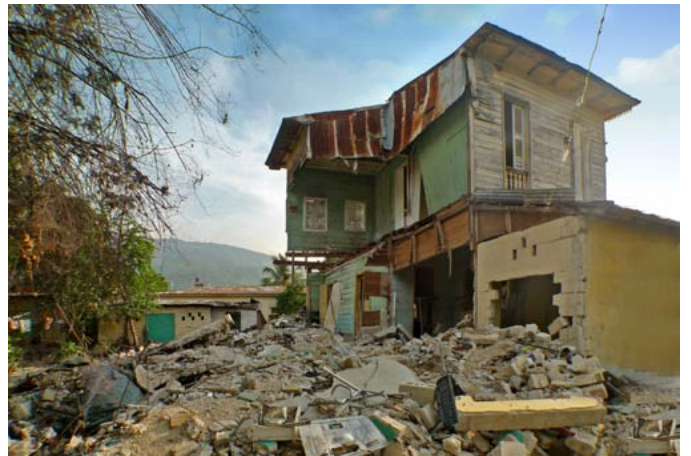
FIGURE 110 The concrete addition to the right of this Gingerbread house at 34 Lamartiniere collapsed and took down the second floor adjacent wall of the house as well.

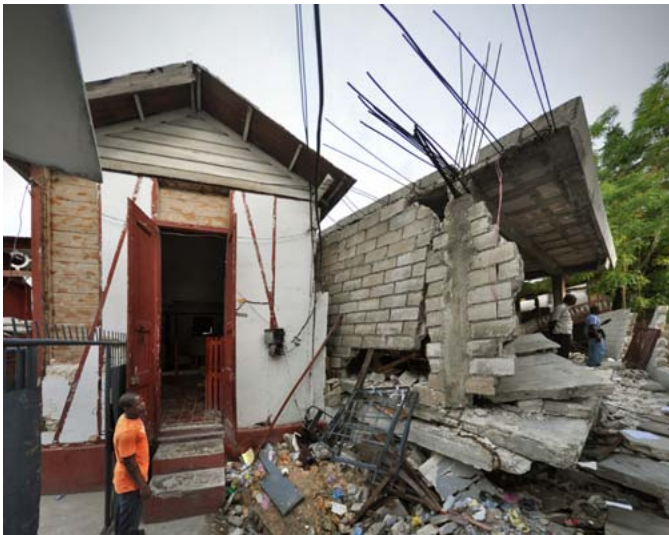
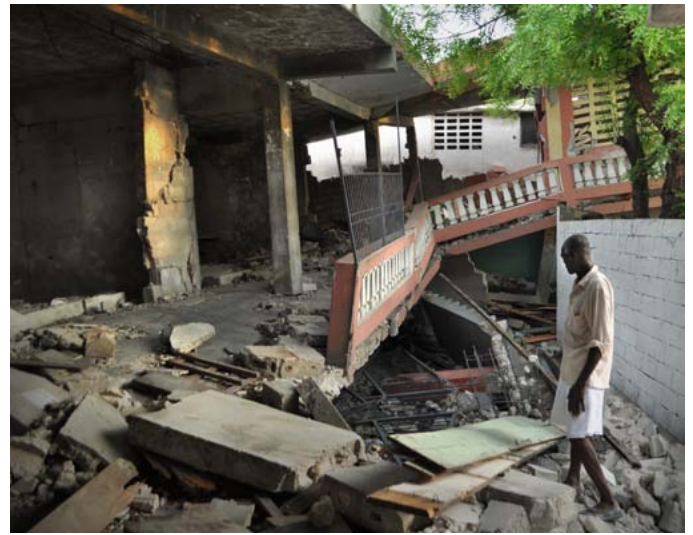
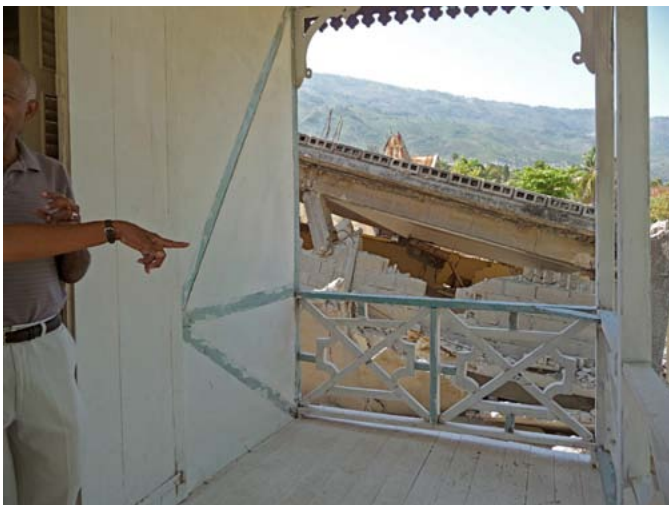
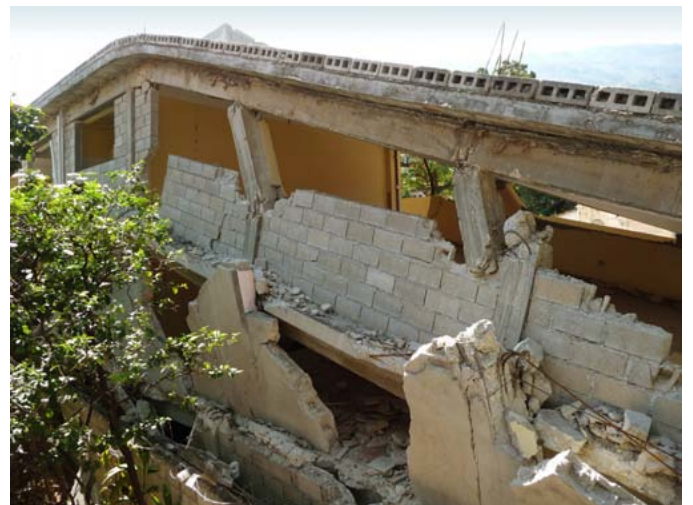
FIGURE 113 Owner of Rue 5 Jose Marti points to adjacent collapsed concrete and concrete block school building.

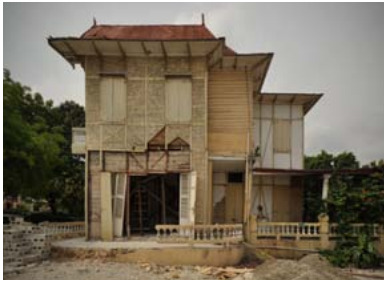
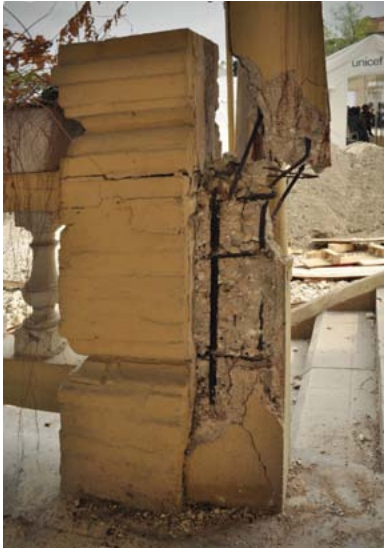
**FIGURE 114** The Bazin House on Rue du Travail Deuxième. An upstairs bathroom of reinforced concrete and block construction clad with wood visible in the middle of the left photo almost caused the collapse of the entire house because it was standing on thin legs of heavily deteriorated concrete with rusted rebar. It was heavy, causing the whole house to sway, almost collapsing the bathroom wing, which may then have carried part of the house down with it.

constructed with heavy concrete and tile interiors. When bathrooms were installed at the second-floor level, the additions sometimes were constructed on reinforced concrete legs, and thus their weight under lateral loads was imposed onto the historic house, leading to damage both to the addition and to the main house. One example of this can be seen at the Bazin House. Sometimes these additions were old enough to have suffered serious deterioration of the reinforcing due to corrosion. At the Bazin House, the legs that supported the second floor bathroom were broken by the earthquake, revealing that the reinforcing bars were seriously corroded, weakening the structure. This bathroom addition came very close to collapse and the house was badly damaged and out of plumb. (Figure 114)

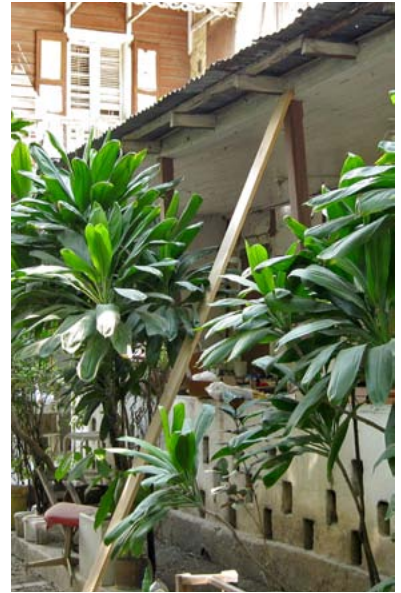
Team members observed that the shoring in place during the April mission was often under-structured and not configured correctly for best protection, whether due to a lack of resources or a lack of knowledge (Figures 119 and 120). This seemed

FIGURE 119 Temporary measures are important: this lateral brace is a good idea, but it is too slender and there is only one.

to be particularly true of lateral bracing, which is less intuitive to most people than vertical shoring. Training would improve the safety of this work. Also, it may be helpful to establish a group of contractors and assist them in securing shoring materials and equipment. In general, the team found that shoring should consist of timber (or other material) members leaning diagonally against a vertical wall to counteract the overturning action or placed vertically beneath a structure where the original bearing members or walls had been compromised. Other materials that are missing or in short supply include adjustable steel columns with threaded steel extensions, and polypropylene straps that can be wrapped around a structure. For examples of post-earthquake shoring in Italy, see Figure 121 and also: <http://haiti-patrimoine.org/wp-content/uploads/2010/02/ItalianShoring-MoliseEQ.pdf>

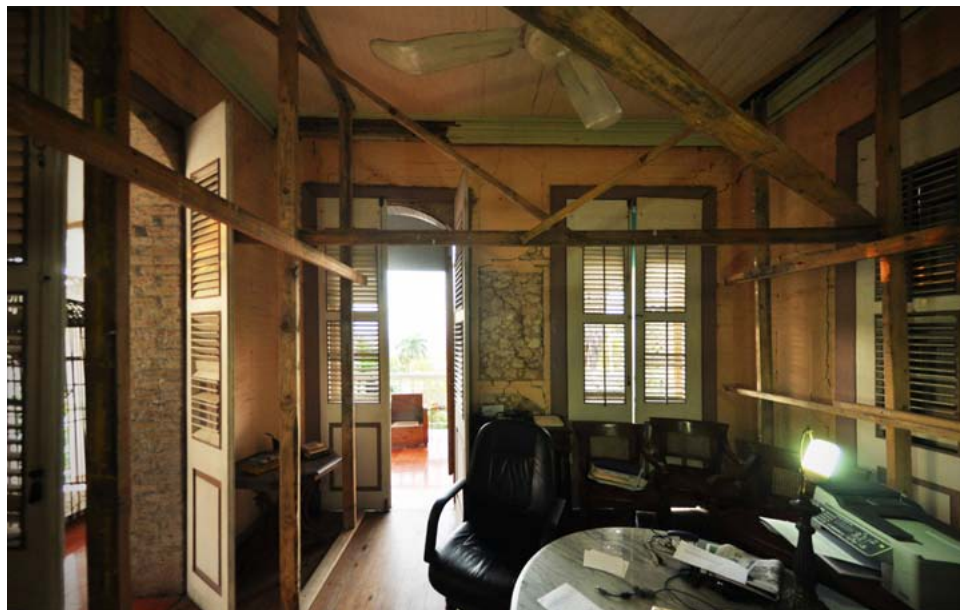
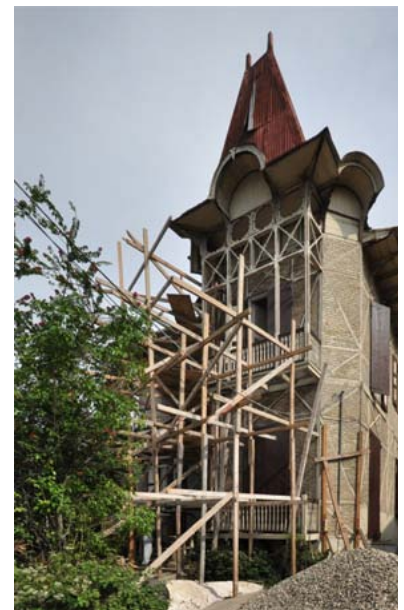
FIGURE 120 Scaffolding and shoring at 32 Lamartiniere, and shoring on the interior of 22 Rue Pacot.

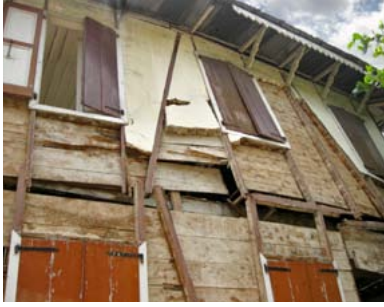
**FIGURE 123** Typical vulnerability: the wall pulls away on the side parallel to the floor framing due to lack of connectivity between the floor and the wall. This is easily improved in most houses.

- Improve connectivity between various building elements. Mechanically connect wooden structures to their foundations, floors to walls, between wall framing members, and roofs to the building below (Figure 123).

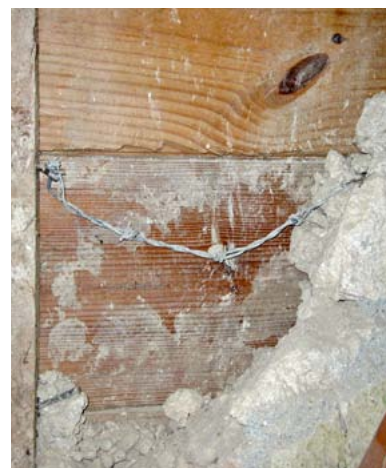
**FIGURE 125** Barbed wire is frequently seen in the wall cavities as a restraint for the rubble fill. This is a good practice and should be continued.

- There is evidence in a few houses that the rubble stone infill masonry was reinforced with barbed wire at the time of the original construction. Continuing this tradition when rubble infill is reconstructed is advisable (Figure 125). Other types of mesh, including plastic geogrid, could be explored as a reinforcement, but barbed wire may be ideal for the following reasons: (1) it is widely available in Haiti for farming purposes, as well as security fencing, (2) it is almost always galvanized (which is essential if it is to be used for permanent construction), (3) it can be easily installed as the masonry construction is laid up. It is, however, recommended that a different configuration for its layout be used so as to improve the reinforcement effect. Historically a zigzag layout was used. If it is installed primarily as a horizontal bedding reinforcement with some strands crossing over the exposed exterior surface of the masonry (behind the plaster finish), then it can better hold the masonry in place.

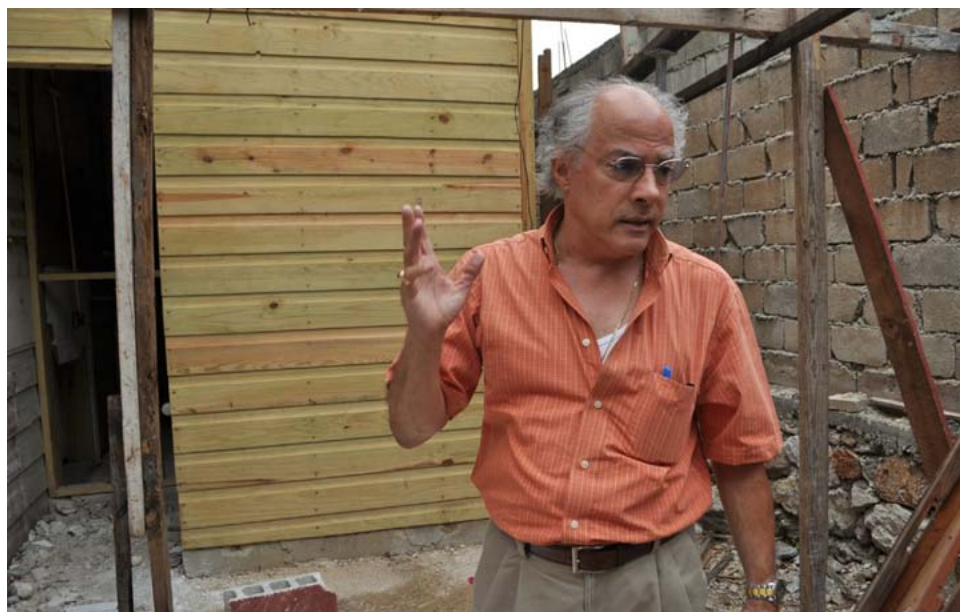
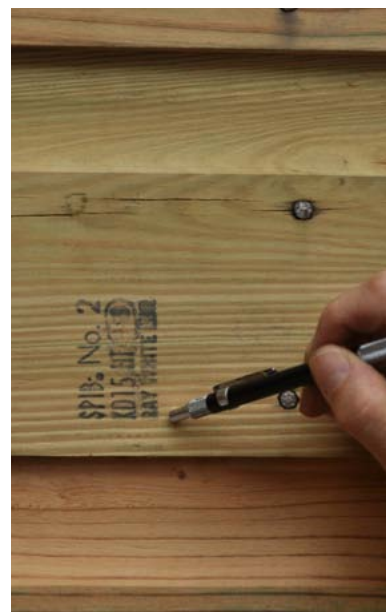
**FIGURE 126** Owner and architect Gilbert Mangones explaining the restoration work he is doing on his house at 24 Avenue Lamartiniere, shown in Figures 24, 35, and 134. The new ship lap siding is pressure treated imported timber. The timber grade stamp is shown below.

- Replace damaged or decayed timbers (Figure 124). All newly added timber must either be natural heartwood from a species of tree known to be resistant to the local insects, or pressure treated (Figure 126). Because of the presence of toxic chemicals, pressure-treated wood should be painted when used on the inside surfaces of a house, and should never be used for kitchen cabinets or counter tops.

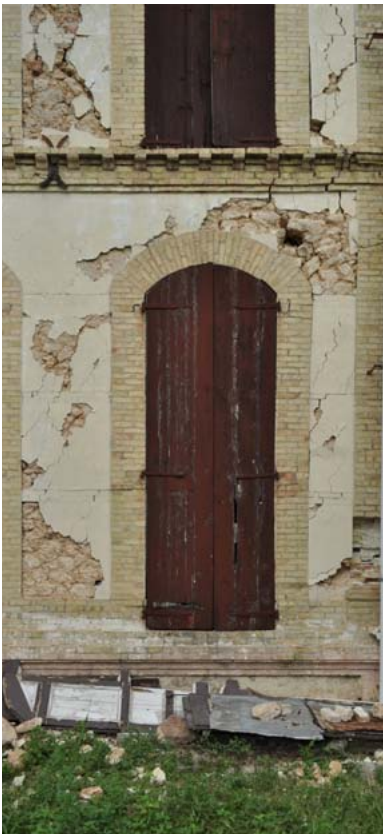
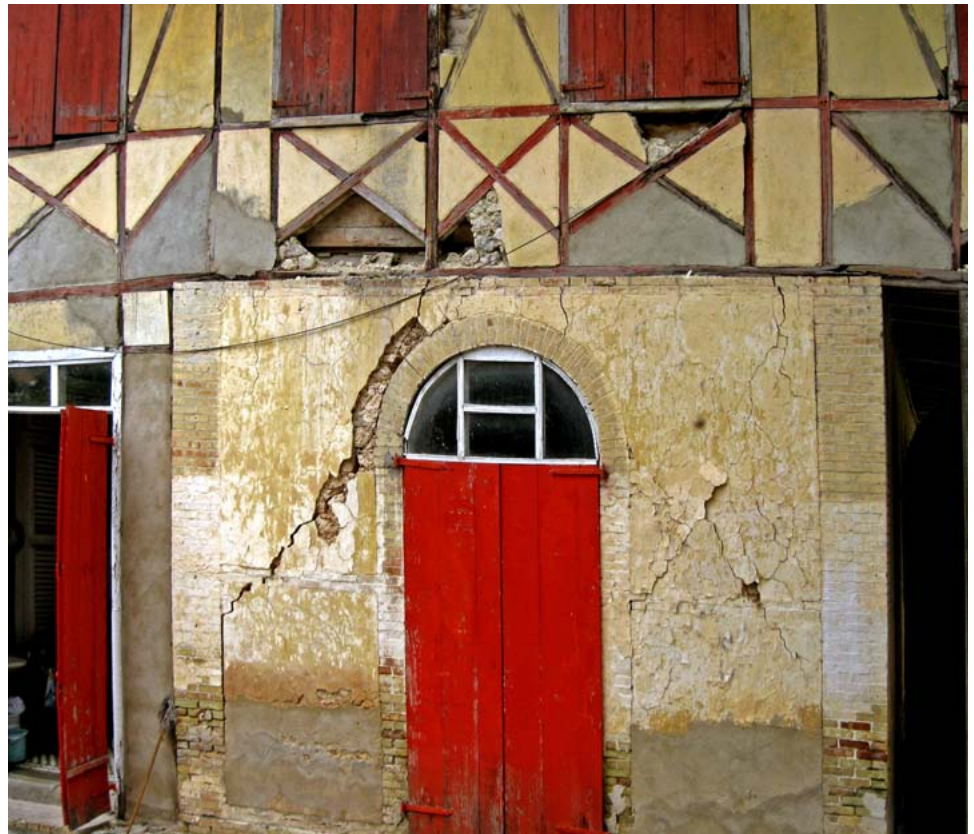
**FIGURE 127** Typical 'brick frame' with rubble infill construction. Note crack pattern/energy absorption in rubble fill. The addition of ties to resist the spreading of the arches at the tops of the openings will improve earthquake resistance, especially when the arch is close to the corner of the building as in the figure on the left.

- Where missing or damaged, install tie rods at the top of walls, tying buildings in both directions and reinforcing arches and other openings as needed (Figure 127). Rebuild severely damaged areas. Inject cracks with lime grout. Only use lime mortar, not cement.
- Reinforce existing interior walls with well-nailed plywood so that they will serve as structural cross-walls, or add additional nails to existing interior horizontal wood cladding on interior walls. In the absence of adequate interior walls, add new interior plywood-sheathed interior cross-walls.
- Stitching of un-bonded multi-leaf walls may be needed in some cases.
- Restore timber floors that have been replaced by concrete.

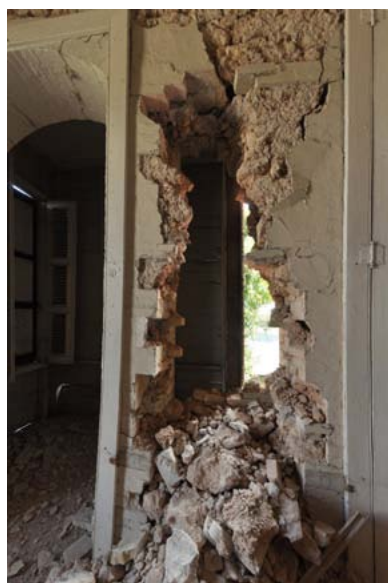
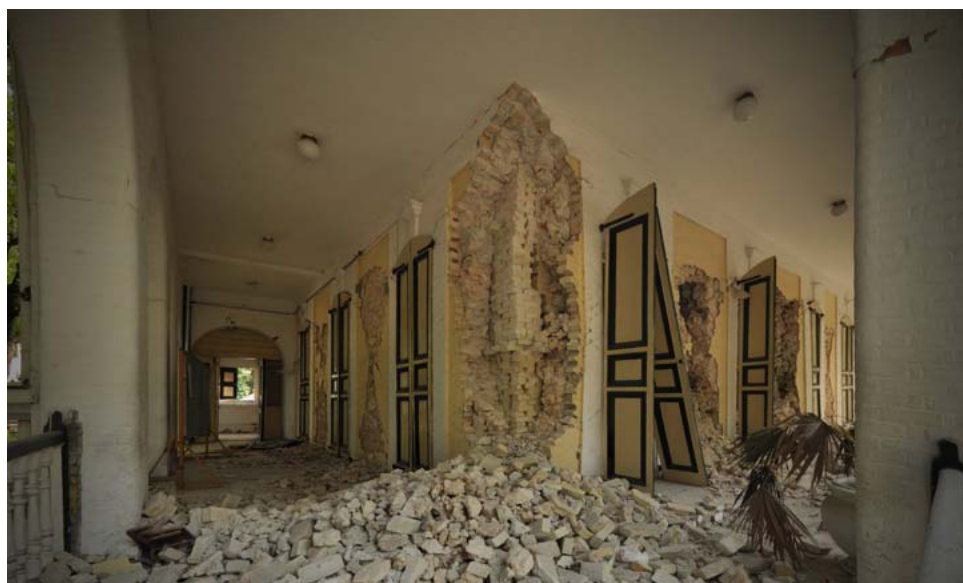
**FIGURE 130** *below left* A rubble panel on the second floor of the Villa Castel Fleuri that collapsed showing the displacement of the bottom of the brick pier into the doorway which resulted from the expansion forces from the panel. *below right* Le Manoir on Avenue John Brown showing a heavy level of disruption of the masonry walls caused by the rapid degradation of the rubble stone panels during the earthquake.

- ❑ In the case of the Dufort House and Le Manoir (Figure 130), the damage consists of very heavy disruption to the masonry walls on the ground floor level—including dislocation of the brick piers as well as the collapse of the rubble ma-

sonry panels. The partial collapses of the walls have revealed that the brick piers themselves were not well bonded in their construction, and the mortar had become unusually weak and powdery. Repair essentially requires the re-laying and reconstruction of most of the walls of the ground floor level of the buildings. To accomplish this, a carefully engineered and constructed system of shoring will have to be undertaken, and then, section by section, the walls can be rebuilt. Considering the example of the Hotel Oloffson (Figures 99 and 100, page 48), the best rebuilding will be to carry the brick masonry throughout the walls, without the brick pier and rubble panel configuration. The architecture can be restored by recessing the panel areas and plastering that section. All brickwork should be bonded, so that all wythes are interconnected across the collar joints, the absence of which has contributed to the extensive damage in the earthquake.

- ❑ In instances where the rubble in a particular panel is heavily disrupted, with gaps appearing at the top or in parts of the panel, and a “belly” appearing in the middle of the panel from the expansion of the front to back thickness of the rubble wall, the best course is probably to dismantle and replace the panel. In such cases, in those instances where a “repair” approach (rather than a “restoration” approach) is to be taken—that is for non-museum level work on private homes—the replacement of the rubble panel with other material is probably the best course. Of the choices for masonry materials seen in Haiti, the small hollow clay tile bricks observed to be used in Haiti may be the best alternative because they are lighter than solid bricks. Because of their horizontal bedding and compatibility with the solid brick piers, they will perform much better in an earthquake than the rubble stone.
