# **Preserving Haiti's Gingerbread Houses**

## **2010 Earthquake Mission Report**

**A World Monuments Fund / ICOMOS Project funded in part by Prince Claus Fund and FOKAL**

**2010 Earthquake Mission Report  
December 2010**

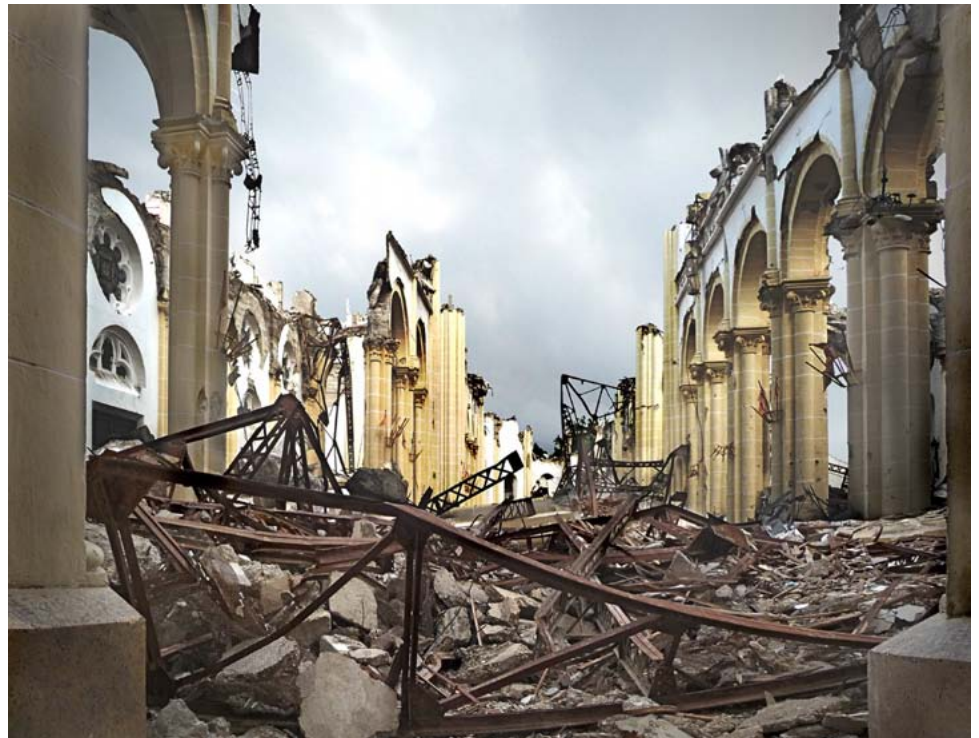
**FIGURE 131:** interior of the *Cathédrale Notre Dame de L'Assomption* after the 2010 earthquake suffered a complete roof collapse, collapse of sections of its interior arcades, and collapse of the tops of its two bell towers. Remarkably, all four of its two-story exterior facades remained largely intact. The building was constructed between 1884 and 1914, with walls of reinforced concrete with infill masonry construction. Much of the reinforcing had become heavily corroded by the time of the earthquake. Weak bonding due to the use of smooth rebar also made this and other reinforced concrete structures particularly vulnerable to seismic damage.

- Surface-applied steel reinforcement like that seen in the Saint Louis de Gonzague Chapel, and the small chapel next to the Cathedral (Figures 131, 132, 133), has performed well in the Haiti environment, probably because of protective coatings and subsequent application of paint. This kind of strategy can be considered, especially where the floor level chains are missing or corroded, and replacing them *in situ* internal to the wall is not possible. The remarkably good performance of those two churches could be considered an inspiration and a model for good performing masonry construction.

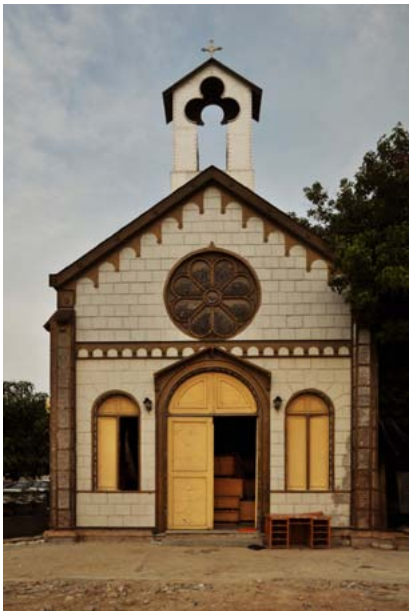
**FIGURE 133** Saint Louis de Gonzague Chapel on Rue Du Centre after the earthquake. While the modern buildings of the Roman Catholic School collapsed, the Saint Louis de Gonzague Chapel survived without major damage. The Brothers of Christian Education founded the School in 1890, and the Chapel dates from after that date. This chapel is as large and tall as the nave of the Cathedral had been. Its iron frame, which serves to confine the masonry walls, was prefabricated in France. This structural system proved remarkably resilient compared to the early reinforced concrete construction found in the Cathedral as well as the National Palace.

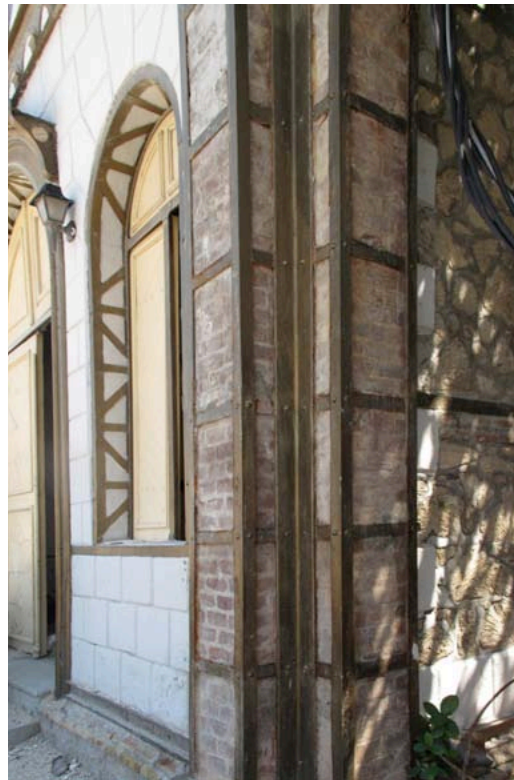
**FIGURE 132** This small chapel next to the Cathedral has the same surface-applied steel reinforcement system as the Saint Louis de Gonzague Chapel and fared very well in the earthquake.”

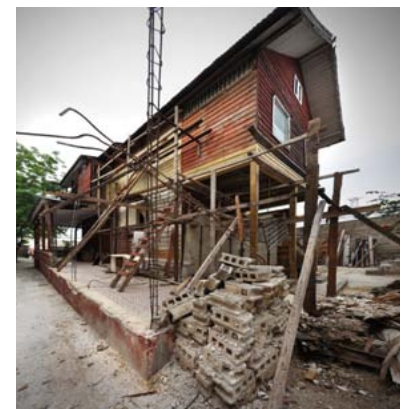
**FIGURE 134** The modern reinforced-concrete frame with concrete-block back additions to the house at 24 Avenue Lamartiniere collapsed in the earthquake and have been removed. The owner, architect Gilbert Mangones, is now doing all of the repairs with timber framing and cladding, which will be much more compatible with the flexible timber frame of the original house, and less likely to collapse in a future earthquake.

To the extent possible, additions should be constructed of materials and structural systems compatible with the original house (Figure 134). Any additions not constructed of the same material and structural system of the original house—particularly when they will have a different lateral stiffness—should (1) be designed and engineered as separate structures with their own seismic system, rather than relying on the existing structure for either vertical or lateral support, and (2) be separated from the existing structure with a seismic joint. The seismic joint needs to be sized for the expected sway of both structures to avoid pounding, so that the two structures will not strike against each other during any future seismic event. It is recommended that a structural engineer be consulted to determine the size of this joint, and on the design of the floor and enclosure system on both sides of the joint. The joint can be bridged so that there is no gap in the weather enclosure of the house with its addition.

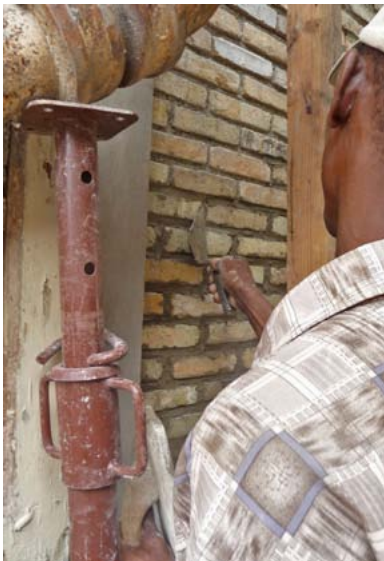
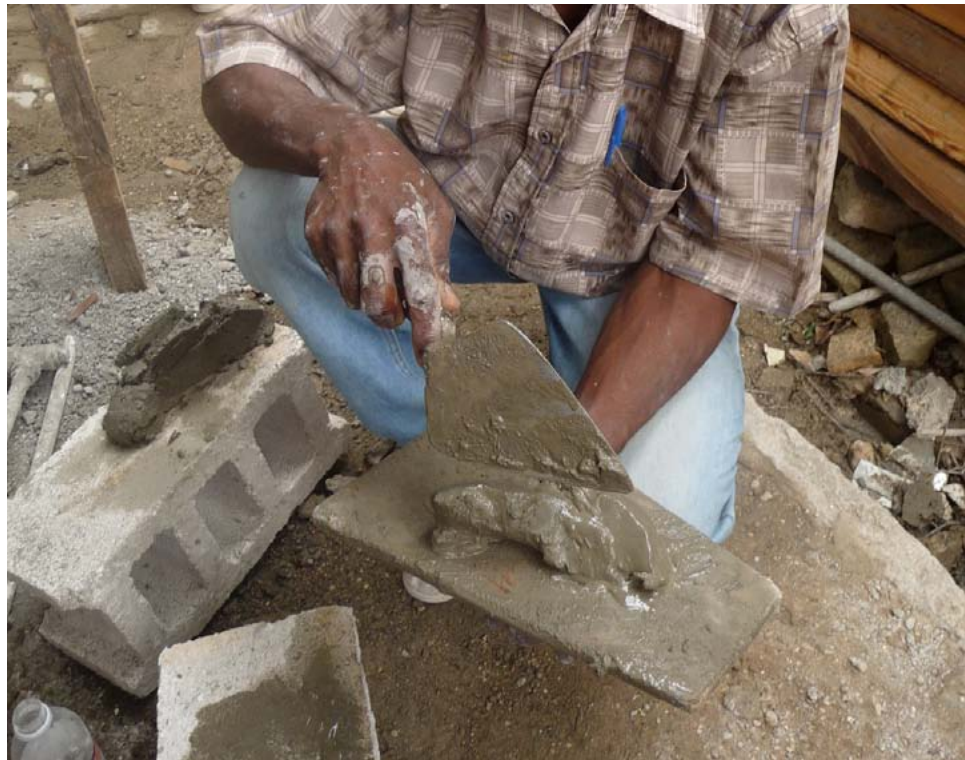
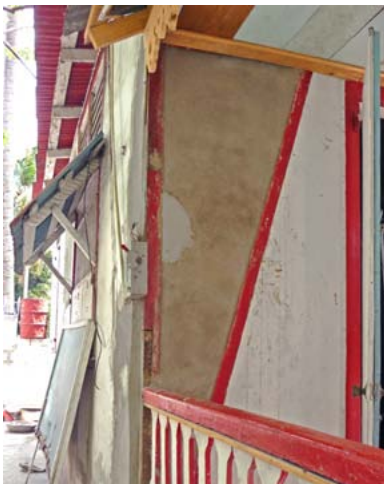
**FIGURE 135** Well-intentioned but improper repairs with cement mortar in brick work (*above and right*), and cement plaster for colombage infill (*below*). Lime mortar and lime plaster should be used.

- Avoid the use of cement mortar when reconstructing the *colombage*. There were many examples where panels that had been reconstructed with cement mortar fell out of the frames as large pieces causing greater risk to life during the recent earthquake. Use mortar of the same character and strength as the mortar used originally, and mortar that is appropriately soft for the rubble stone.

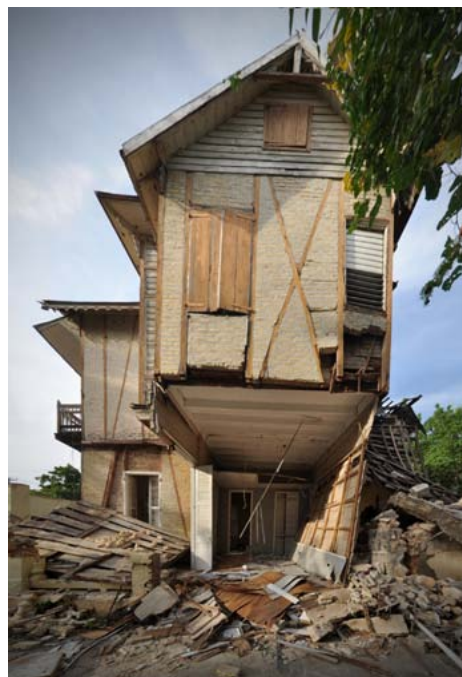
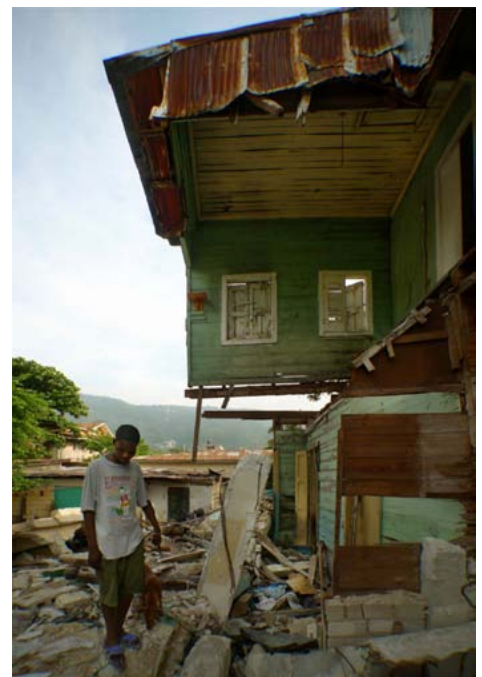
The countless concrete buildings that became death traps during the 35 seconds of the earthquake are the product of a process of building that betrayed the very people it should serve (Figure 136). In addition to their catastrophically poor quality in terms of safety, these concrete buildings have little of what can only be described as "spirit" or "soul." This becomes especially clear when compared with the ample spirit and soul proudly exhibited by the Gingerbread buildings.

**FIGURE 136** *left* House on Rue Jose Marti where the concrete addition collapsed, leaving the Gingerbread house cantilevered over the rubble. *right* The son of the owner of this house is pointing to the place where his cousin remains buried in the rubble of the collapsed concrete addition. This house is also shown in Figure 111 on page 52.

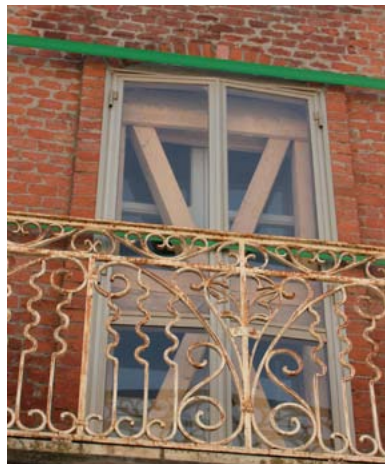
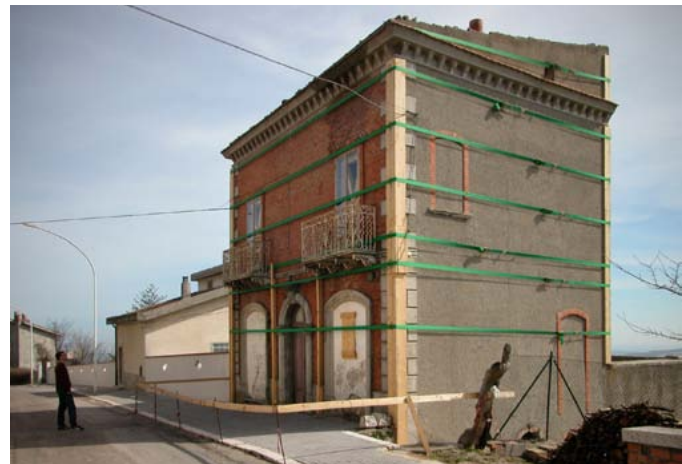
**FIGURE 138** Examples of shoring constructed after the two recent earthquakes in Italy demonstrate different solutions to the important problem of stabilizing heritage structures to avoid emergency demolition for public safety. The two photos on this page show an unreinforced masonry building damaged in the 2002 Molise earthquake shored entirely with polyester straps, thus eliminating the need to block the street with diagonal braces. Shoring has been installed in the window openings—an important part of any system as it gives the damaged masonry wall structural continuity across openings.

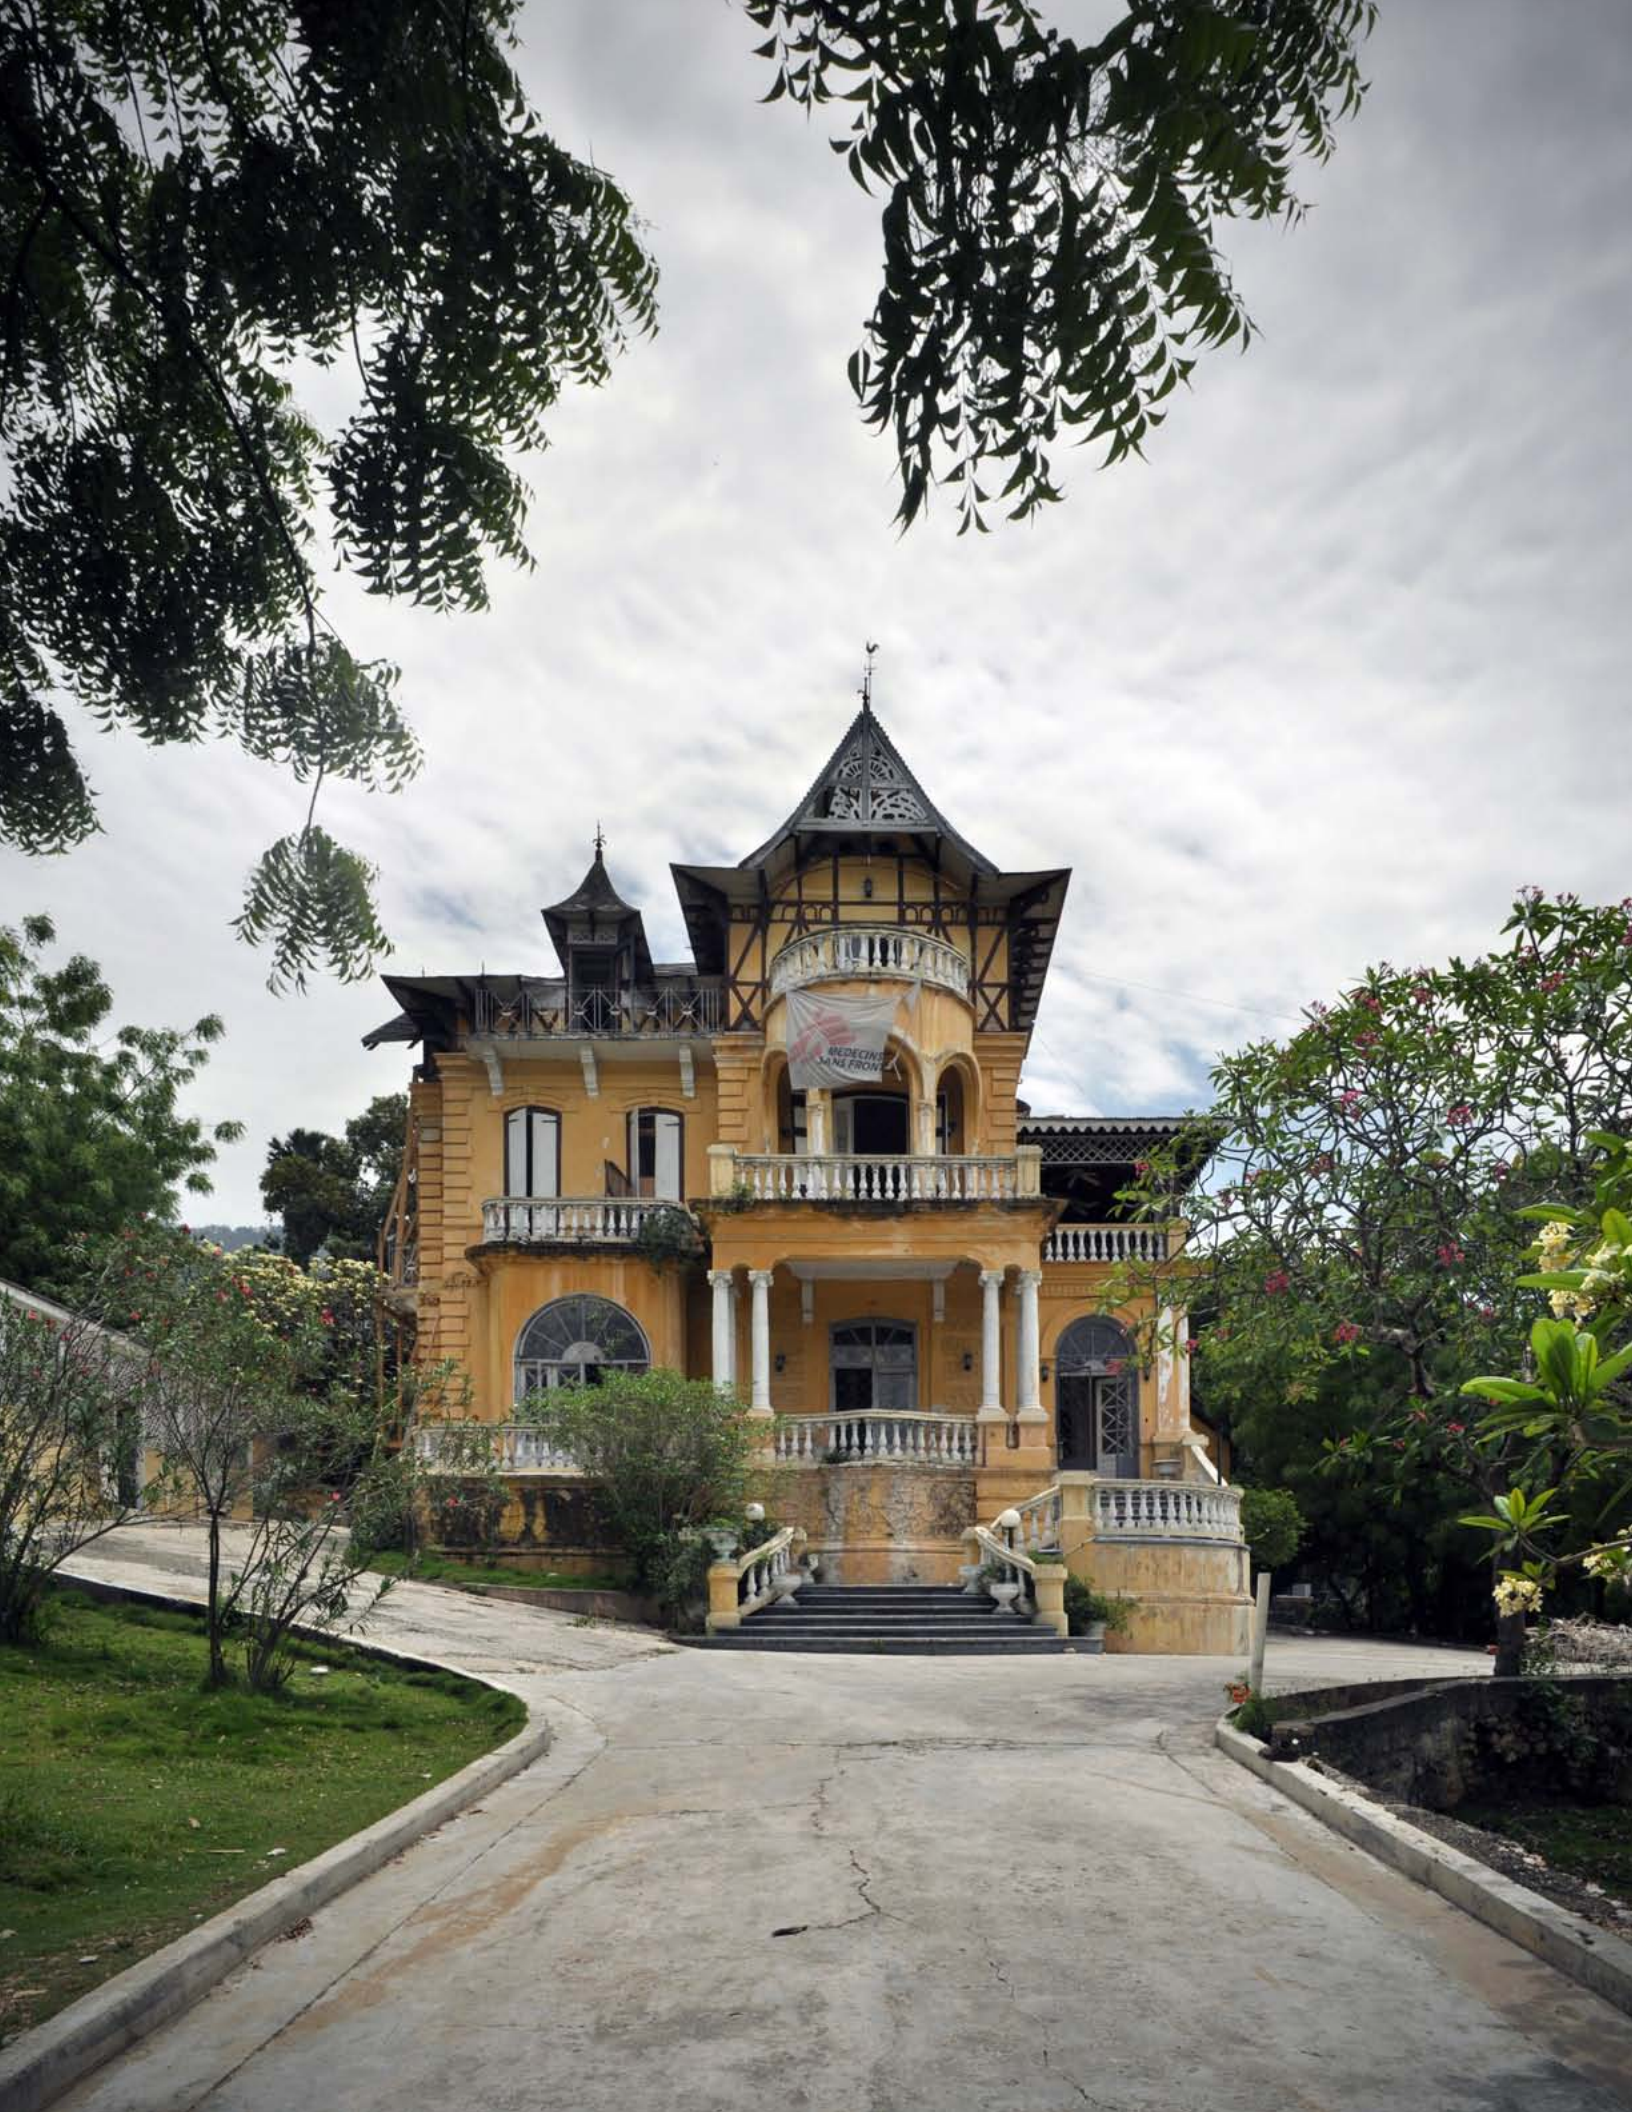
**FIGURE 141 back cover** A splendid mansion of masonry construction on Rue 4 Pacot occupied at the time of the earthquake by Doctors without Borders. The house generally suffered only a moderate amount of damage, but the back masonry wall separated from the frame at the third-floor level. This may have been caused by the later construction of a bathroom with a raised concrete floor.
