## Rebuilding Skills and Traditions

The project aimed to showcase conservation techniques reflecting international best practice throughout the planning, documentation, design and implementation stages to serve as a reference point for future work in Egypt. The process began with a systematic damage assessment, archaeological investigations and documentation of the monument's history. Conservation work started in June 2009, performed by a team of specialists and local craftsmen, many of them residents of the surrounding communities. Vocational training in modern heritage conservation techniques was an important dimension of the project.

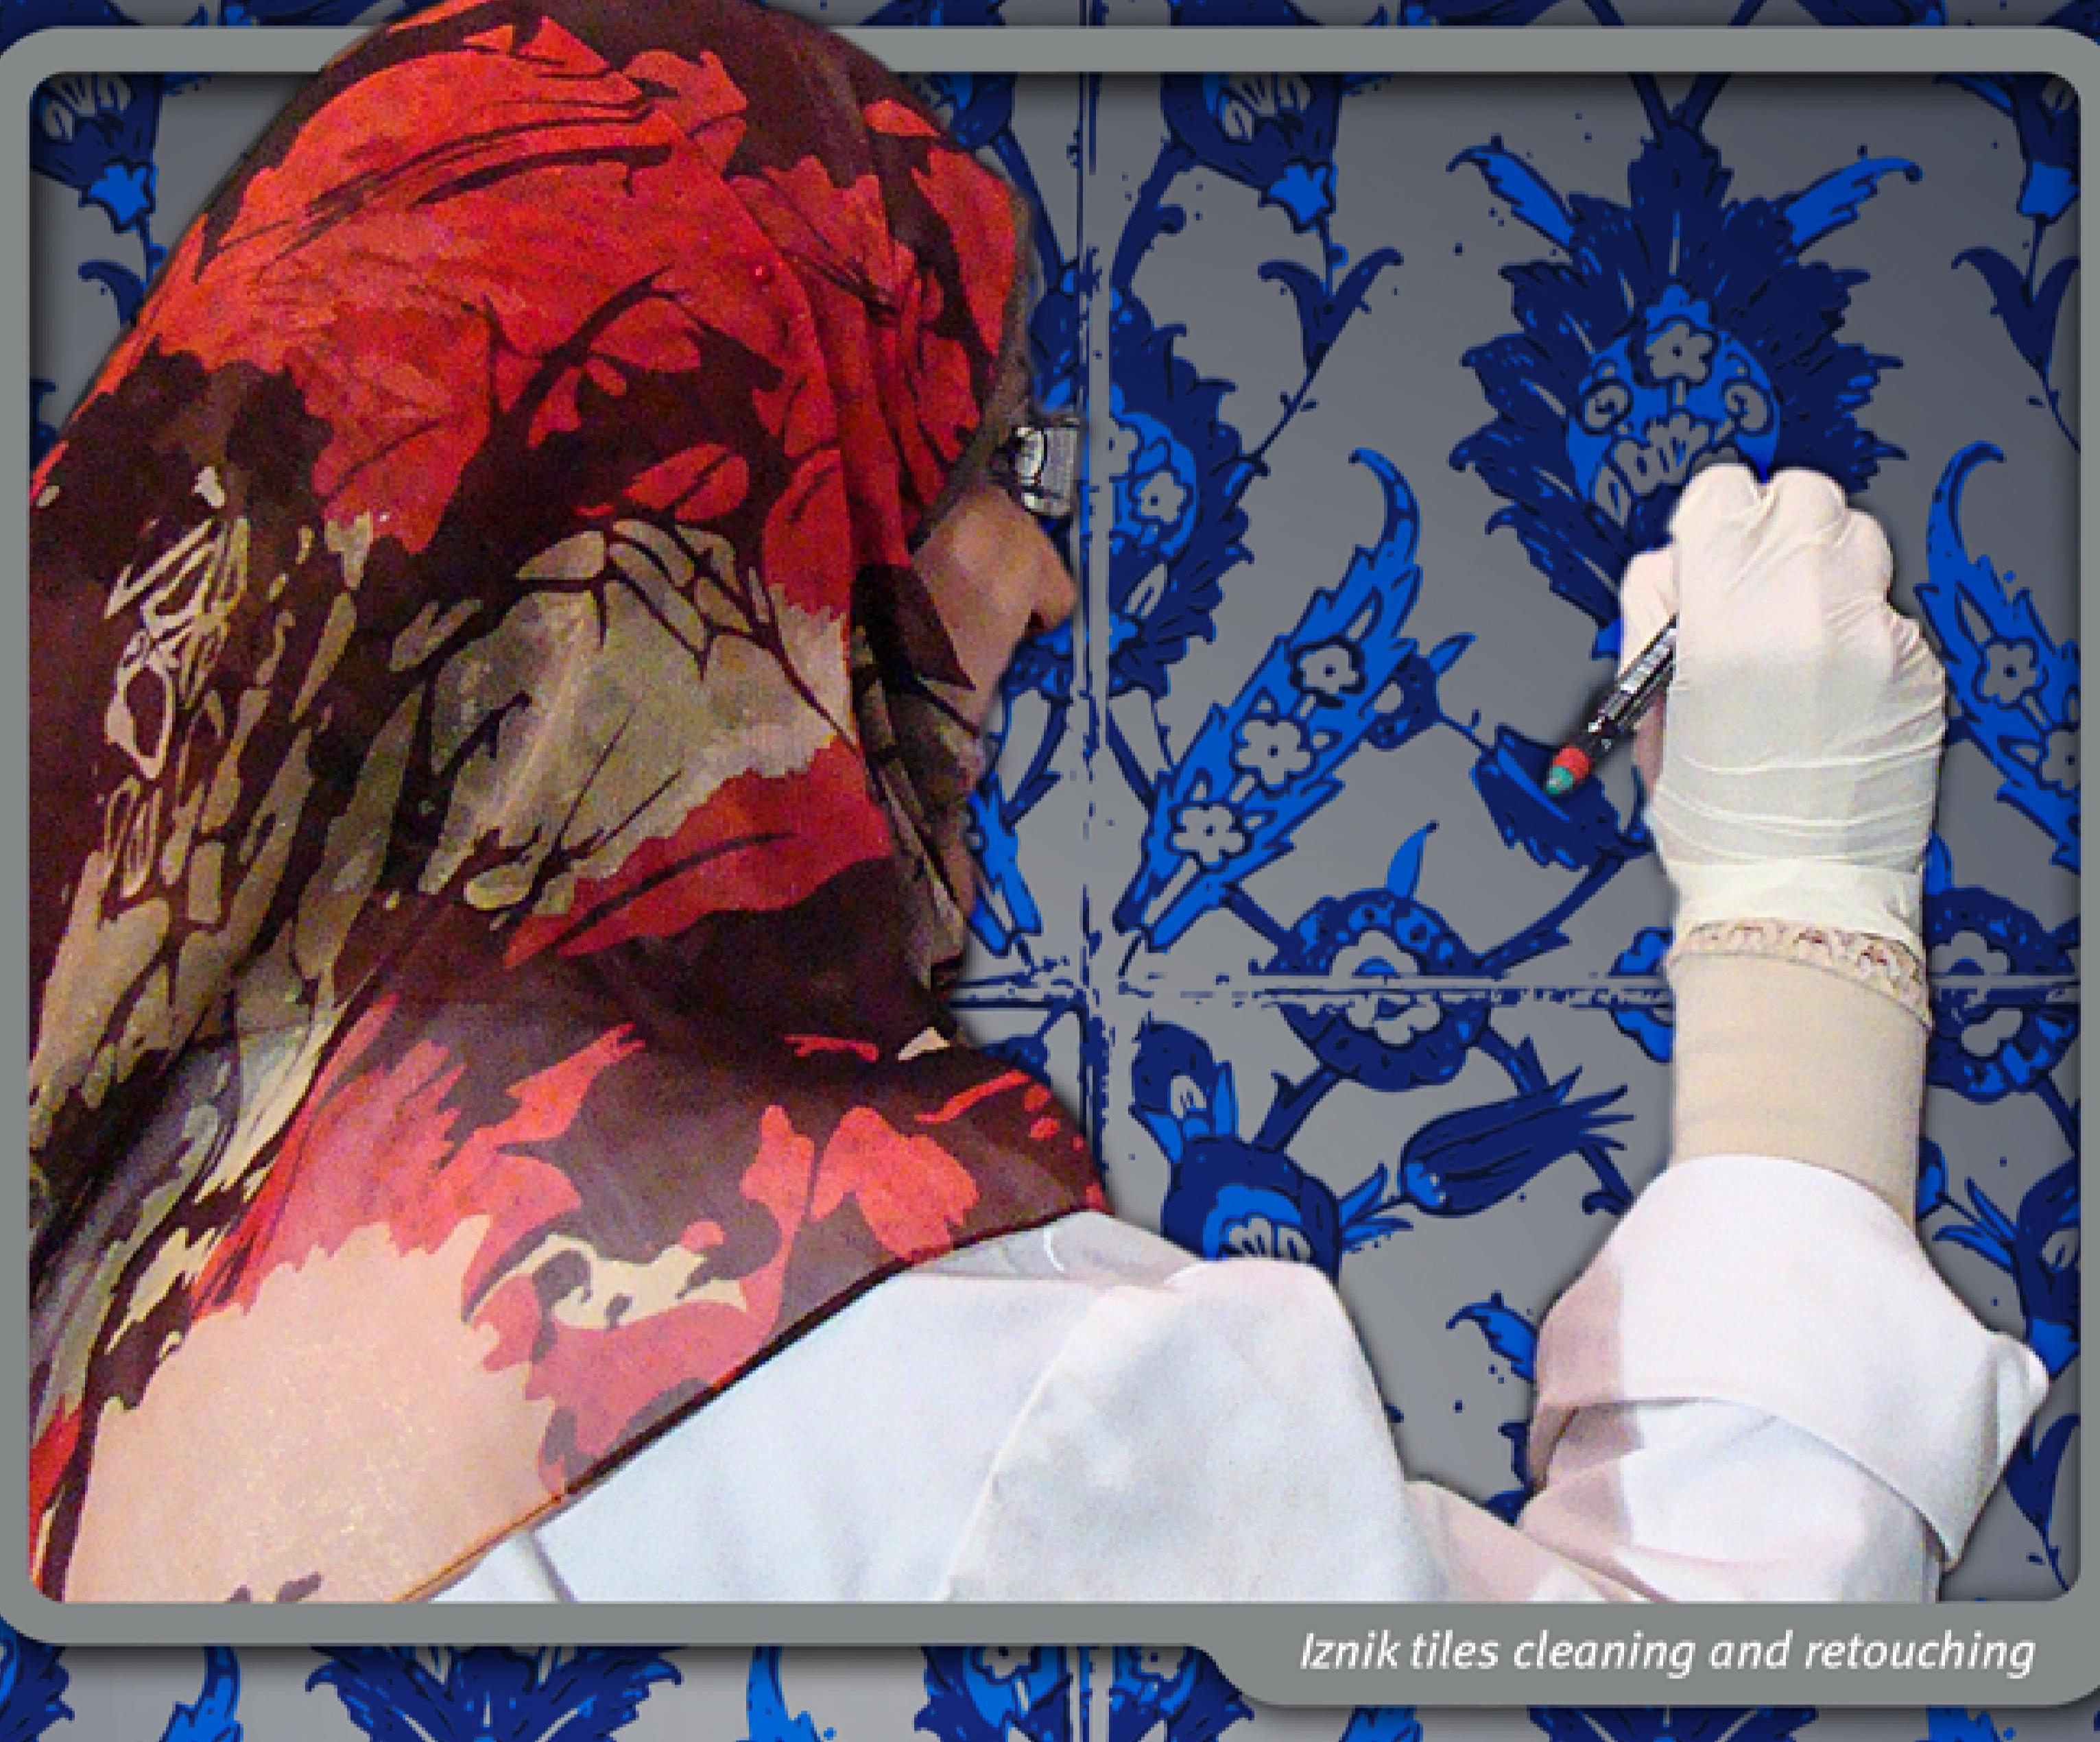
Iznik tiles cleaning and retouching

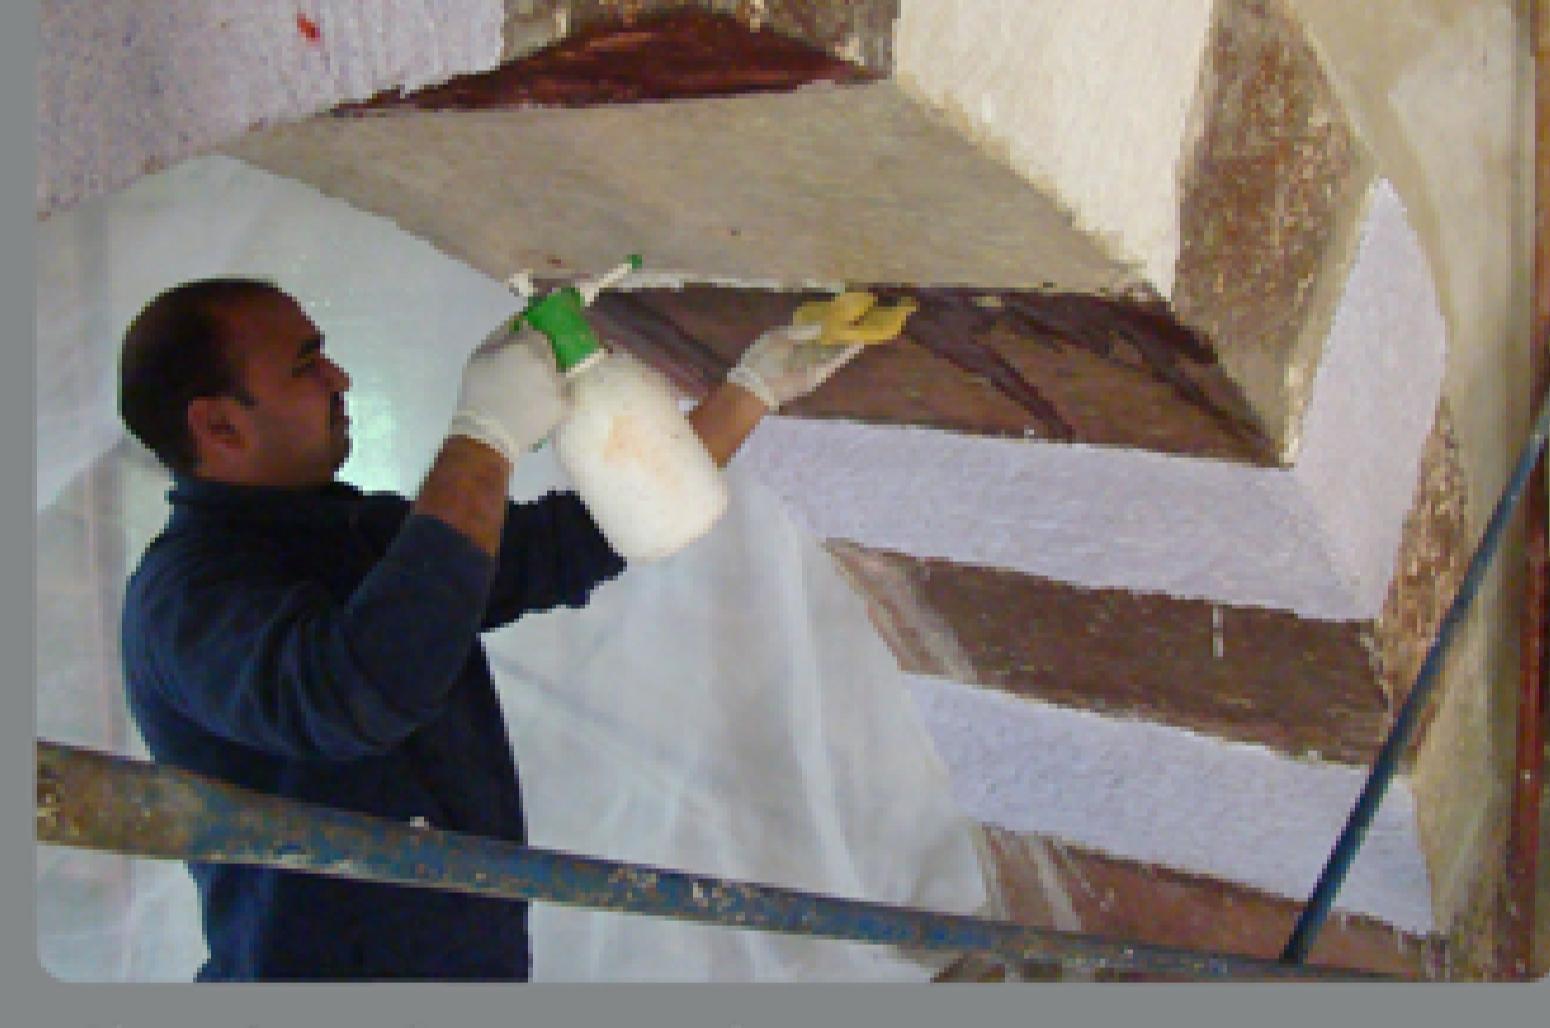
Cleaning of stone arches

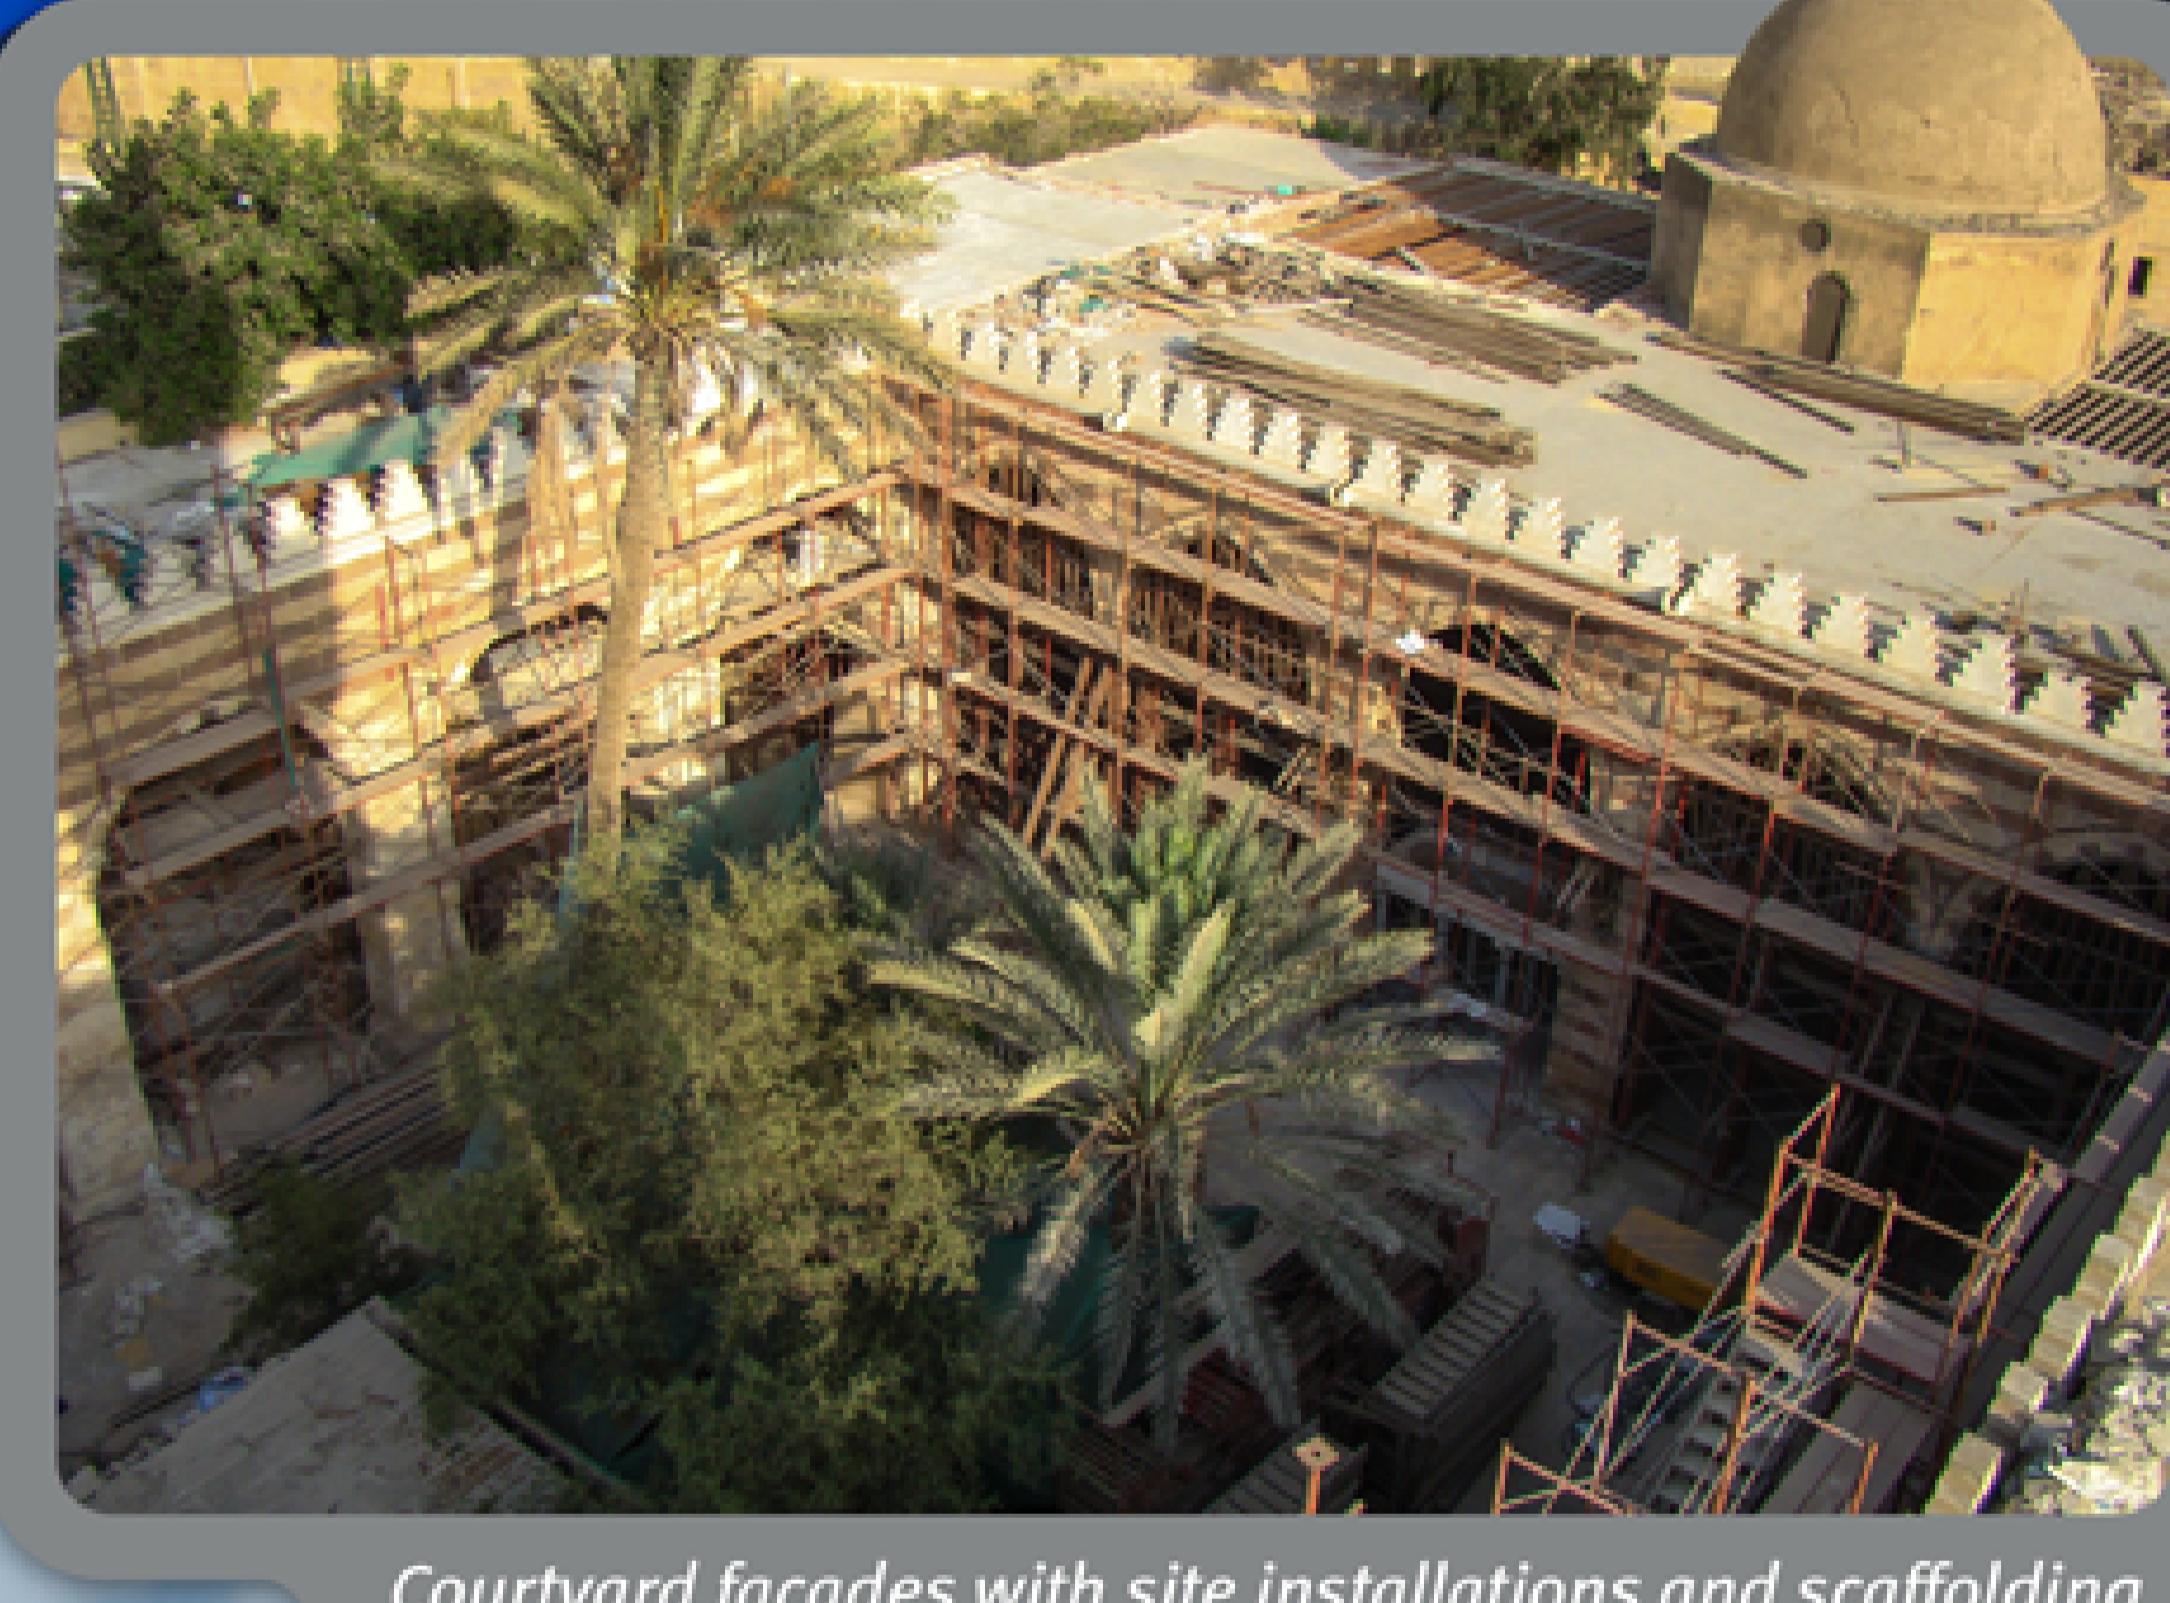
Courtyard facades with site installations and scaffolding

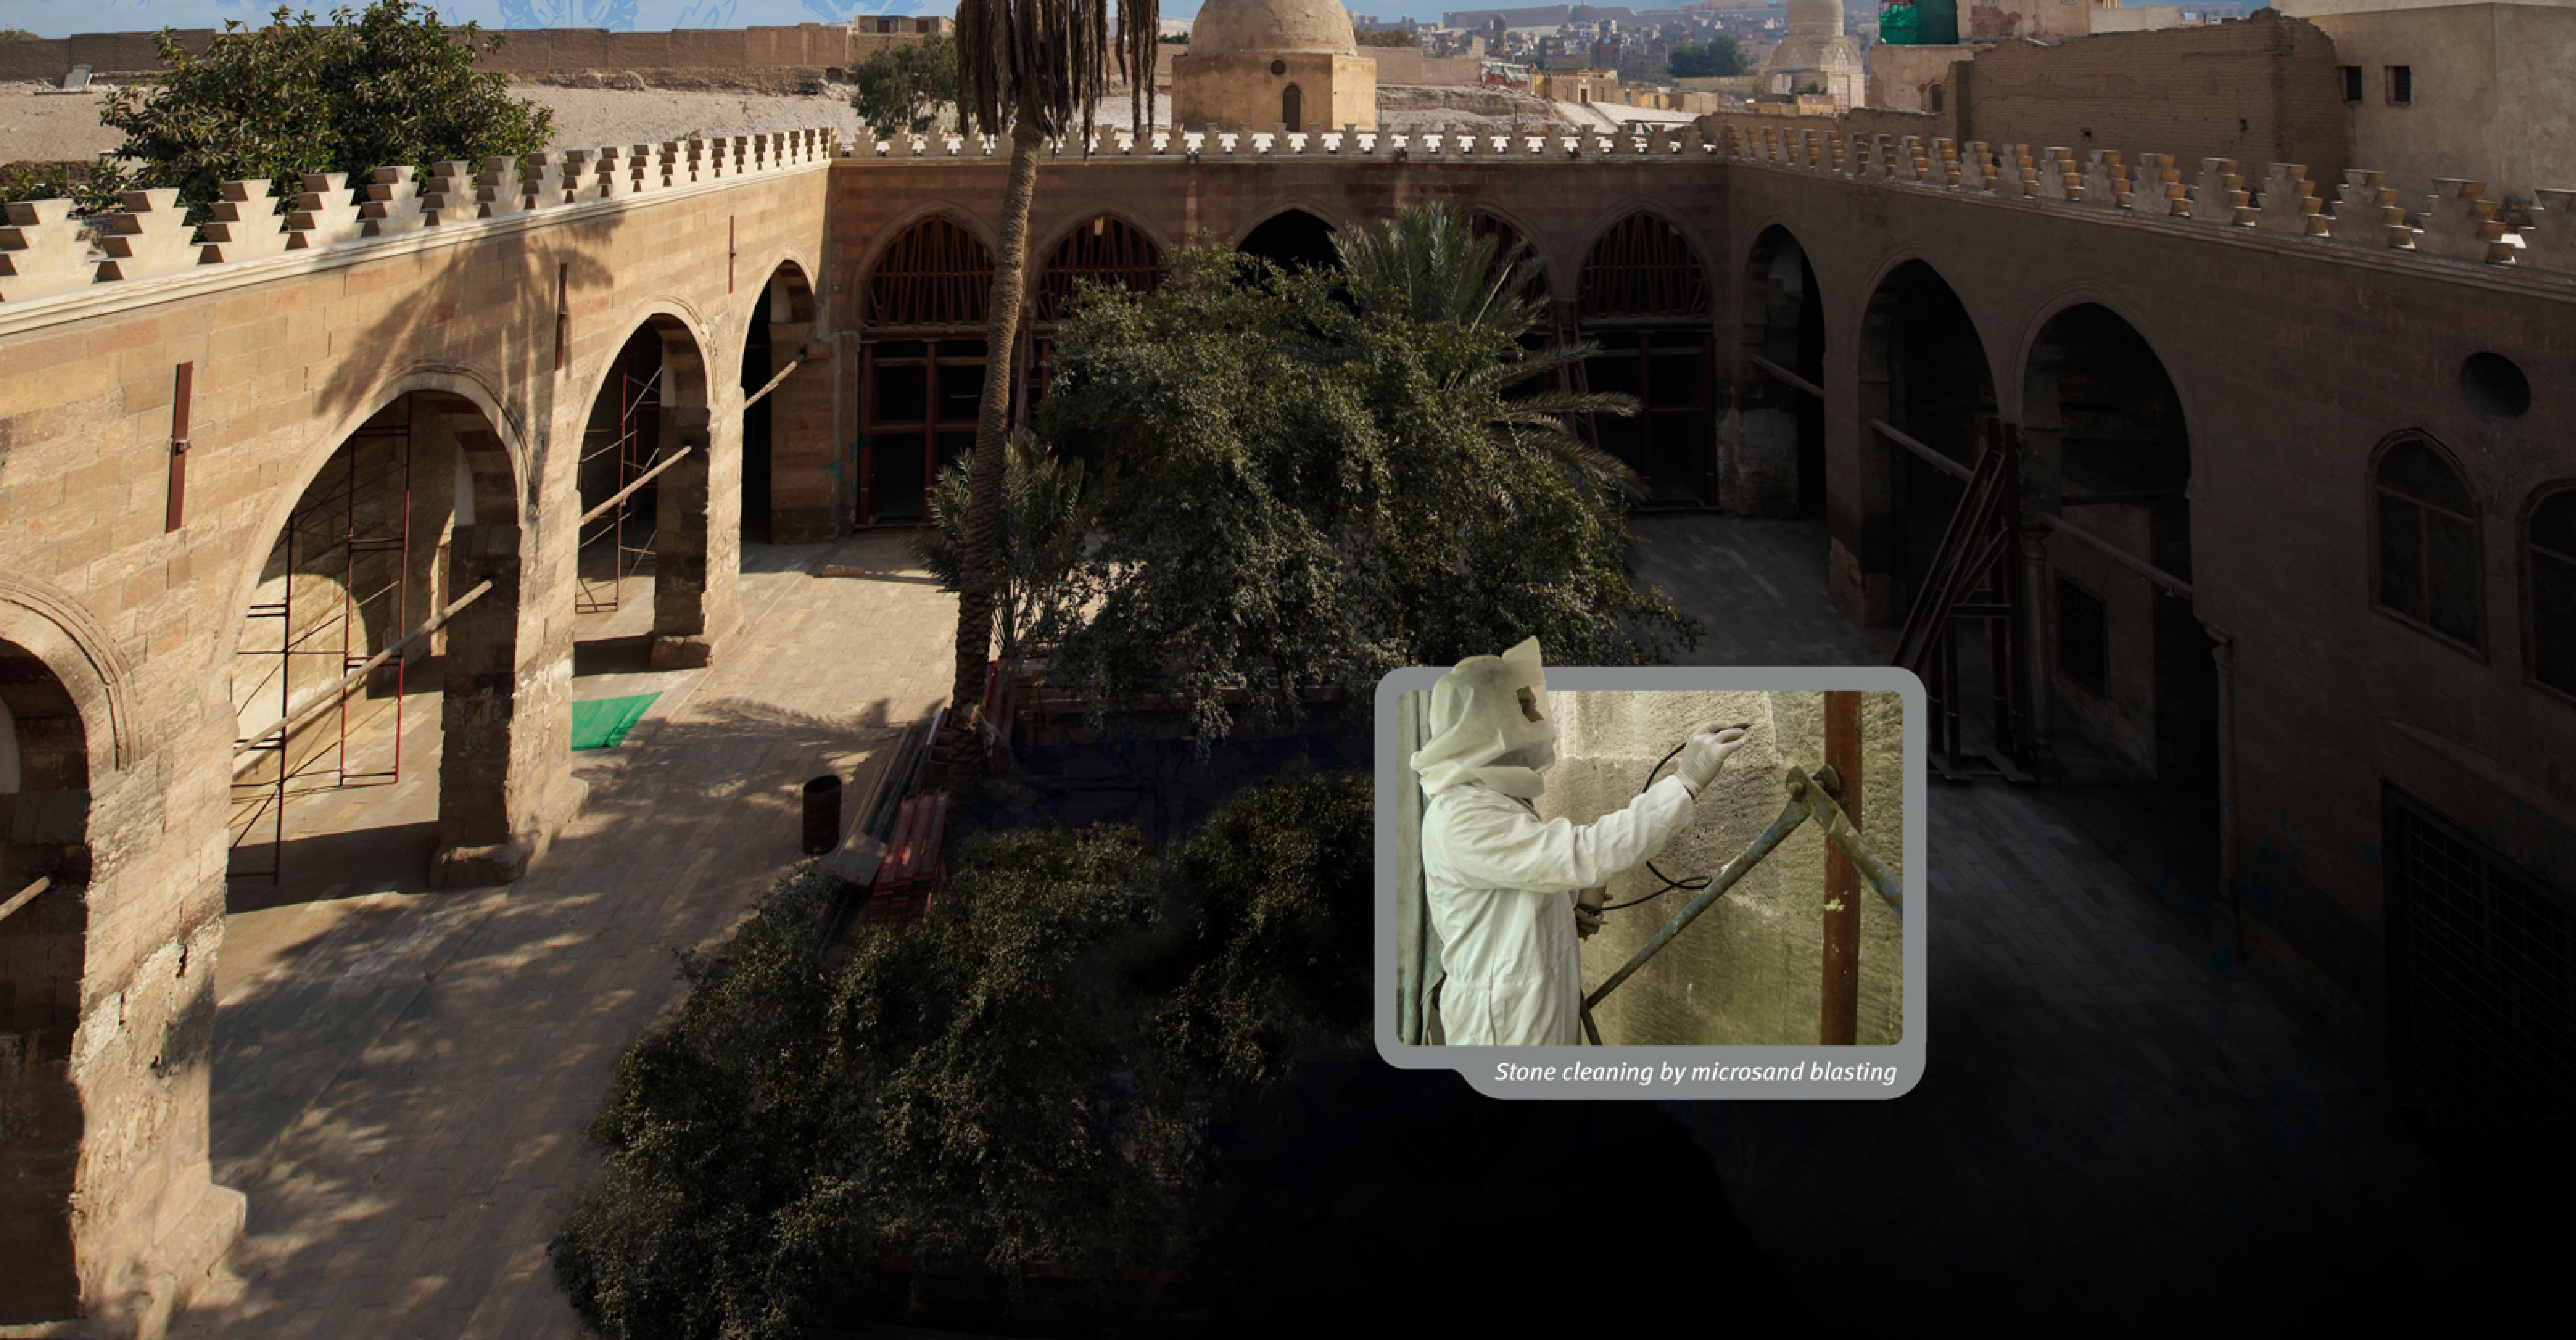
Mosque courtyard before intervention

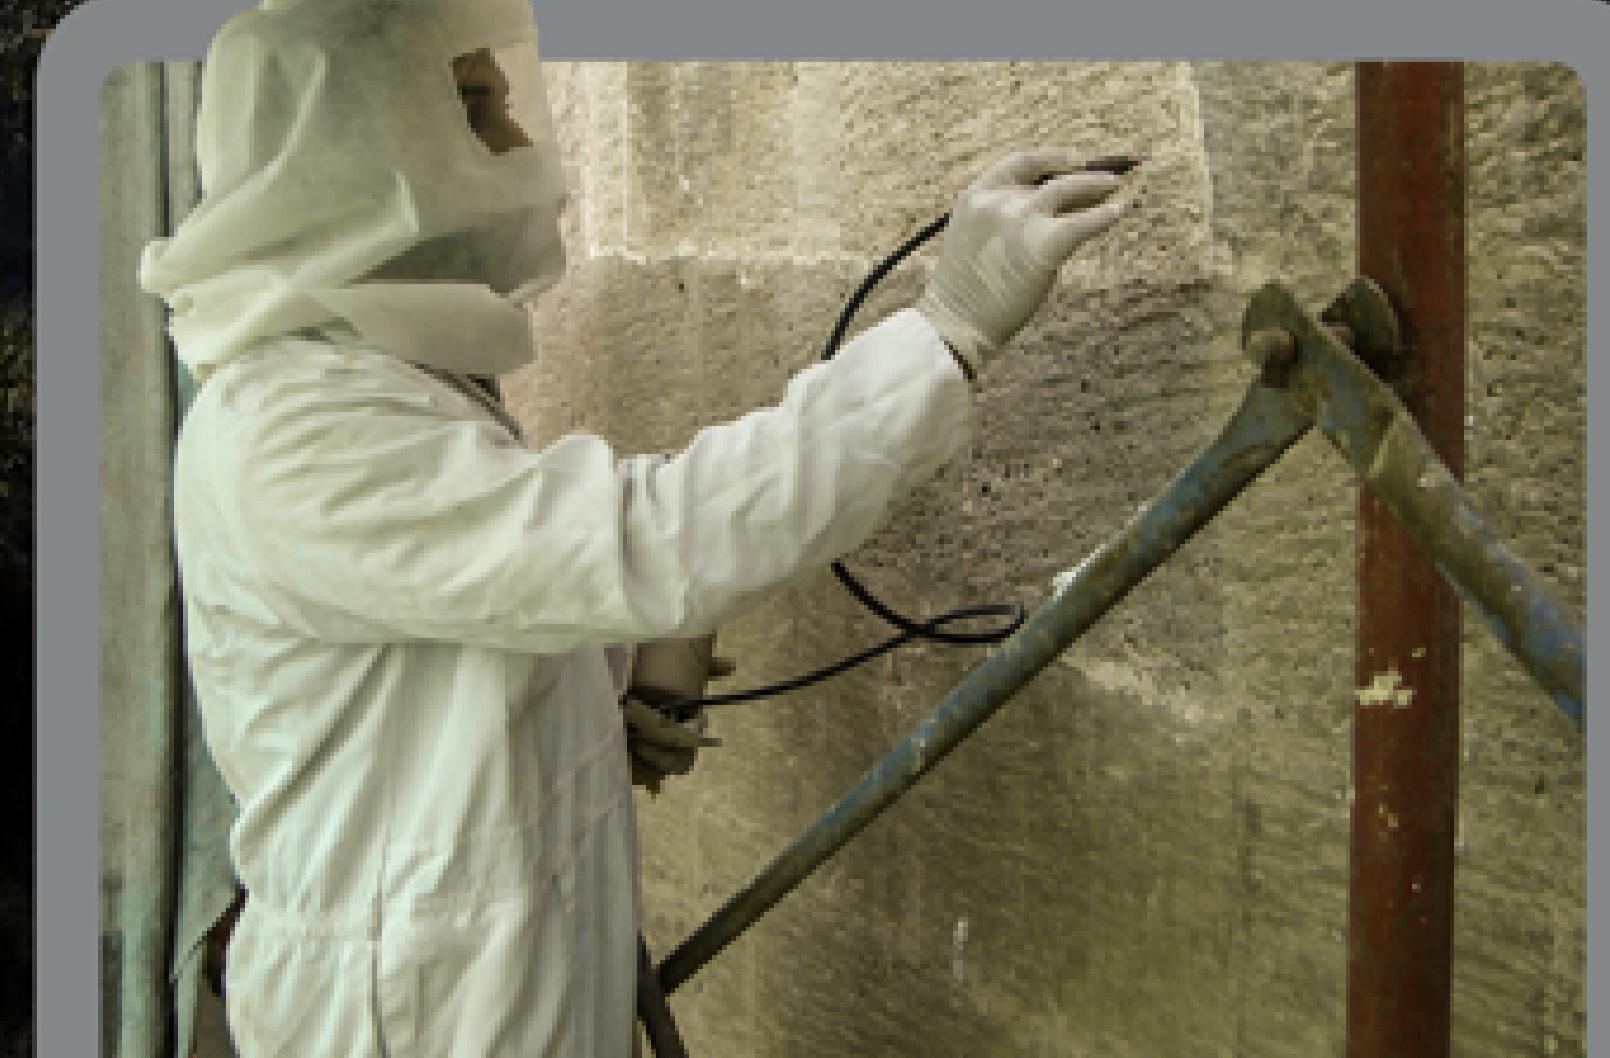
Stone cleaning by microsand blasting
