WORLD
MONUMENTS
FUND

PHNOM BAKHENG BRICK SHRINE CONSERVATION AND STABILIZATION WORKSHOP

June 1 - 4, 2010

BRICK SHRINE CONSERVATION AND STABILIZATION WORKSHOP PACKET

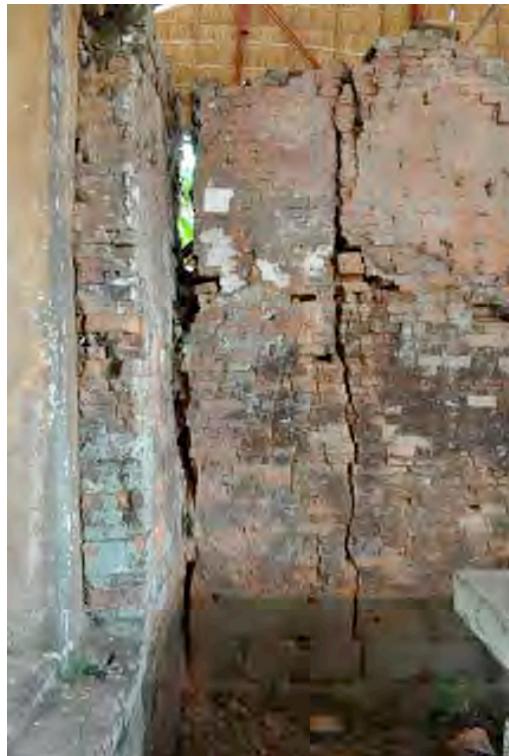
Fig 6: G10 typical crack at corner where interlocking is missing

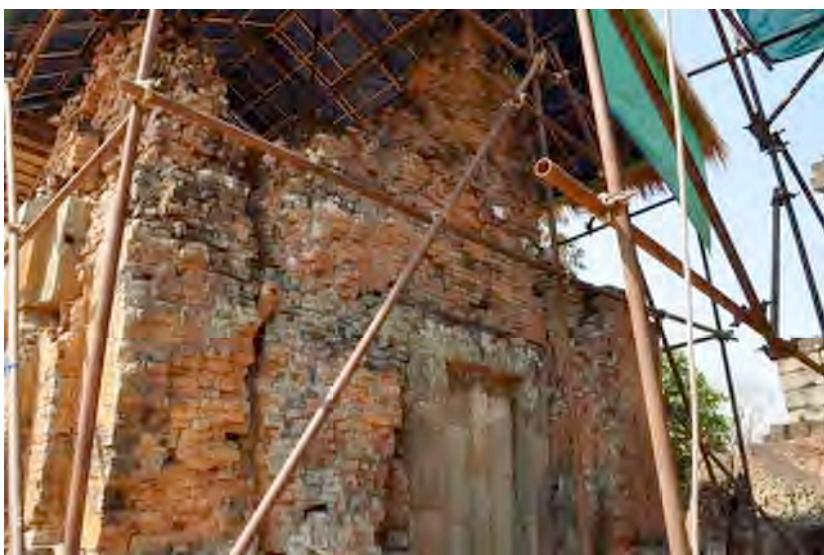
Fig 7: G5 Crack in brick with tree

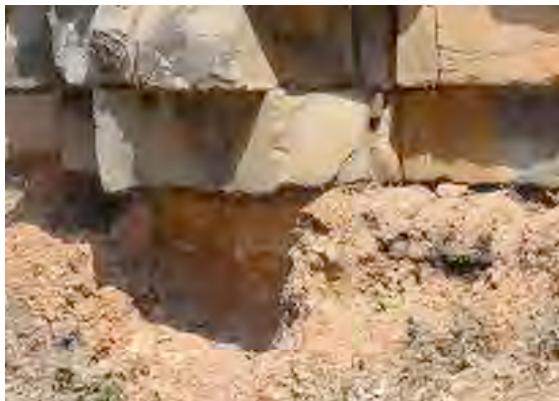
Where laterite is exposed to the elements it is heavily deteriorated and has lost its bearing capacity as supportive foundation material. In locations where laterite is covered by sandstone it is well preserved and structurally intact.

Fig 8: G10 SW corner - deteriorated laterite

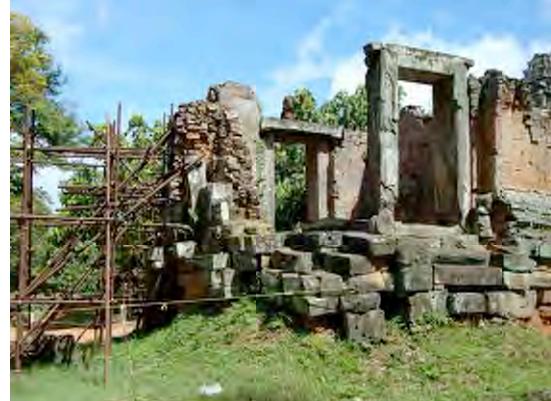
Fig 9: G10 NE corner – freestanding sandstone door

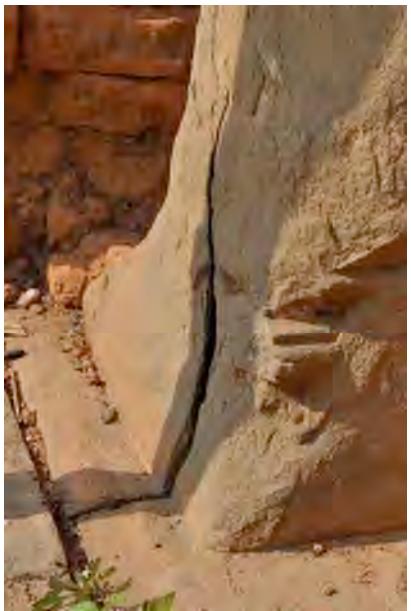
In comparison to laterite and brick, most of the sandstone elements are well preserved based on its greater resistance to physical stress and water induced deterioration. As a result there are examples where sandstone elements are preserved whereas the rest of the shrine has collapsed. Decay in sandstone concentrates at the base and in upper areas of doorframes and adjacent pilasters. Weathering in these locations has led to exfoliation and scaling and in some areas resulted in loss of material. The occurrence of salt crusts near weathered areas suggests salt-water induced deterioration processes. There is little microbiological deposit and some lichens, especially in protected and horizontal areas where water can accumulate.

Fig 10: Deteriorated sandstone at base of door

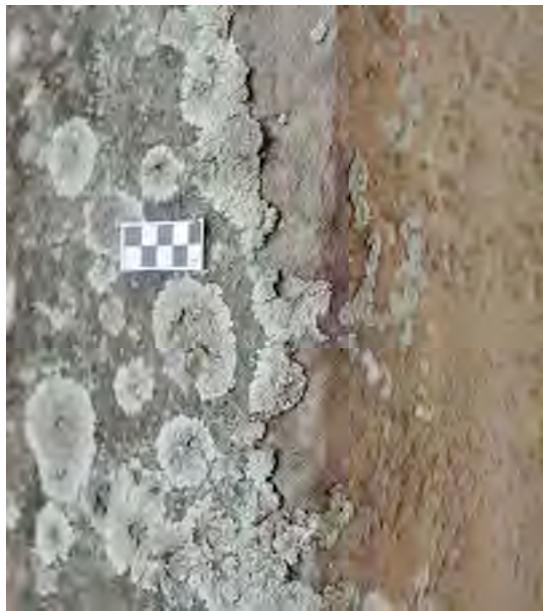
Fig 11: Lichens on sandstone at doorframe

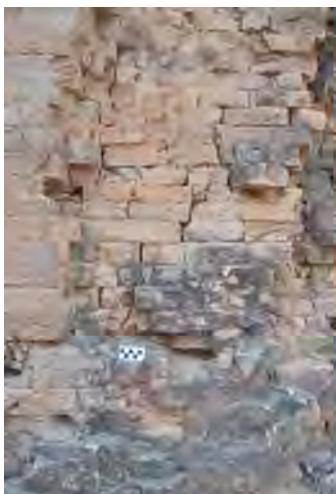
The majority of bricks are in moderate to good condition. In locations where structural damage occurred, bricks are heavily damaged and have lost their structural bearing capacity, which has often led to loss of larger sections of walls and roofs. In addition, there is crumbling disintegration and exfoliation on surfaces that are exposed to heavy weathering, for example on superimposed architectural features like cornices. The surfaces of straight walls are generally in good condition. Microbiological growth is located where water accumulates and mainly occurs in a black biofilm.

Fig 12: Deterioration in brick

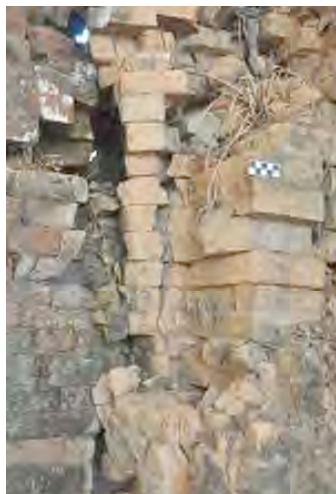
Fig 13: Structural damage in brick

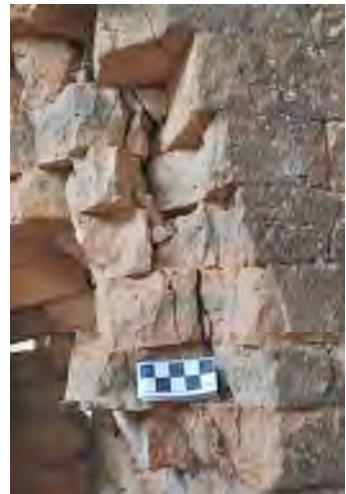
Fig 14: Detail of structural damage

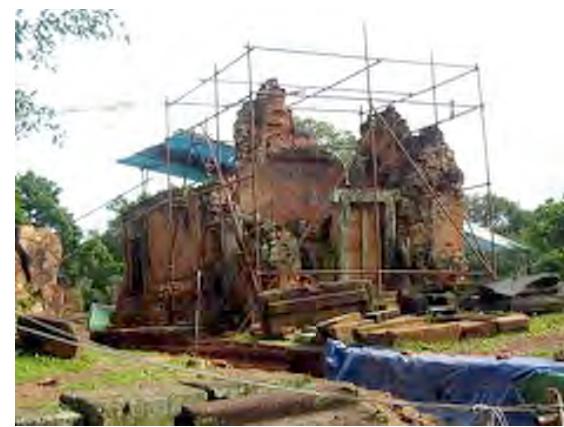
Fig 17: G5 - SW corner

There are vertical cracks that run through the entire height of the remaining walls at each elevation and upper corners are missing, which leaves walls yawning open. Gaps give space to vegetation and accumulation of soil, as there is a tree root in the north elevation.

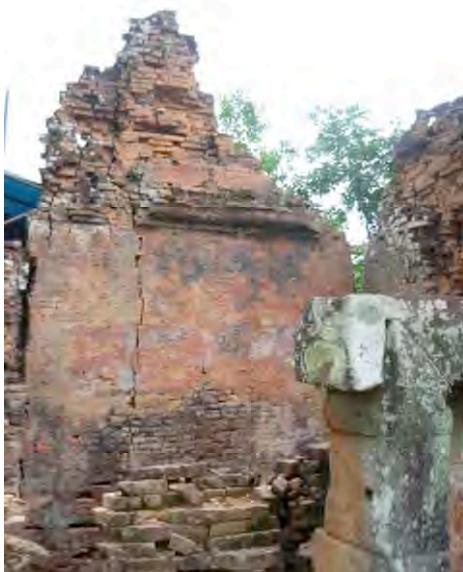
The majority of the brick walls above the doorway height are missing and the remaining walls are in bad condition. The north wall is relatively intact and contains the largest amount of remaining bricks. It carries some of the few remaining colored plaster at interior walls of brick shrines in Phnom Bakheng. The plaster is in decent condition with partial loss due to vegetation growth and deteriorating brickwork, and is subject to microbiological growth. On top of this wall sits a large mass of structurally unstable brickwork that is in danger of collapse, hence poses a threat to the intact wall with plaster remains underneath.

Fig 18: G5 – North wall with colored plaster

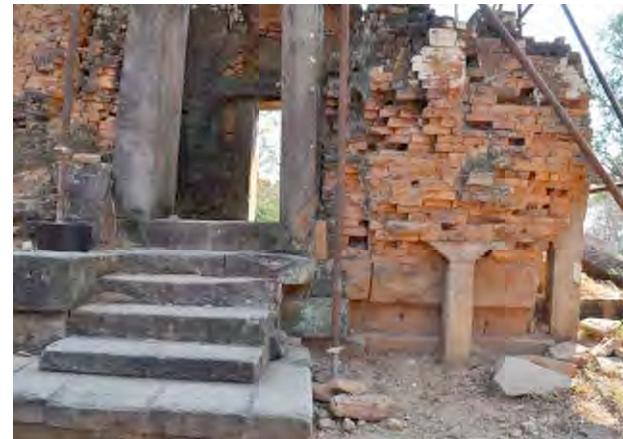
Fig 19: G5 - Concrete columns installed by EFEO

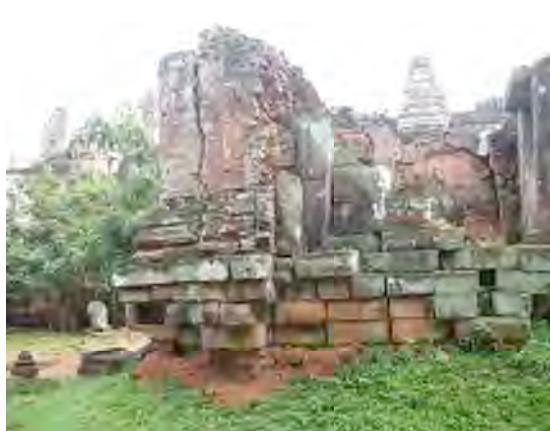
The majority of sandstone platform encasement of brick shrine G10 is missing, which has left the laterite blocks exposed to the elements. As a result the laterite foundation has deteriorated to the point that sandstone blocks of the base of the shrine are undermined and destabilized. Several units have dislodged leaving the corners in danger of collapse. The southwest corner is in very bad condition and remaining sandstone blocks are currently being held in place by a pipe scaffolding shoring and wooden props. At the northeast corner, several sandstone blocks fell out of place during a large rain storm in 2009. These blocks were replaced and are currently shored with wood supports.

Fig 21: G10 - deteriorated laterite foundation

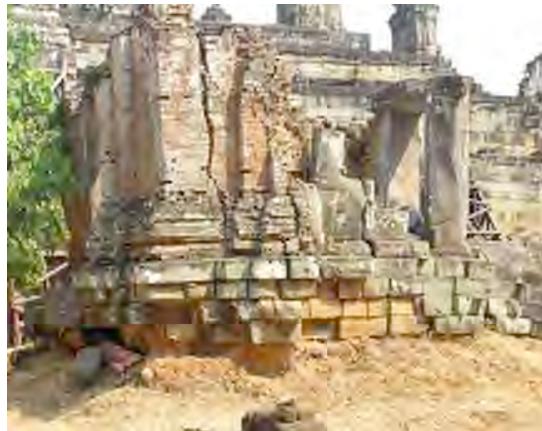
Fig 22: Cracks in brick at G10

The entire brick wall at the east elevation has collapsed, as has half of the north and parts of the south, leaving the sandstone door almost free standing. Remains of walls show vertical cracks and are cut open, which allows water to enter into the masonry and promotes deterioration.

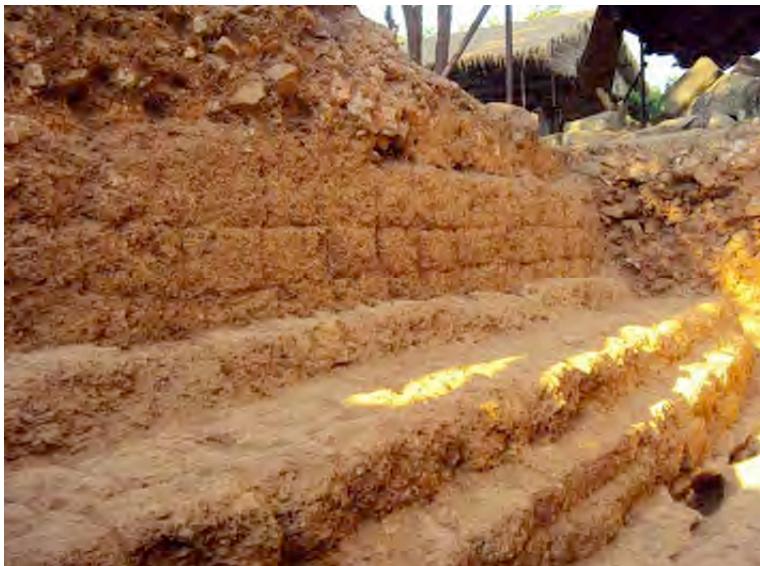
The southeast corner of G10 was excavated during the beginning of 2010 to confirm that the laterite foundation is sitting directly on the bedrock. The excavation confirmed that the laterite, while deteriorated at the exposed surfaces, is in relatively good condition and does sit directly on the bedrock.

Fig 23: excavated laterite foundation sitting directly on bedrock

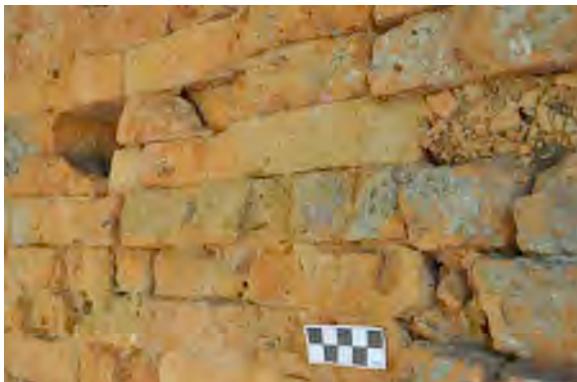
Photo: G10, West wall, exterior

a) Brick deterioration includes exfoliation left, and crumbly disintegration right

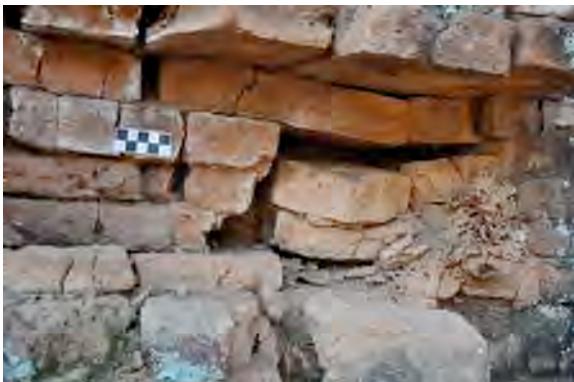
Photo: G10, North wall, exterior

b) Loss of brick material due to heavy deterioration and structural failure

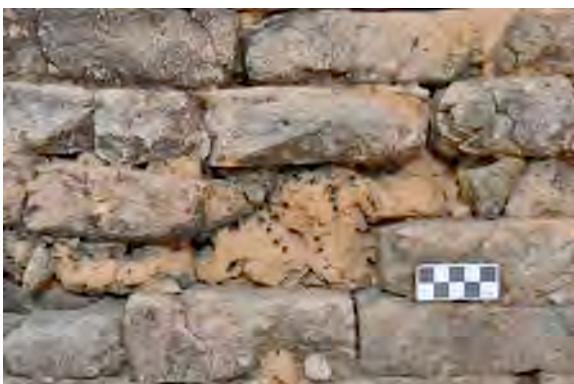
Photo: G10, South wall, interior

b) Loss of brick material due to vandalism or later renovations

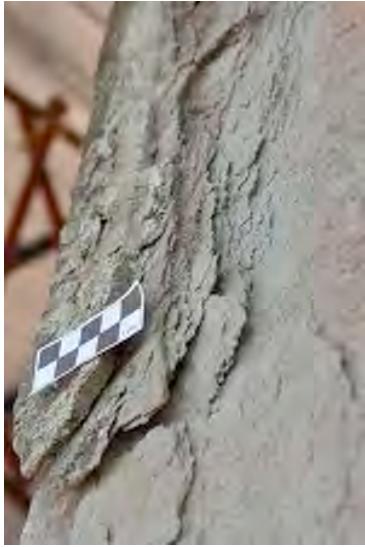
Photo: G10, doorframe, East, exterior

d) Exfoliation of sandstone.

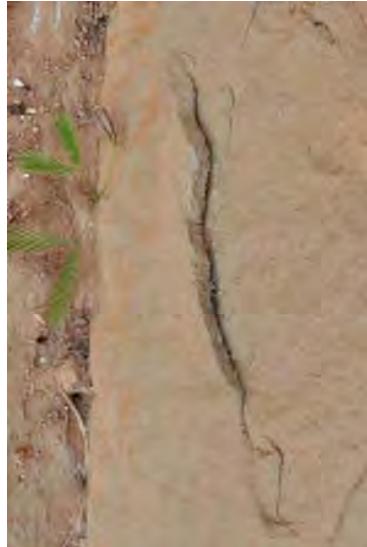
Photo: G5, doorstep, East, exterior

d) Scale of sandstone

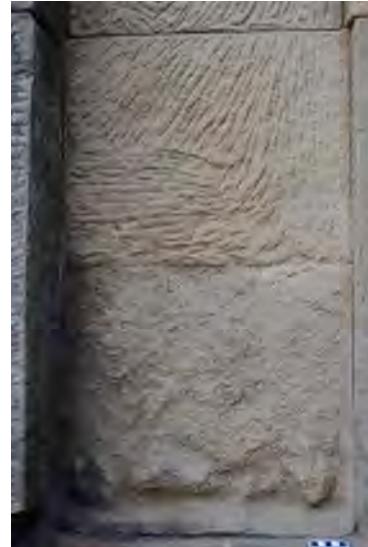
Photo: G10, doorframe, North, exterior

e) loss of material due to heavy deterioration

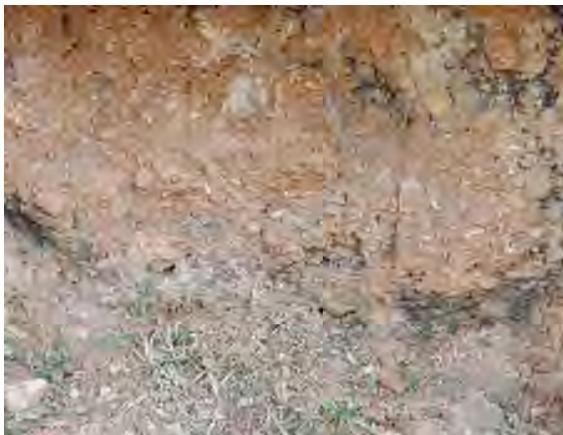
Photo: G10, South

f) Laterite deterioration

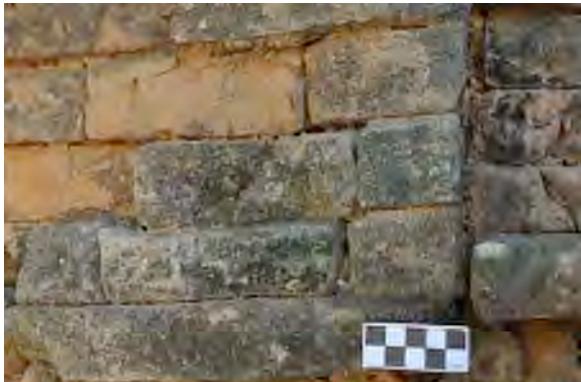
Photo: G10, East wall, exterior

Biofilm microbiological growth including algae, bacteria, and lichens

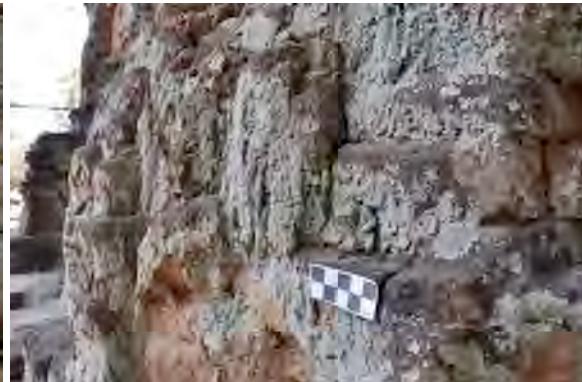
Photo: G10, North wall, exterior

Biofilm microbiological growth including algae, bacteria, and lichens

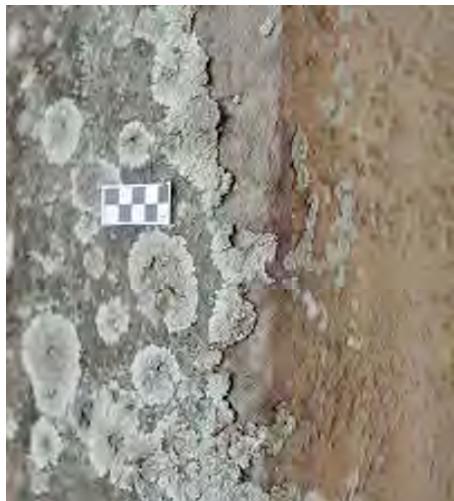
Photo: G10, West doorframe, interior

Lichens on sandstone

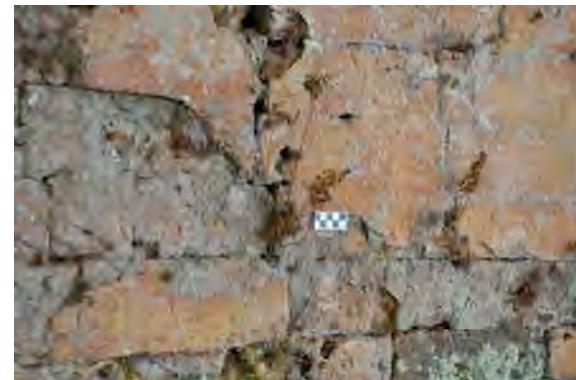
Photo: G10, North wall, interior

Macrobiology (includes all plants and mosses)

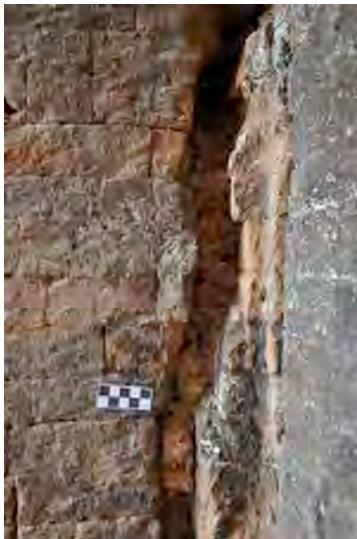
Photo: G10, SW corner, interior

Soil deposit due to termite colonization inside crack

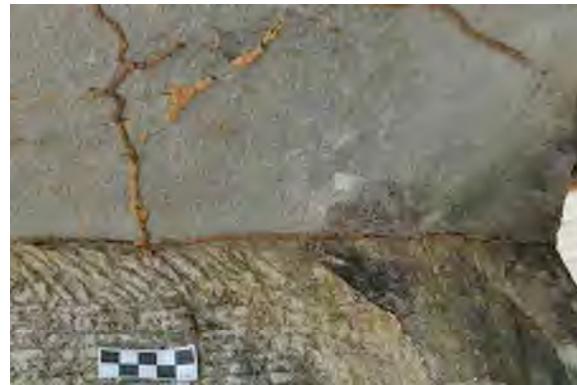
Photo: G10, East, doorframe, lintel

Soil deposit due to termite colonization on sandstone

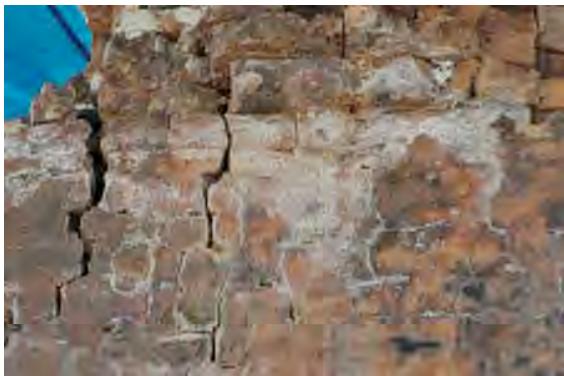
Photo: G5, North wall, interior

Salt crust on brick

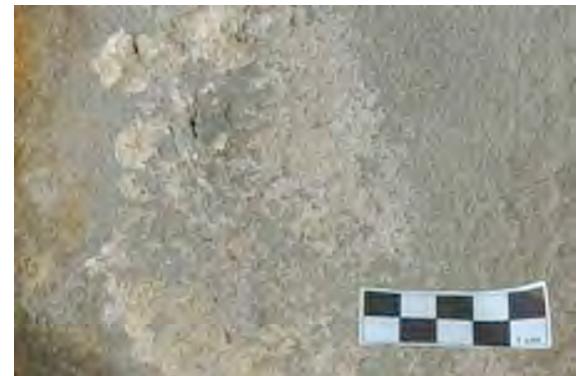
Photo: G10, East, lintel

Salt crust on sandstone

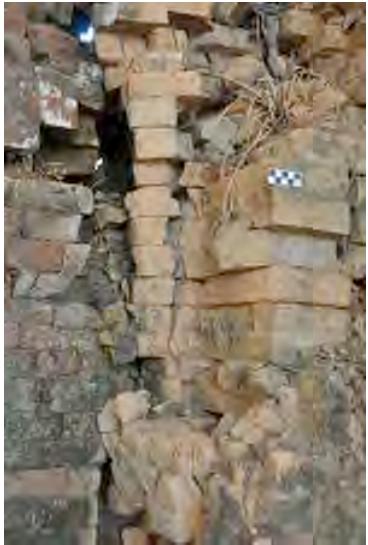
Unstable area in danger of collapse

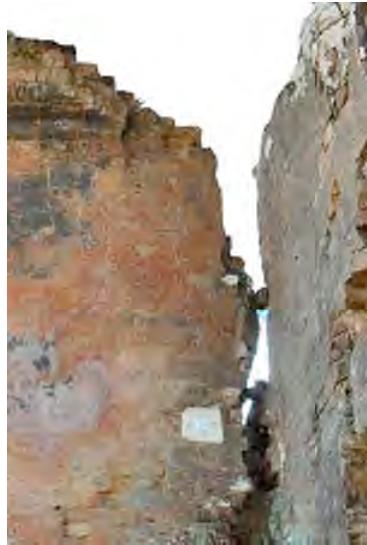
Gap

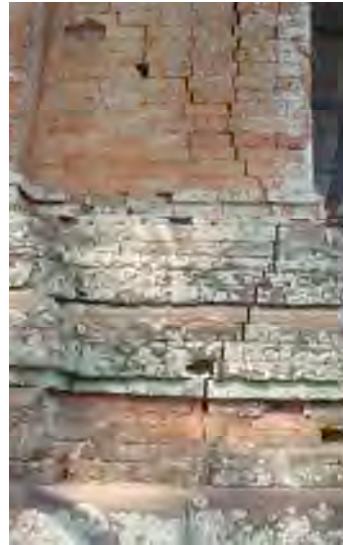
Photo: G10, NE wall/corner, interior

Crack

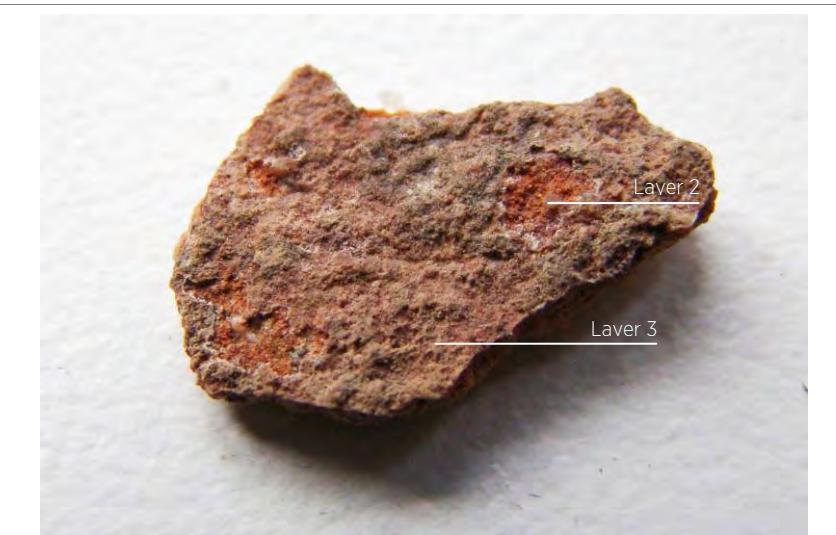
Figure 9

Exposed surface of stucco, note semi-opaque layer 3 over red-orange layer 2.

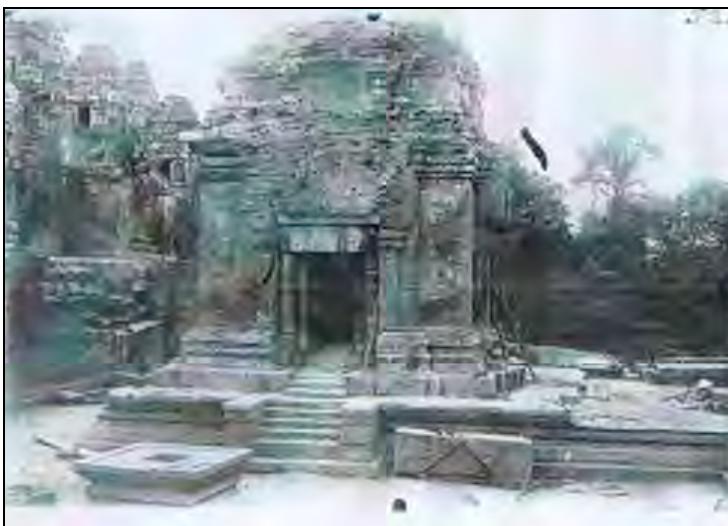
Photo CA 523, 14132, East façade of G34

We are removing the rock that was supporting the foundation of a matching shrine on the east side, but this shrine is completely demolished and there remains nothing but a heap of dirt and bricks. The stones themselves that made up the covering of the sub-flooring have disappeared. We found a pedestal that appears to still be "in situ" and that marks the center of the missing ... this can be seen in photo 523, which can be compared to photos 509-510 and 513 showing the same view.

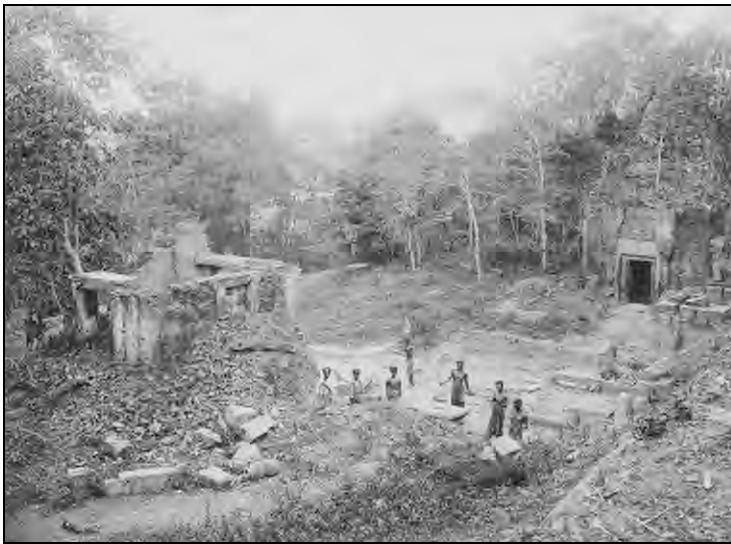
Photo 1538, 13958, rapport 05/29, G10 avant degagement (before clearing)

Photos 1537 and 1538b (combined to form a single view) and photo 1538 show two perspectives of this work. I sent to the warehouse the statue found in August 1928 near the foundation of shrine B. This statue is 1.5 m high, with all of the characteristics of style 1 – photos 1539 and 1540.

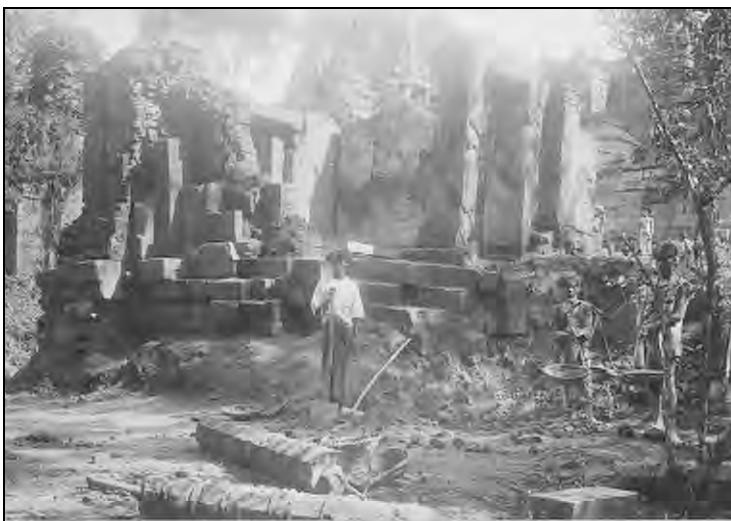
Photo 1555, 14140, G10, 06/29

Photo 1555 shows the southeast corner of this shrine during clearing, and 1556 shows its northwest corner. A hole in the foundation at this corner threatened to cause the wall to collapse, and had to be filled with cement. The pedestal mentioned in my earlier report is still in place. The interior of the shrine's cella has been cleared of rubble. It should be noted that the slab of the cella is .9 m below the level of the east and west door frames.

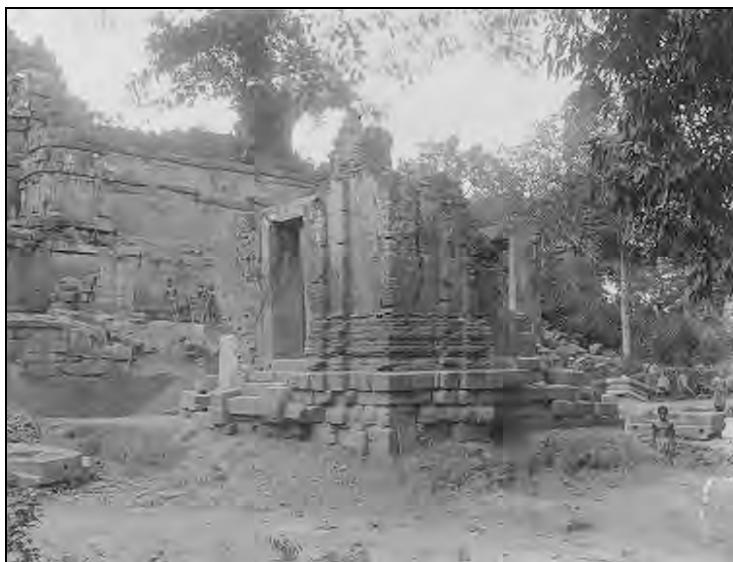
Photo 1654, 13961, G10, 08/29

Photo 1654 shows the work site, with the previously cleared shrine in the foreground, and pencil marks indicating the stones brought in for reinforcement.

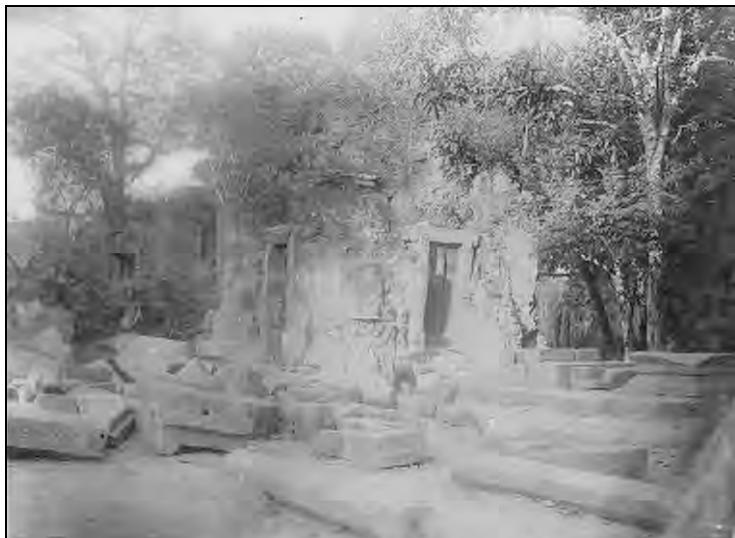
Photo CA 1792, 13969, pyramid SE angle, 12/29

In the southeast corner of the first tier of the pyramid, after removal of the rubble, the bedrock of the hill was completely revealed, as the sandstone cladding of wall has completely collapsed. Photo 1792.

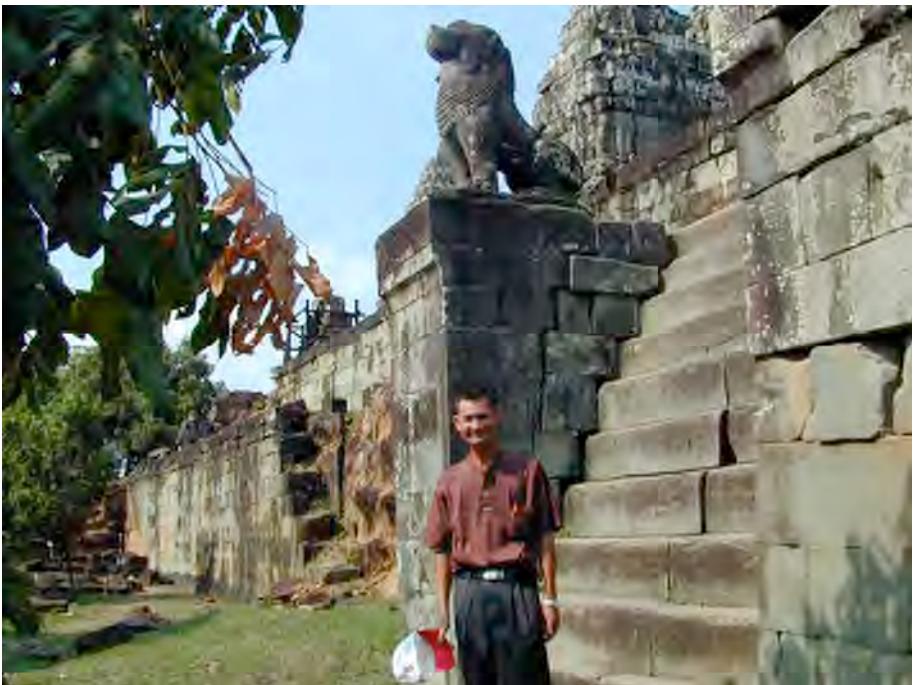
West elevation north of stairs. Tree blocking exact reproduction of photograph.

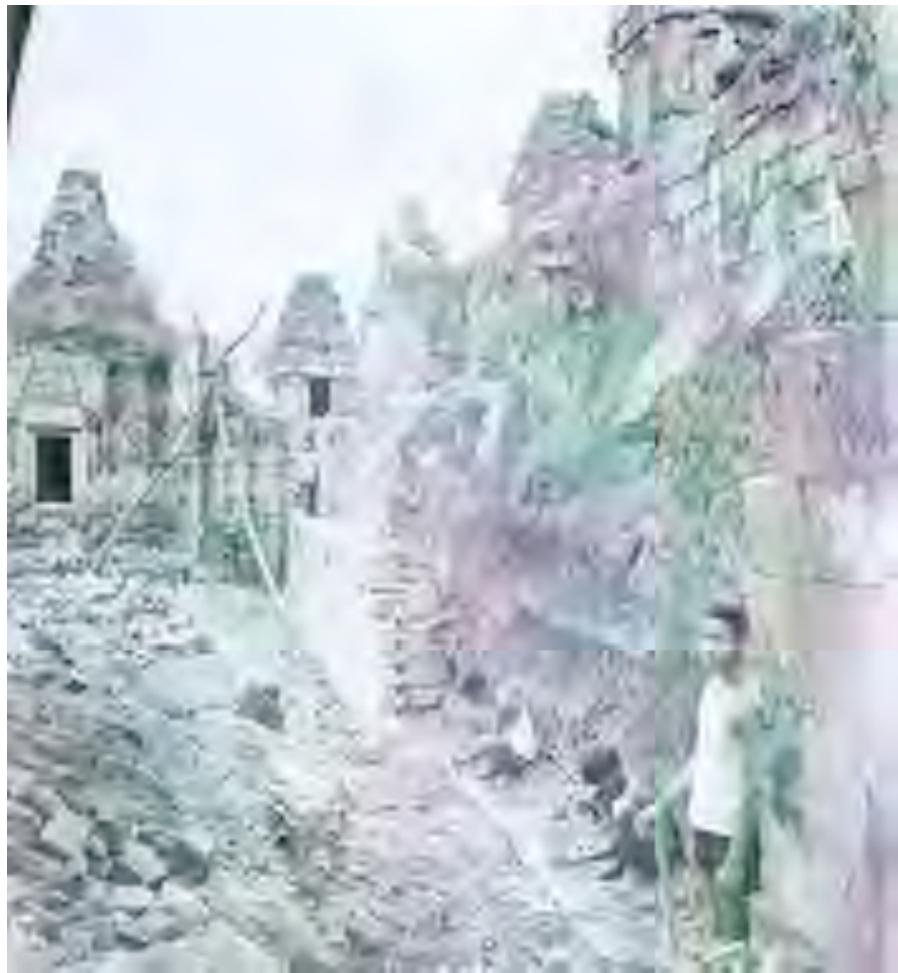
South elevation, east of stairs. Tree blocking exact reproduction of photograph.

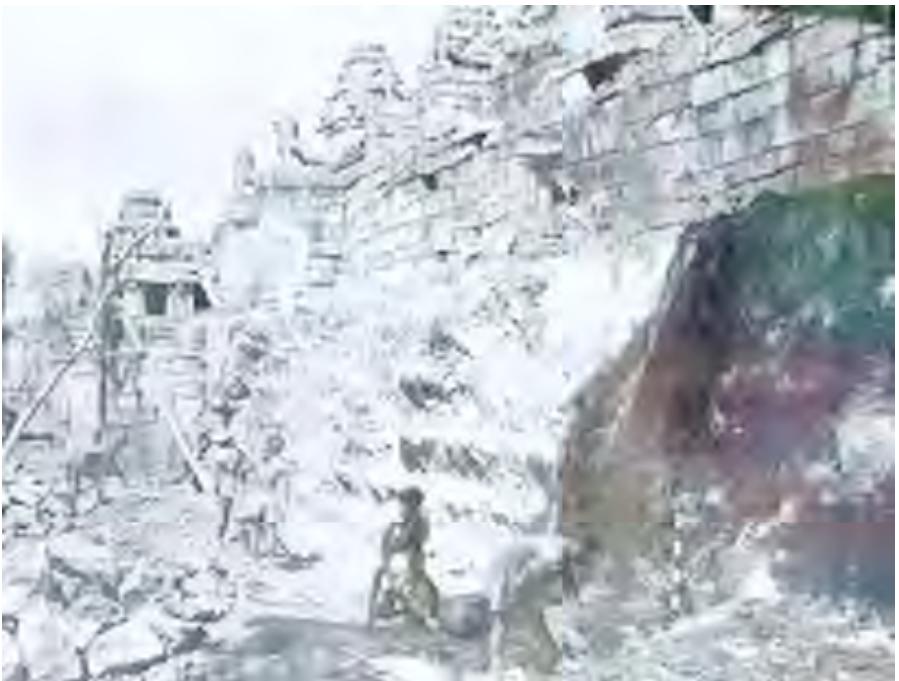
South elevation, 1st level, to east of stairs. Trees in the way for exact photo reproduction.

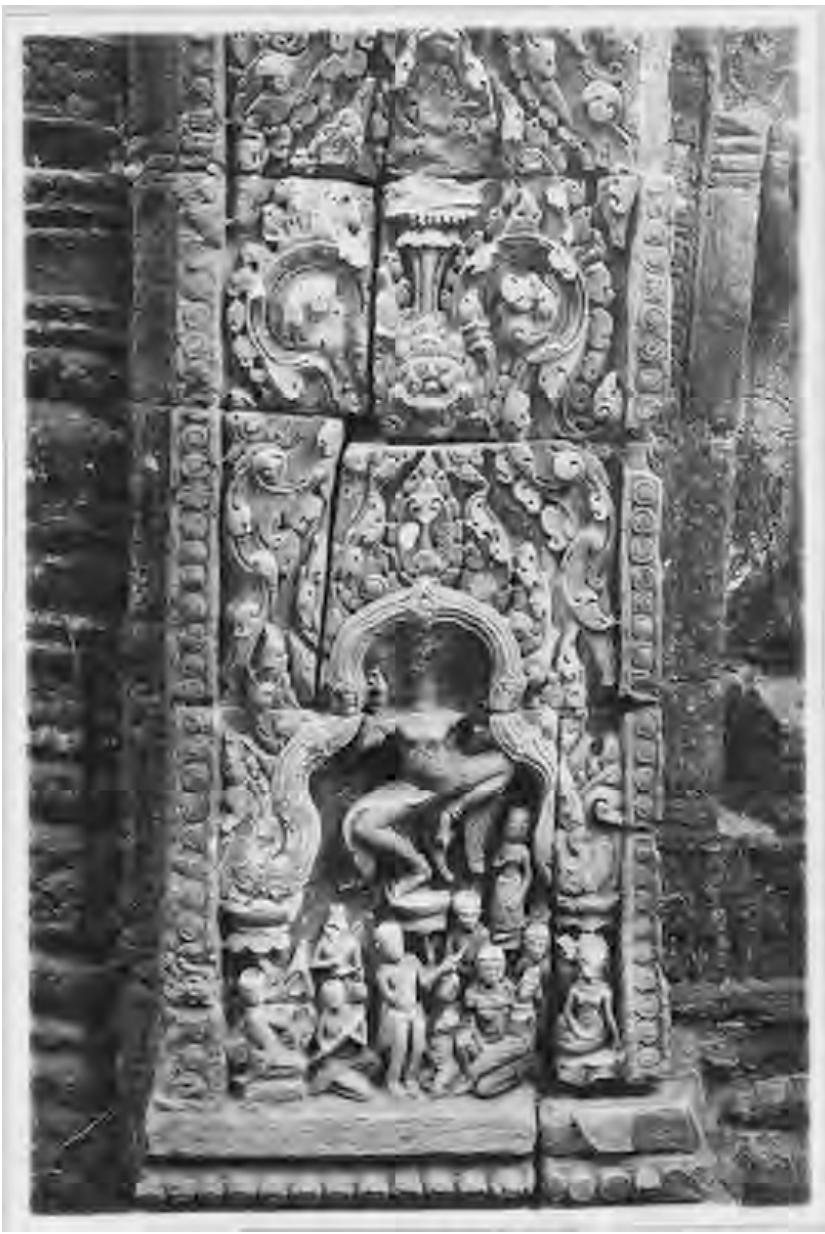
This does not exist at Phnom Bakheng.
